# STEREO IMPACT

PROBLEM REPORT

PR-1001

QualBoomDeploy

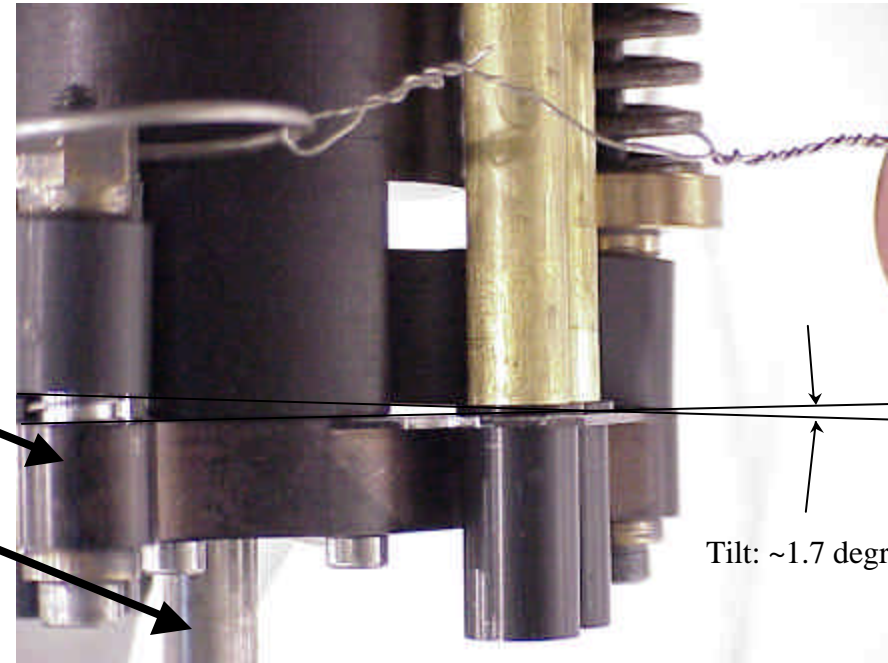
- **The bobbin was nominal. Harness was unaffected.**
  - **SMAR pinpuller appeared to have functioned correctly.**
  - **The source of the anomalous behavior was then able to be seen: The tail of the tip piece was trapped in the SMAR 'floating' mount.**

- The mount is used to preload the tubes for resisting launch loads. There are 2 fixed pivots, and a coil spring used to apply the load to the tip piece tail. The release of the SMAR pinpuller allowed the coil spring to unload faster than the tip piece could clear the floating mount. This induced a tilt to the mount.

Due to the tight tolerance required, there was insufficient room for the tip piece to withdraw from the mount, and thus became locked into the SMAR mount.

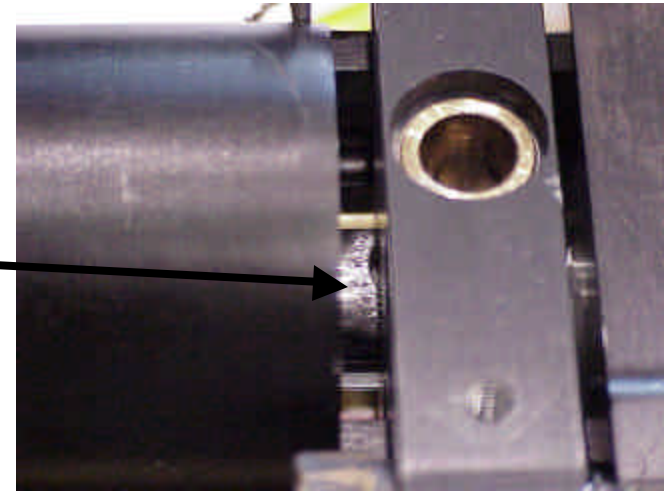
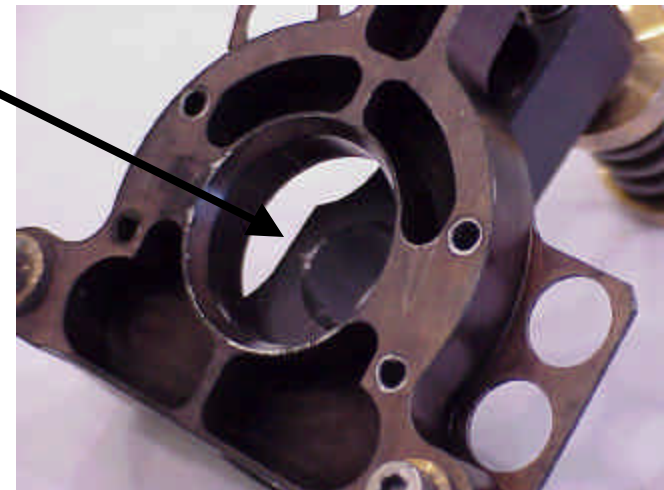
- This was not seen during the previous anomaly as the latching had been released when the safety pin was installed
- Close inspection revealed galling of the Ti tip piece, as wear had accumulated from deploying. The mount functioned as a sliding clamp, with 2 edges grabbing the tip piece. The second picture shows the wear on the mount from hanging up the tip.

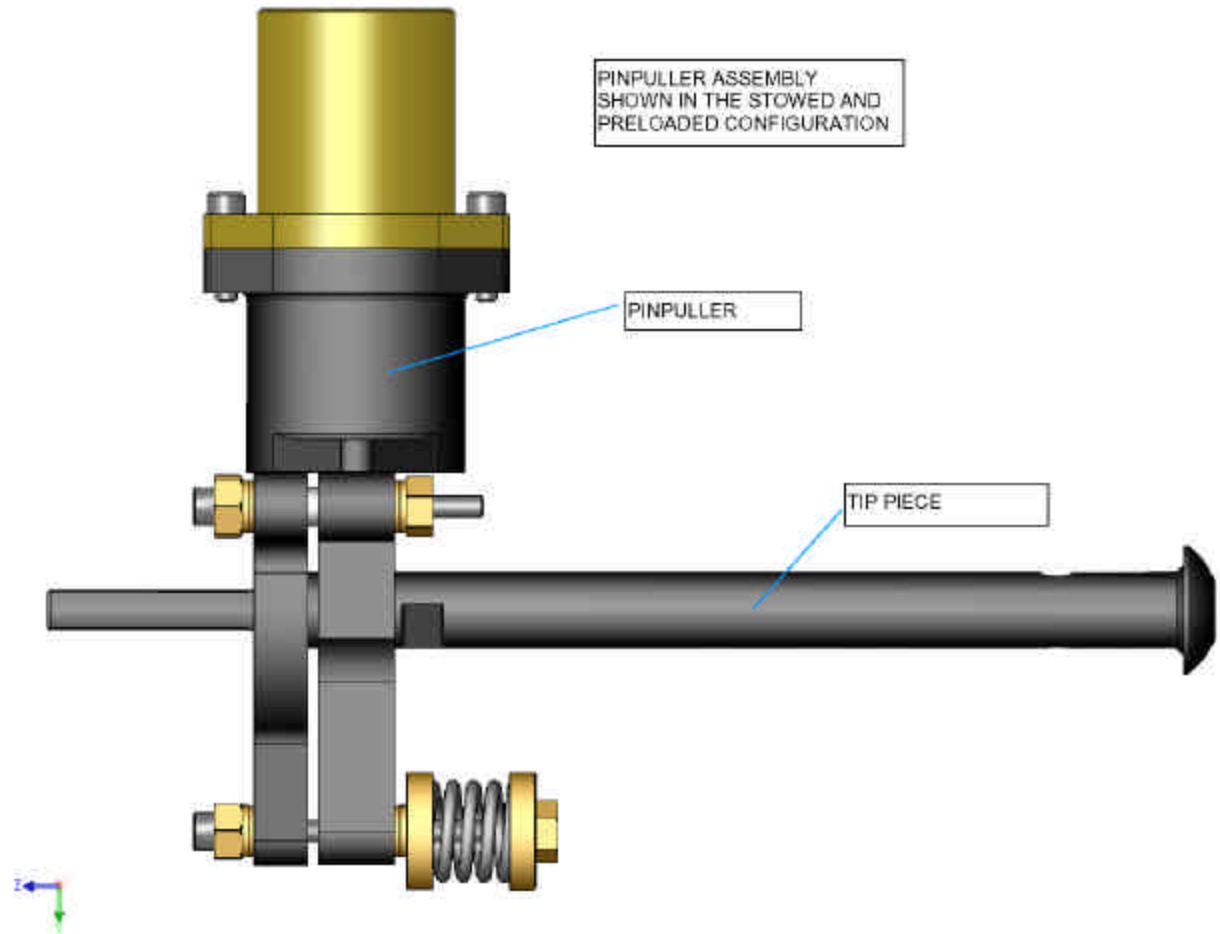
- The solid model was re-examined for verification of the anomalous condition
- This first drawing shows the affected parts, in their stowed, nominal condition

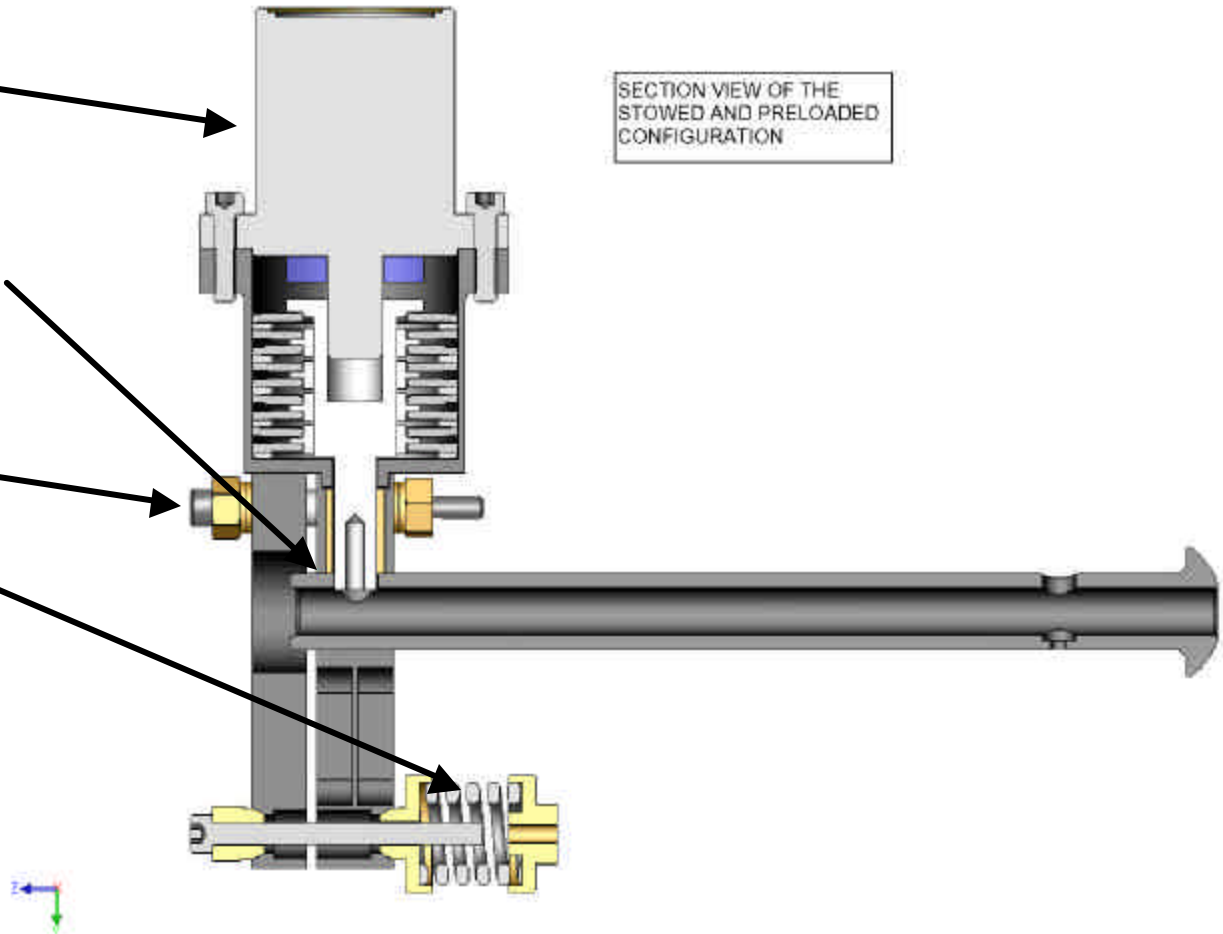
- Note the close fit of the tip piece to the floating mount, where the SMAR pinpuller is inserted into the tip piece.

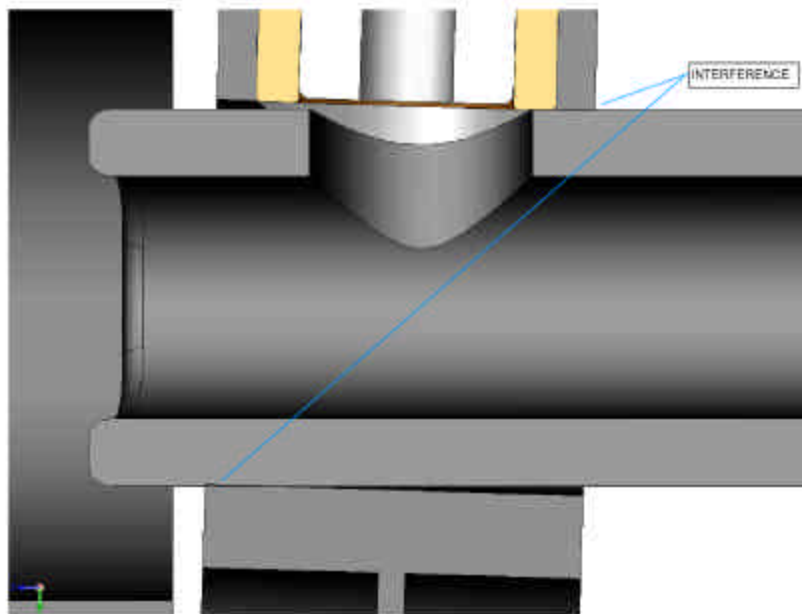
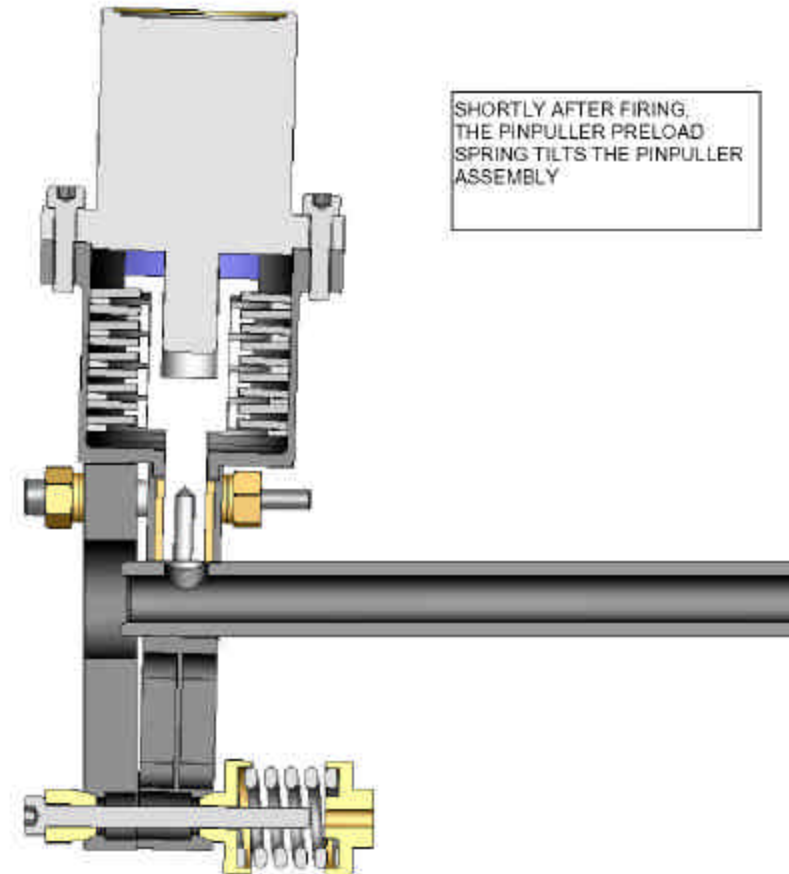
- This drawing is the section view, post SMAR firing
- Coil preload spring has pushed the mount against the housing sooner than the tip piece can clear the through hole.
- The tip piece binds in the mount (detail)

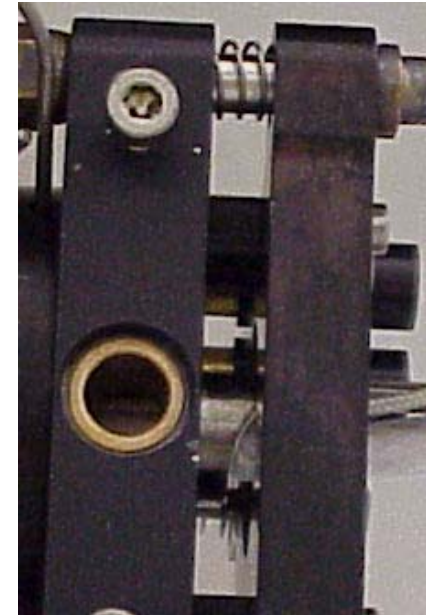
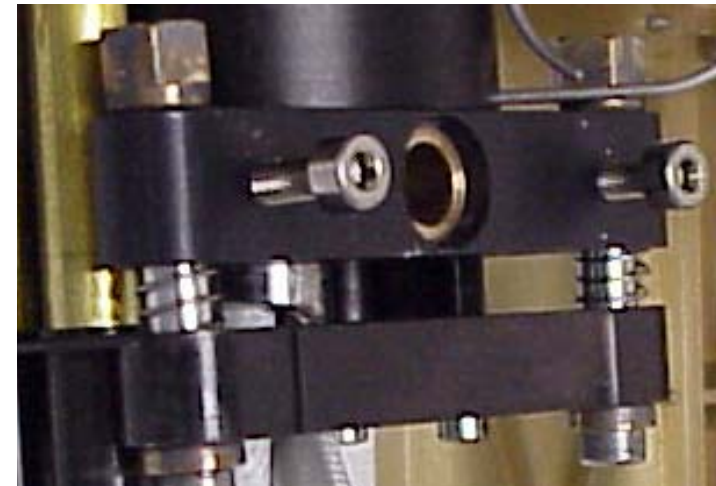
- **After successful deployment of the boom (cold) and Thermal Balance, the boom was disassembled and inspected to look for signs of galling**
- **The pinpuller is removed to increase the viewable area.**
- **Pictures show the tip piece to be free of the markings associated with galling as previously seen.**
- **The tip piece previously showed longitudinal streaks from the "teeth" generated by the galled aluminum in the deployment fixture.**

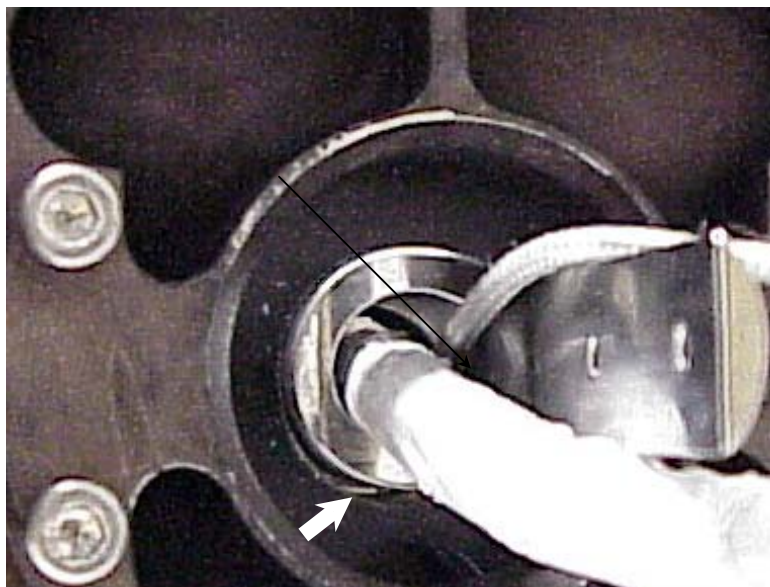
- This picture shows the modification as viewed along the tip piece. The opening that was added to provide clearance is now seen at the bottom of the picture.

- These pictures show that the modifications done to the pinpuller mounting ring are sufficient to remove the galling between it and the tip piece.
