# STEREO IMPACT

PROBLEM REPORT  
PR-1002  
STE-U FM1 Assembly  
2004-04-12

STE-U FM1 Assembly

2004-04-12

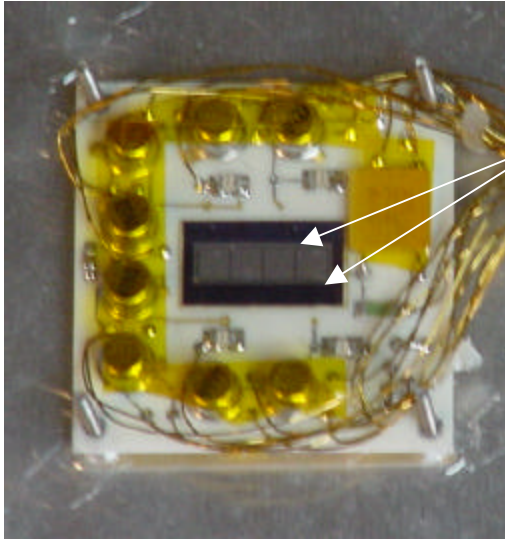
1. One of the detector bond wire has been broken at the detector bond point. There is wire bonded to the detector surface still visible, indicating a break at the knee of the bond joint. The bond wires had been tested mechanically by the manufacturer, and electrically by UCB prior to assembly. The bond wires are exposed during the installation of the detector into the box to damage from accidental contact by the installer. No such contact was noted at the time (three people were present), but no other opportunity for damage existed.

Close inspection of the bonds in question under a microscope reveals that not only was the first bond wire broken where the wire meets the joint, but that the second bad segment bond wire was deformed such that it makes contact with the detector surface at a second location (grounded shield segment). Both bonds are fairly close together, and were likely broken in the same event. The other bond wires look un-touched.

Failed STE detector.

Broken  
bond  
wires

- Rework       Repair      Use As Is      Scrap
1. a. Replaced the damaged detector board (S/N#002) with a flight spare (S/N#004).  
b. A protective GSE cover was added to the assembly procedure of the flight units and will be used for all subsequent builds.  
c. The S/N#002 detector board was returned to the bonding house and the two failed bond wires were removed and replaced. Each segment had multiple contact pads, so fresh pads were bonded to the detector. The reworked detector board was retested and meets the performance requirements and is considered a candidate for use in one of the STE flight units.
  2. Installation of kapton tape over the conductor on the block fixed the problem.  
Resolution: Rework completed. Preliminary tests indicate that the instrument is working fine. All 4 channels are functional and the door is working nominally.

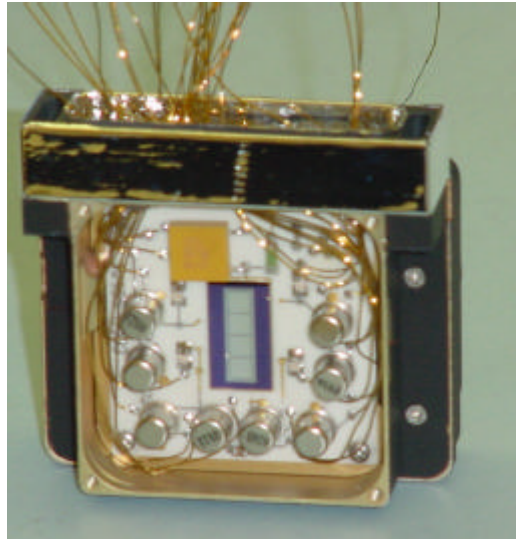
Detector installed in box

Note protective shield taped over detector

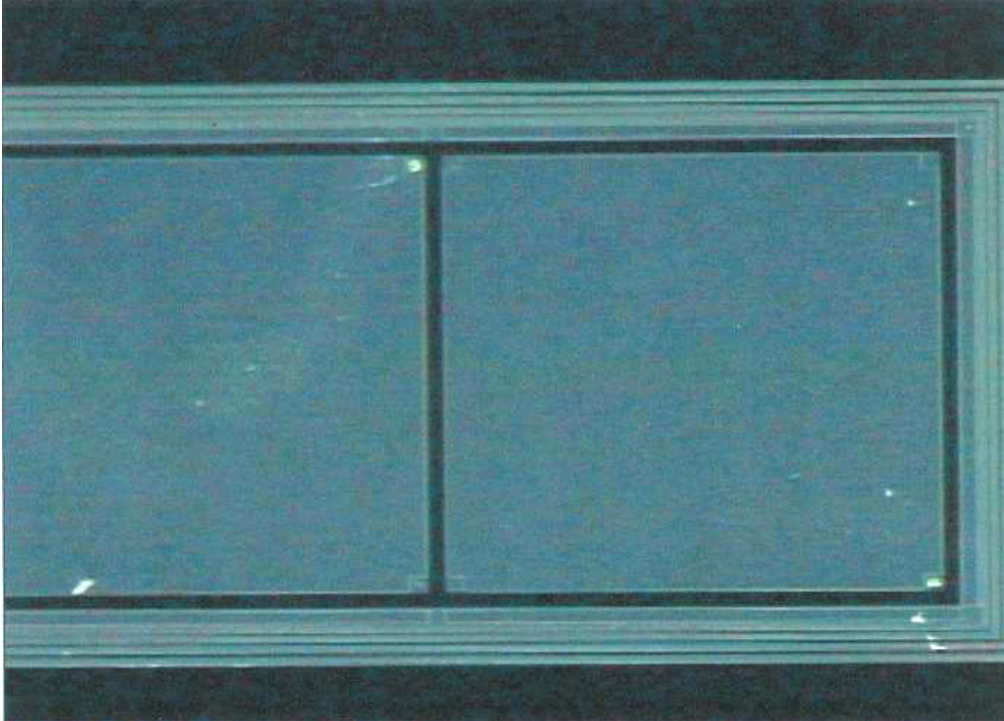
Failed detector board after bond wire removal. Dimension of large squares are 3mm x 3mm.

Detector board was returned to the bonding house. All bond wires were inspected. The two failed bond wires were removed and replaced. Each segment has multiple contact pads, so fresh pads were bonded to on the detector. There was plenty of room on the board side for the new wire. See attached photos before and after the new bond wires were added. The reworked board is in the queue for performance testing and possible use on one of the other 3 STE flight units.
