STEREO IMPACT

PROBLEM REPORT
PR-1004
SEP LVPS Middle FM1
2004-04-23

Assembly : SEP LVPS	SubAssembly : Middle Board
Component/Part Number: SEP_Middle_F001	Serial Number: FM1
Originator: Selda Heavner	Organization: U.C. Berkeley
Phone : 510-643-8640	Email : selda@ssl.berkeley.edu

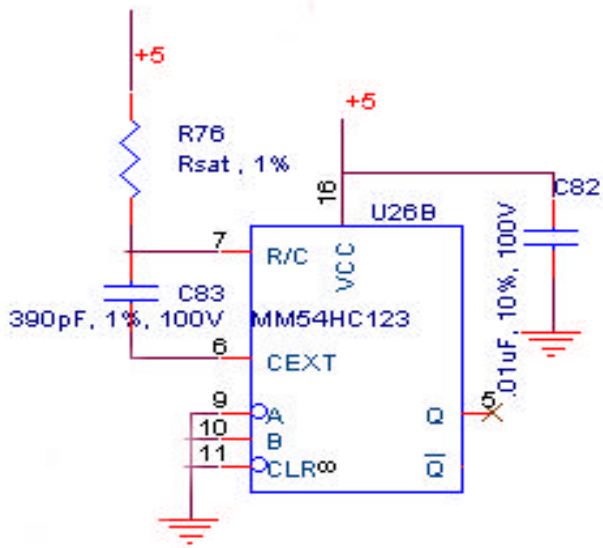
Figure 1: SEP LVPS Middle board Schematic

During first power-on of the SEP LVPS Middle Board FM1 the no output was observed at pin 12 of MM54HC123A (one-shot).

The layout is inspected. The capacitor C83 is supposed to be connected only to the Rsat and the Pin 6 of the one-shot. However Pin6 of the one-shot (U26) is also connected to Vcc due to an error in layout generating software.
