STEREO IMPACT

PROBLEM REPORT

PR-1009

STEU FM1 Oscillation

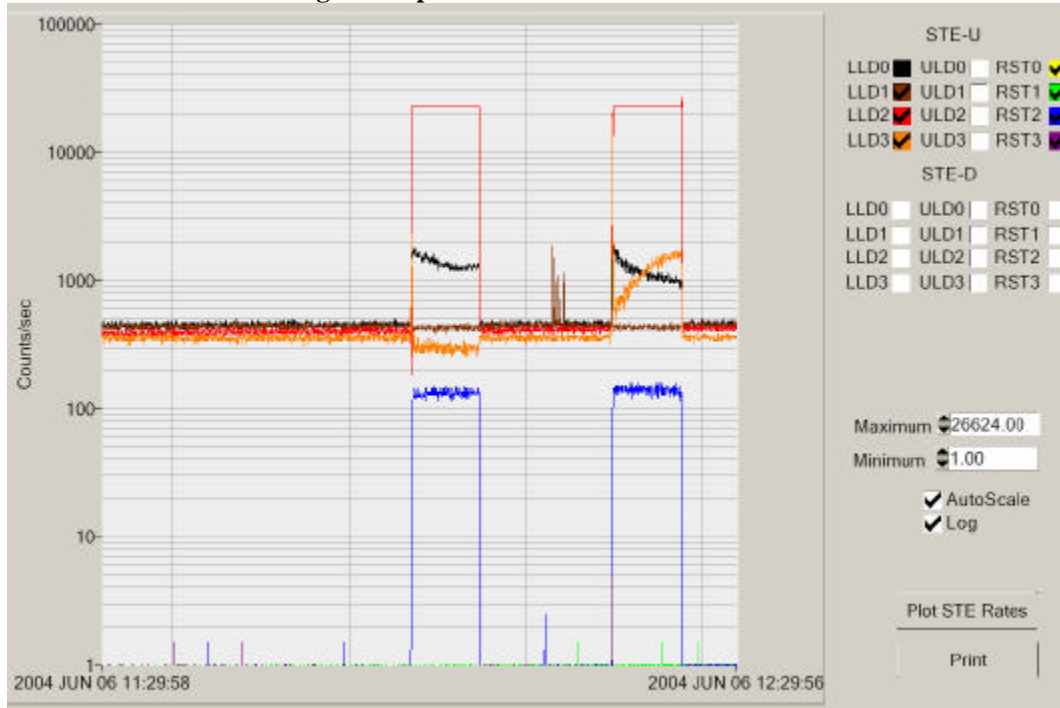
Occasional bursts of very high noise rates were seen in the STE detectors during thermal vac when the instrument was at the warm part of the cycles. Bursts typically lasted several minutes, and happened as often as twice an hour, but at least a few times each hot soak. They affected mostly detector segments 2 and 3. Some correlation was observed between the onset of this noise and the chamber operations that might cause noise (heaters coming on for example). The noise could be stopped by cycling the detector bias voltage.

STE Monitor Rates showing 2 examples anomalous rates observed in the thermal vac chamber

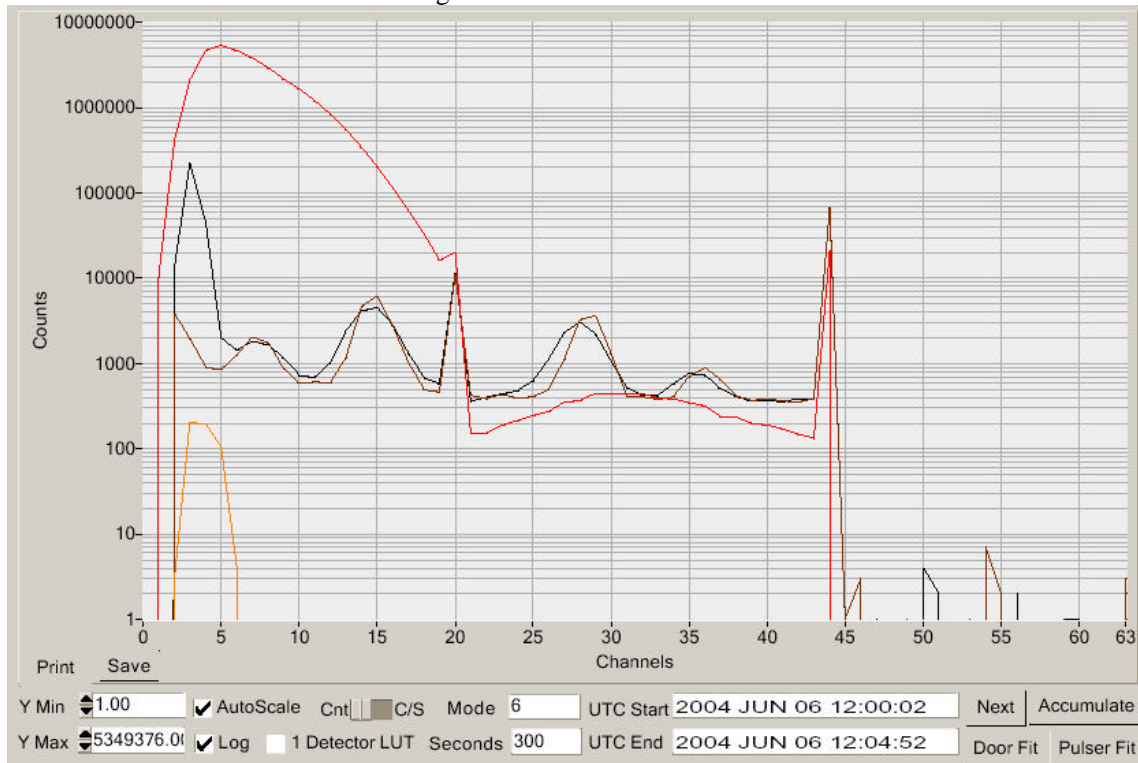
STE Spectra during anomalous rates event
Different colors are different detector segments

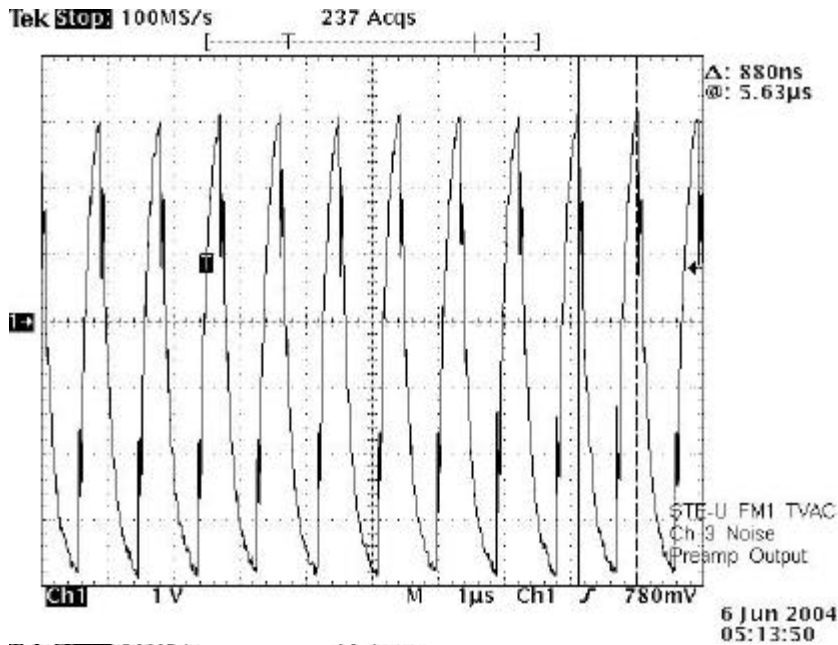
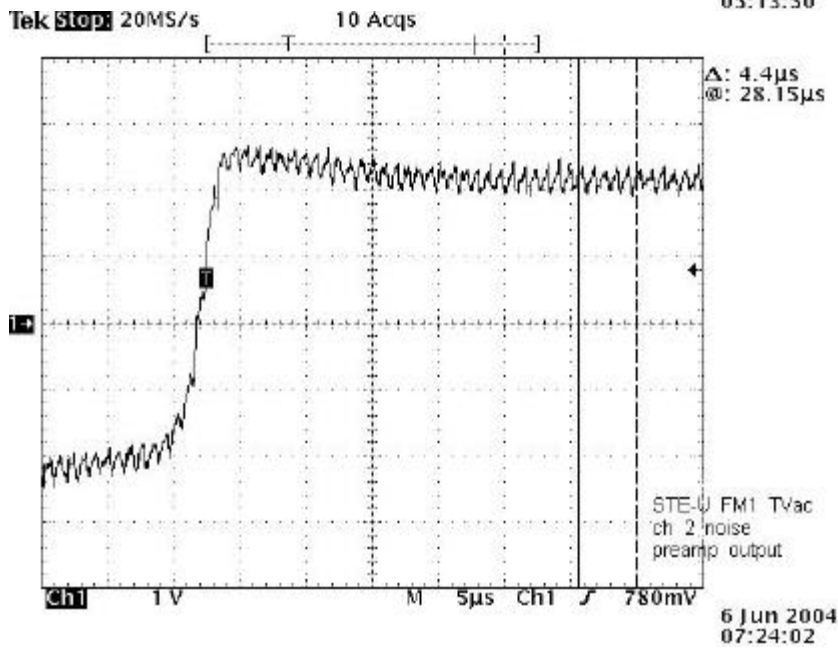
While still cycling we observed the preamp output signals that are routed out of the chamber to the IDPU. Snapshots of the signals are attached. Channel 2 looks normal except for the ~1MHz ringing imposed on the waveform. Channel 3 is completely abnormal, showing nothing but oscillation. After 5 cycles we discontinued cycling to diagnose the problem. It was verified that this effect occurs at room temperature, and then at ambient while in the chamber, but did not happen on the bench. However, a low level oscillation was seen on the bench. We believe that the noisy environment of the chamber caused the preamp, which was marginally stable, to go unstable.

STE-U FM1 Preamp Outputs during Oscillation

We adjusted the compensation capacitors on the preamp (C11, C111, C211, C311) to improve stability and eliminate the low level ringing (new value 390pF). We did bench testing and then testing in the chamber at ambient which verified the oscillation had been eliminated. We then continued with the final 2 operational thermal vac cycles. There was no sign of oscillation during those cycles. There was no stress on the circuit due to the oscillation.
