STEREO IMPACT

PROBLEM REPORT

PR-1012

IDPU LVPS

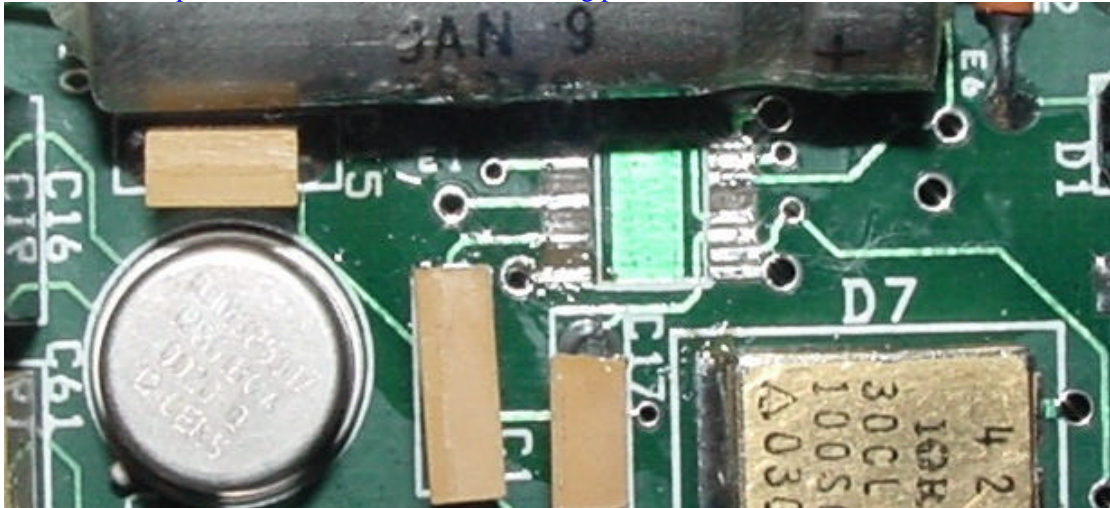
The LT1766 (U1) was removed from the supply. The technician noted that some of the pads were soldered to the part but loose from the board prior to starting to remove the part. The pads came off with the part. All of the loose pads were no-connects. The remaining pads were still well attached to the board.

The board was inspected by QA and a repair procedure was written up and implemented to install a new LT1766 to the board (pins with no pads were attached to board with Scotchweld 1836.).

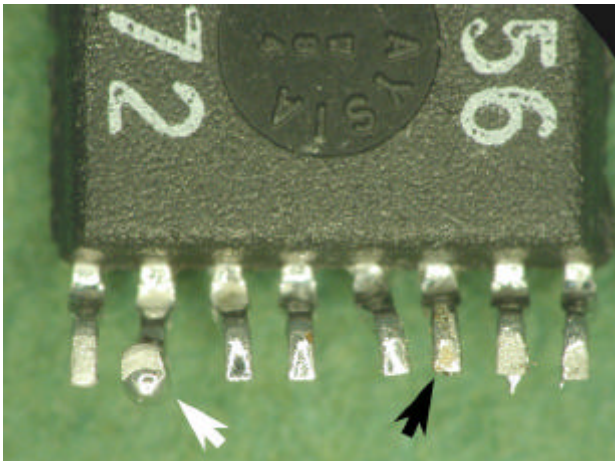
The microcircuit was optically inspected. No external damage was found on the package body. However, Pin 3, which was reported as not connected when removed from the board, appeared to have foreign material on the bottom of the lead. Pin 7, also reported as not connected, appeared to have a clump of solder on its end, and exhibited both a melted and a fractured surface. SEM and EDS were conducted. Contamination on Pin 3 contained carbon, oxygen, fluorine, and bromine, suggesting solder flux residue. Pin 13 also had some contamination.

Figure 3. The white arrow points to Pin 7, which has a blob of solder. The black arrow points to contamination found on Pin 3. EDS analysis of this material showed high concentrations of carbon, oxygen, fluorine, and bromine—constituents of solder flux. Note that Pins 1, 2, 3, 7, and 8 appear rough.

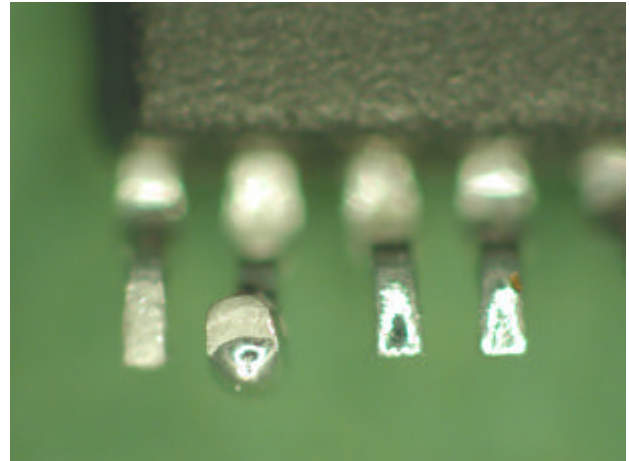
Figure 4. The bottom of Pin 7 exhibits both a melted and a fractured surface.

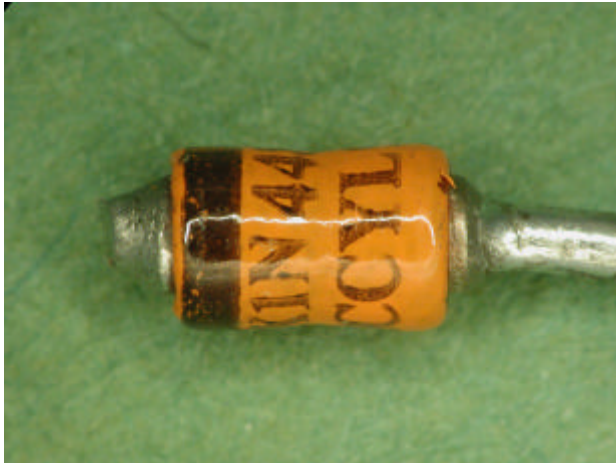
Curve tracer examination was conducted. The diode was found to have a low-resistance short, with a slope of 1.84 ohms (including lead resistance).

Figure 5. A side view of the 1N4480 diode. One lead was clipped close to the body during removal from the board. Curve tracer testing found the device was shorted.

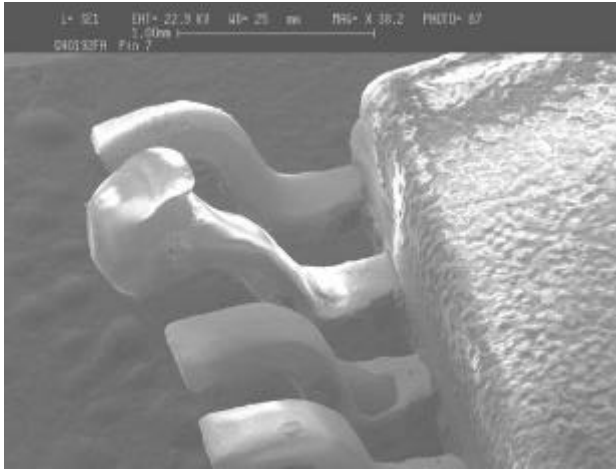
Figure 9. A tilt SEM view of Pin 7 reveals a large glop of solder on the end of Pin 7, the bottom of which appears to have two surfaces as seen in the image at right.

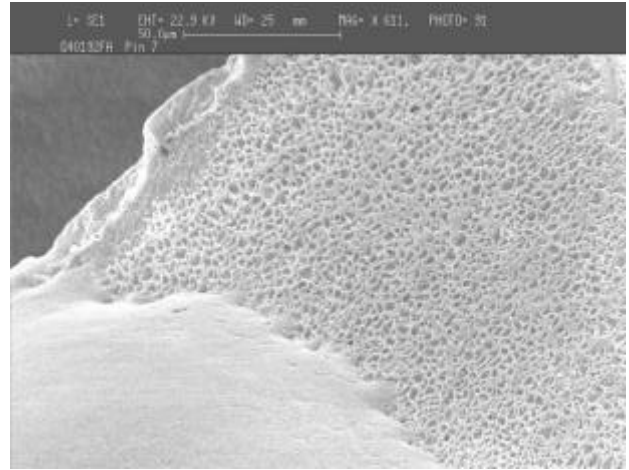
Figure 10. The bottom of the Pin 7 shows evidence of melted solder over a possible fracture surface.

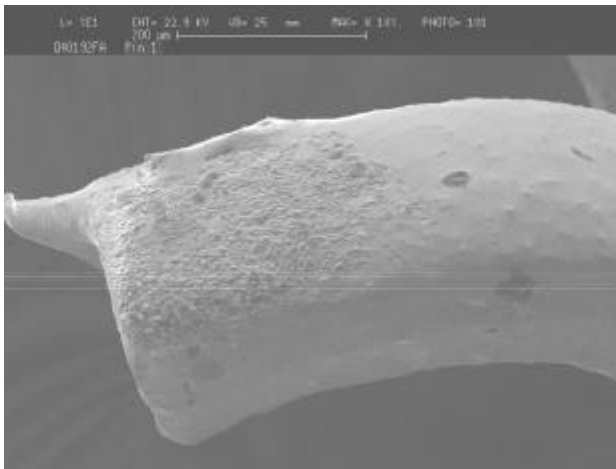
Several leads were found disconnected when the microcircuit was removed from the circuit board.

Figure 11. Several of the pins on one side of the package, such as Pin 1 shown above, had questionable contact surfaces—with neither clear evidence of melting from de-solder, nor evidence of fracture. Three pins on this side, Pins 3, 5 and 7, were reported as disconnected when the part was removed. Pin 13 was reported as disconnected on the other side of the package.

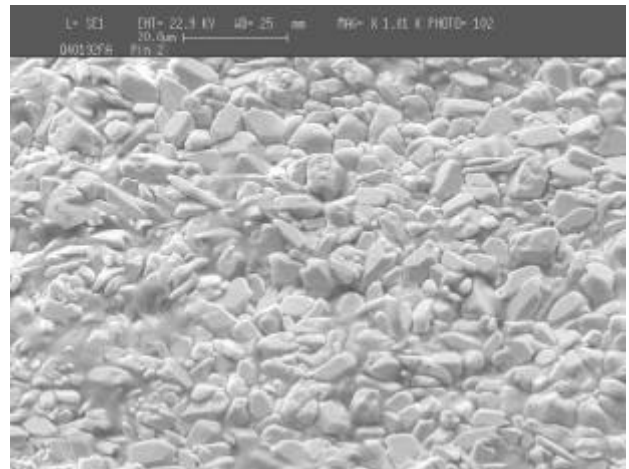
Figure 12. A close-up of the contact surface of Pin 2 shows a rubble-like topography, and was possibly never connected.

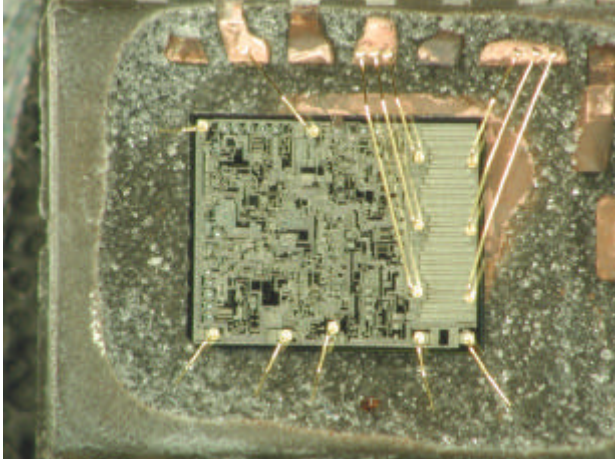
The part was decapsulated and inspected under high-power optical examination. Baked-on encapsulant was found in an area slightly off-center from the middle of the die, where the underlying traces had 'cooked' the plastic material into an acid-resistant state. The anomaly was photographed and examined under the SEM. Sulfuric acid was used to partially etch the attached encapsulant. The part was then re-examined. At this point, melted and missing metal at multiple locations in the affected area was identified and photographed. This evidence confirmed the failure as being due to electrical overstress (EOS).

Figure 13. A view of the die and wire bonds, taken after opening. Heat-hardened encapsulant was found left of the die center in the above image (see Figure 14).

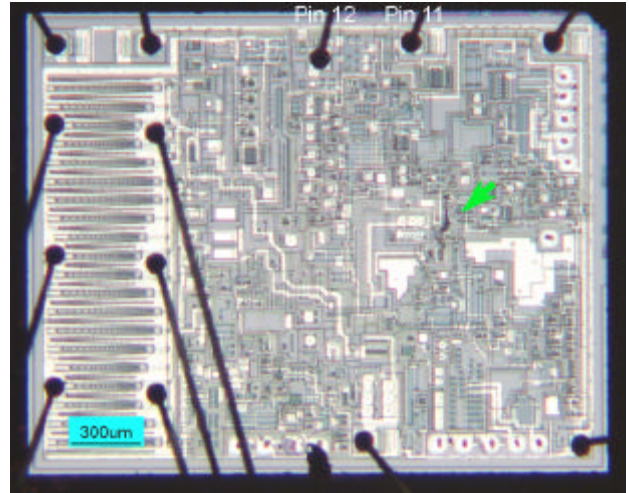
Figure 14. The image shows the overall die. The green arrow points to a location damaged by electrical overstress. Pins 11 and 12 are labeled.

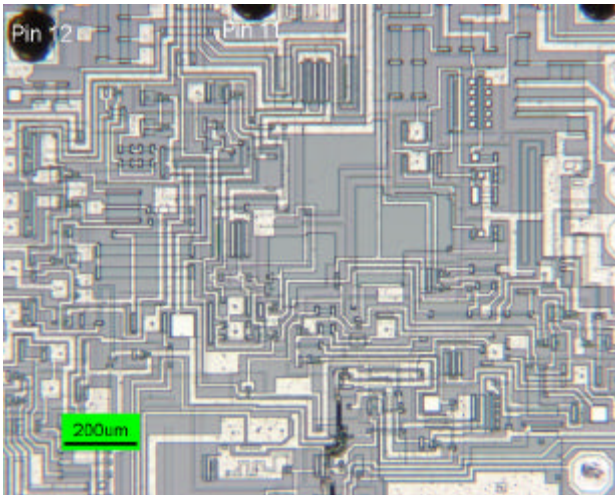
Figure 15. A higher magnification view of the die, showing damage at bottom center. Pins 11 and 12 are seen at top; left of center, and far left, respectively.

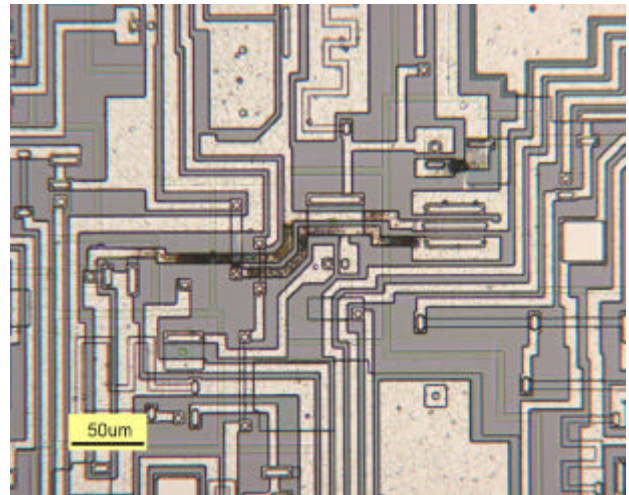
Figure 16. Note that damage was seen at multiple locations, a fact suggesting that failure was due to electrical overstress (EOS).

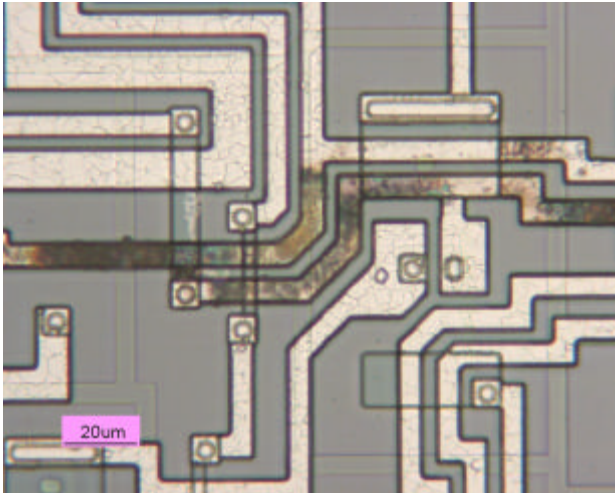
Figure 17. Another view of the thermal damage.

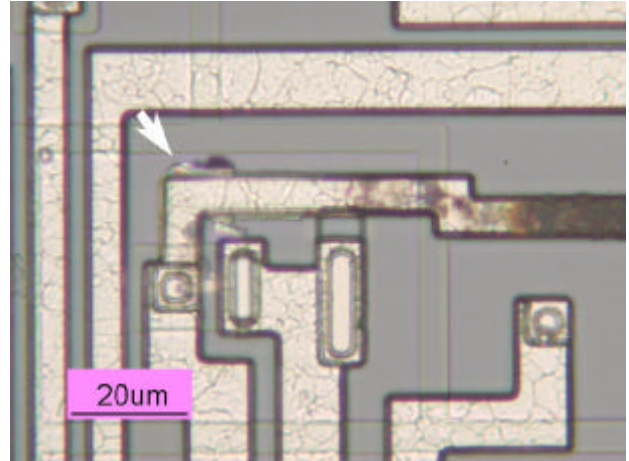
Figure 18. The arrow points to melted metalization found near a corner of an aluminum trace. Melted metal is also seen on the inside.

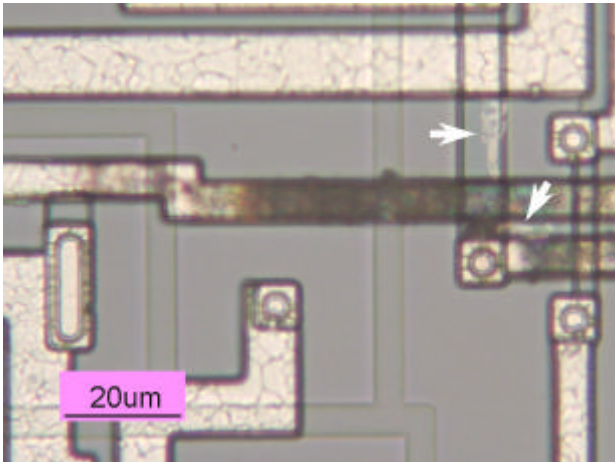
Figure 19. Only a strand of the original metal remains at the top arrow. The bottom arrow points to more evidence of melting.

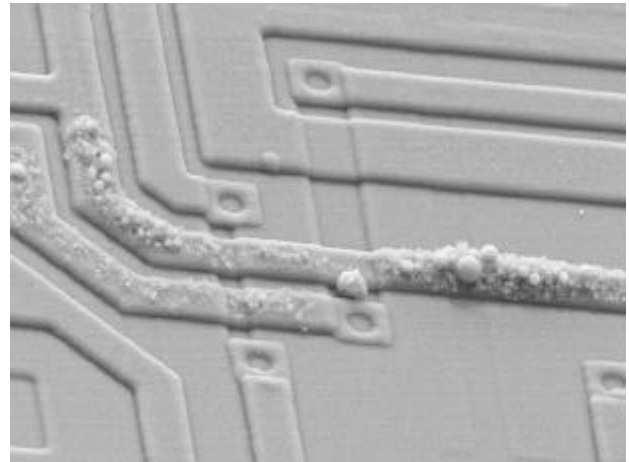
Figure 20. This SEM view, taken prior to sulfuric acid etching, shows baked-on plastic encapsulant, a phenomenon associated with heating of the traces.

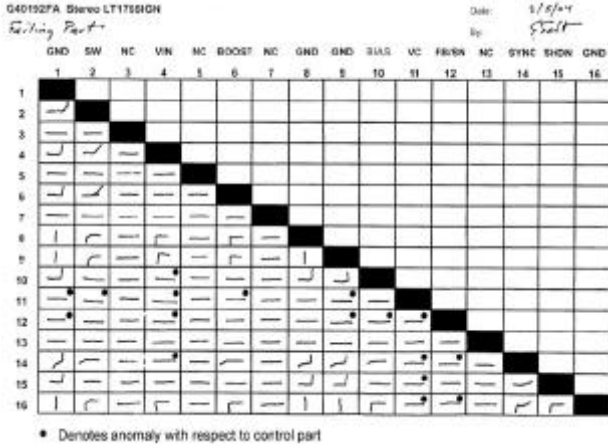
Pin-to-pin curve tracer testing was performed on the failing microcircuit, and on a control part. Comparison of the results between the two parts showed several differences. Notably, the failed part was electrically open between Pins 4, 11, and 12. These three pins also exhibited opens with several other pins. However, the primary intersection failure occurred between these three pins.

Figure 21. The microcircuit pin-to-pin curve tracer test results are shown above. Compared to a good part, anomalies were seen on pins 4, 11 and 12.

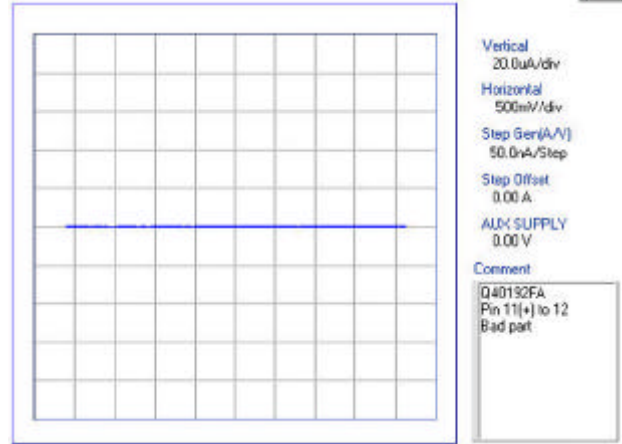
Figure 22. The curve tracer plot of Pin 11 (+) to Pin 12 on the failing part is shown above.

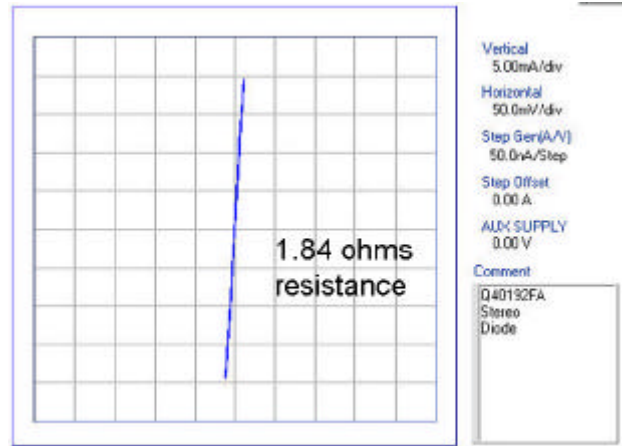
Figure 24. The curve tracer plot of the 1N4480 diode indicates that the diode was shorted with a 1.84 ohm resistance.

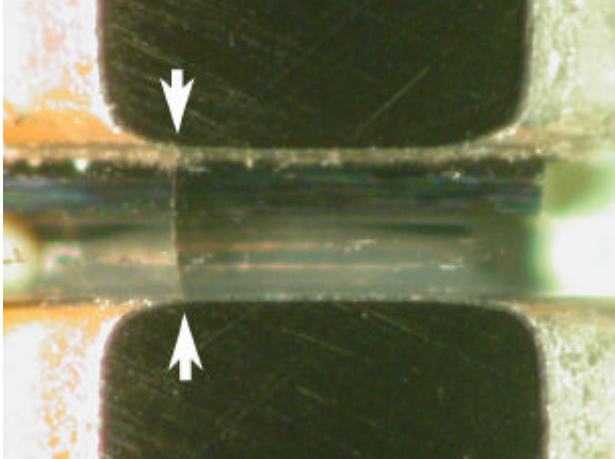
Figure 25. The white arrows bracket a crack in the diode glass, possibly caused by thermal stress.

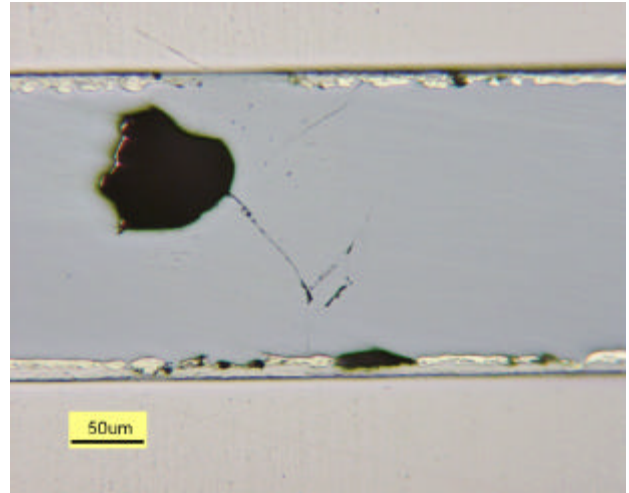
Figure 26. At cross-section Level 6 a large melt void and radiating cracks were found.

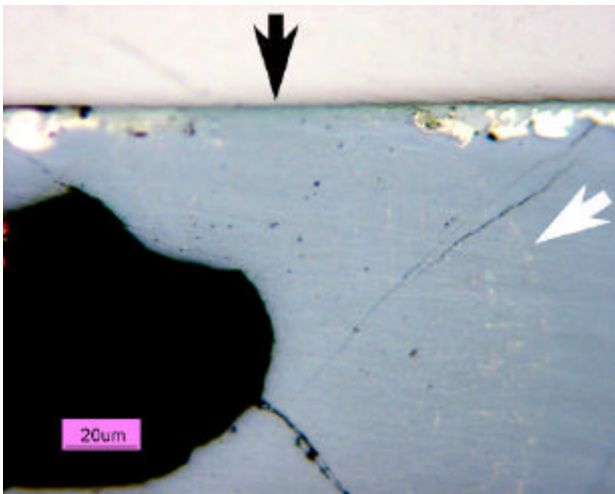
Figure 27. This image shows the void and cracks. The black arrow points to the middle of a missing section of metallurgical bond. The white arrow indicates a ring of dispersed metal which has re-alloyed due to heat.

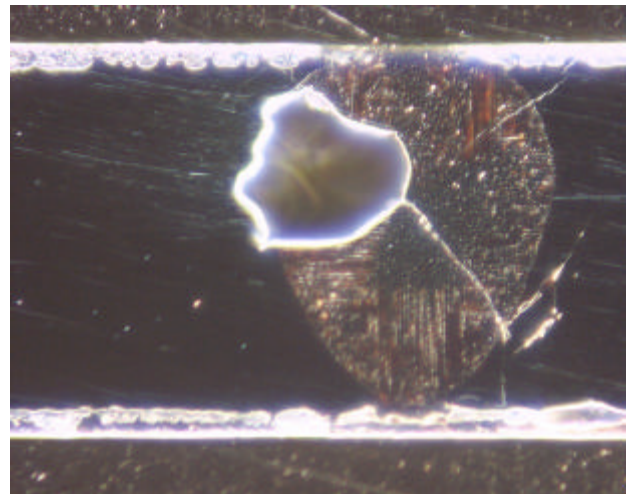
metallurgical alloy normally present at the bonding interface had dispersed throughout an egg-shaped volume, which spanned the die from anode and cathode, creating a shorting path.

This damage was also assessed as being due to electrical overstress (EOS).

Figure 28. Dark-field examination of the damaged area found an egg-shaped region of re-alloyed material, pierced by cracks and interrupted on one side by the void—obvious evidence of heating. Note the symmetry of the re-alloyed, heated region, and the cracks radiating from the center. The anomaly spans between anode and cathode, creating a shorting path.
