# STEREO IMPACT

PROBLEM REPORT

PR-1015

SEP LVPS FM1

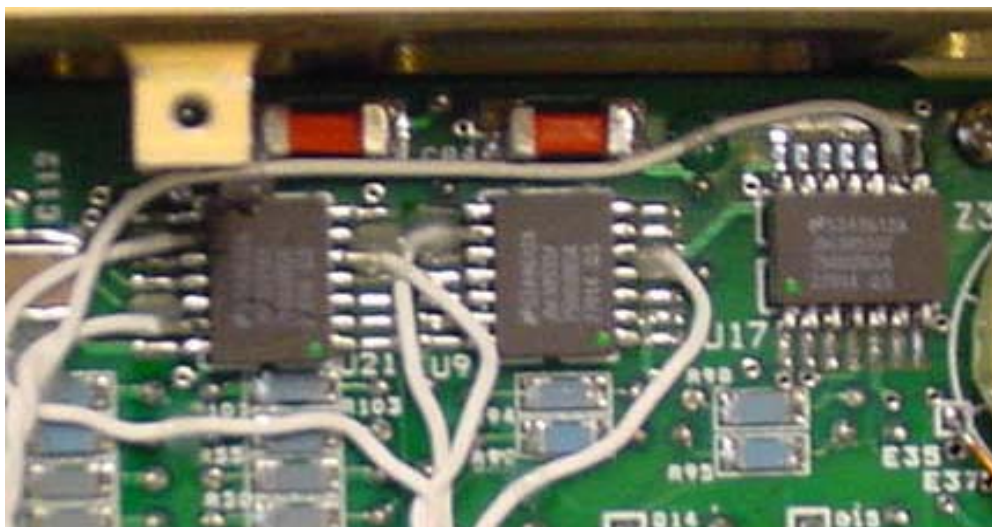
U21 Repair

SEP LVPS FM1 was disassembled to troubleshoot the noise problem on 2.6V and 5.3V outputs. During troubleshooting, it was observed that Q22 and Q15 (FETs) drain waveforms were not the expected waveforms. The output voltages were still within the expected value. The output of U21 the triple 3-input NAND (54AC10) gate was always high.

Initially visual inspection was performed to see if there were any foreign objects on the pcb. The signals at the pins were checked using an oscilloscope. The resistance of each pin at 54AC10 to ground and the resistance between the pins were checked. The signal from the flip-flop U27 (54AC109) was absent. The DRIVE A and DRIVE B signals were jumped due to a lay out error (see rework document dated 4/02/04). The U27 was removed and we found that pin 6 of the flip-flop was missing. Due to damage caused by probing U21 had to be changed as well. The damage to the U27 could have been caused by pulling on the wires while separating the middle and top board.

1. The issues found during the troubleshooting for the noise problem (U27 and then U21) were most likely caused when the boards were disassembled. (Reference the corrective actions steps 1 – 4 below). This fix only applies to FM1.
2. The noise problem required a change in the tuning capacitor for the LTC1877. (Reference corrective action step 5.) This fix is required on both flight units.

- 1- Removed and replaced the flip-flop U27
- 2- Removed and replaced the triple 3-input NAND gate U21.
- 3- Connected U27 pin 6 to U21 pin 5; connect U27 pin 7 to U21 pin 9. (Note: they must be twisted together per rework document dated 4/02/04)
- 4- Staked the wires using Uralane 5753. (Added more staking to the wires to protect this connection)
- 5- Changed C32 to 390pF capacitor to eliminate the unstable output at 2.6V. The drawings were updated to reflect this change. (This fix applies to both flight units.)
