# STEREO IMPACT

PROBLEM REPORT

PR-1017

SEP LVPS FM2

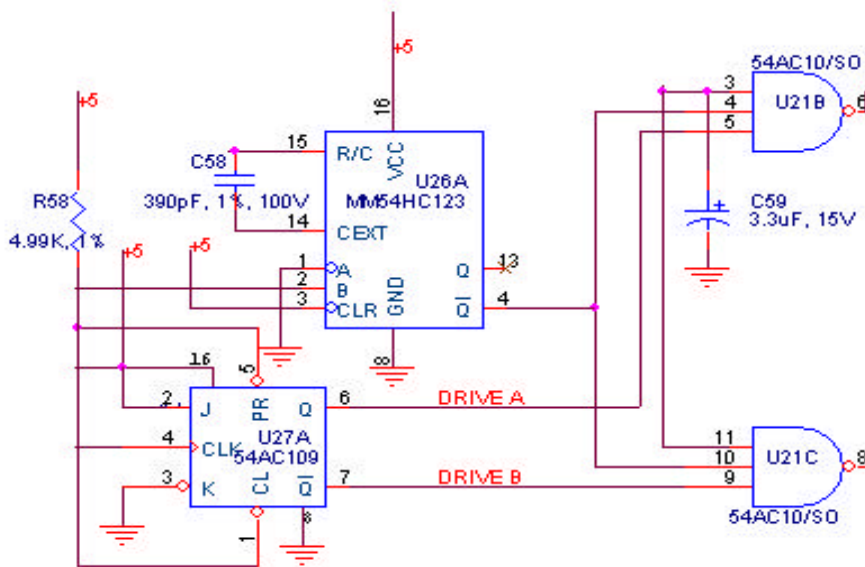
The UUT was left at room temperature for an hour and powered on again after the failure occurred. The problem was repeated. SEP LVPS FM2 was disassembled. The drain waveforms of Q22 and Q15 were not as expected. The jumping wire for U27 (54AC109 flip-flop) per rework dated April 02, 04 was crushed. The resistance from pin 7 to ground was measured as  $0.73\text{K}\Omega$  where the properly functioning pins measured as  $2.6\text{M}\Omega$ . Only the U21 and U27 parts were stressed and need to be replaced.

- 1- Removed and replaced U27.
- 2- Removed and replaced U21.
- 3- Removed the damaged wire. Rerouted wires to avoid crushing.
- 4- Staked the wires with Uralane 5753 to avoid any movement.
- 5- Completed board level tests. Repeated box level thermal test.
