STEREO IMPACT

PROBLEM REPORT
PR-1022
FM1 SIT HVPS Stack
28 September 2004

Assembly : IMPACT SIT	SubAssembly : HVPS
Component/Part Number: Stack	Serial Number: FM1
Originator: David Curtis	Organization: U.C. Berkeley
Phone : 510-642-5998	Email : dwc@ssl.berkeley.edu

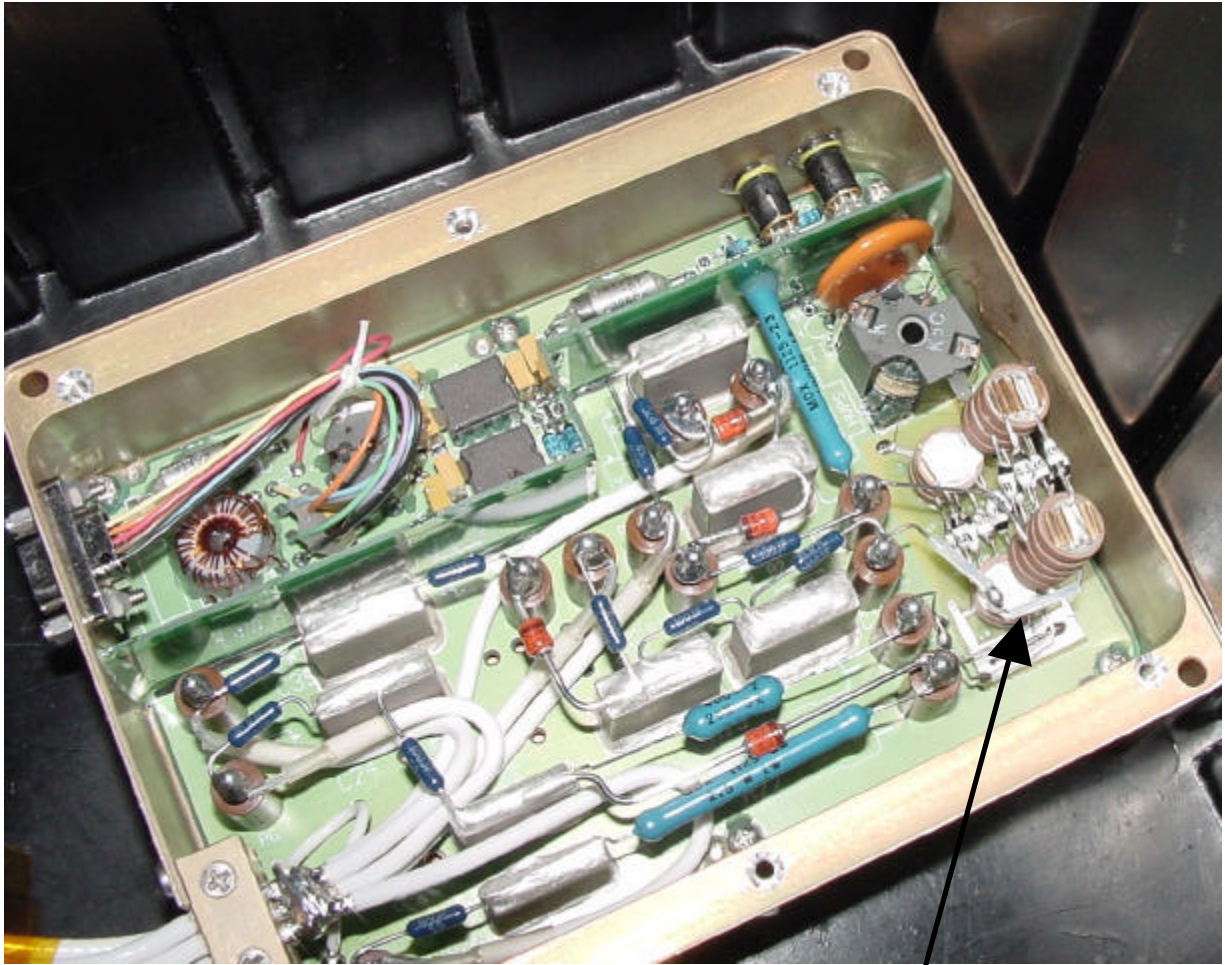
When the SIT FM1 HVPS was returned from UMD to UCB for final conformal coating and staking it was discovered that the stack was broken at a glue bond line (see attached picture). This must have happened some time after the last test at GSFC, probably in shipping.

The stack is silver epoxied together, and is somewhat fragile. As a normal part of the staking/coating process, a structure is added to help support the stack. This was not yet in place at the time of the shipment (it is already in place for FM2, recently delivered to UMD). This structure has proven adequate to pass vibration on similar supplies on other missions.

Broken stack

A replacement stack will be built from existing stock to replace the broken one. The support structure will be added prior to coating and staking.
