# STEREO IMPACT

PR-1023

FM1 SWEA LVPS

### *Transformer Failure Analysis*

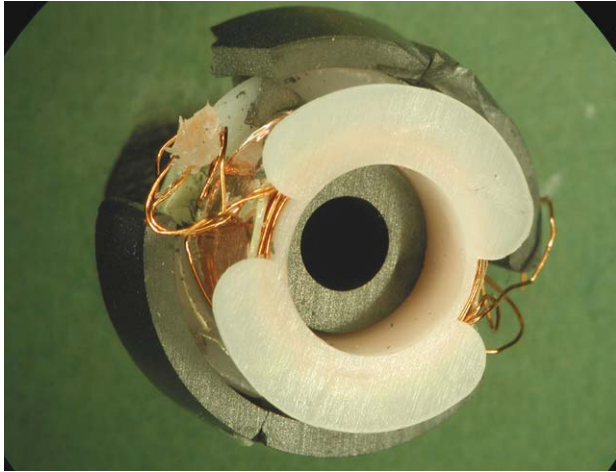
damage was noted. The transformer bobbin was broken in two and cracked. All wires had been broken between the bobbin and the housing. The housing pins were bent. (Figures 1 to 8)

Figure 1. External photo of transformer as received in the laboratory. Extensive damage was noted, presumably due to removing the transformer from the board.

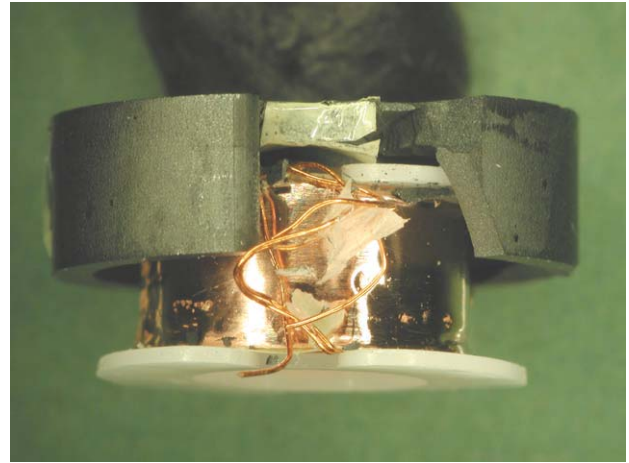
Figure 2. External photo of damaged transformer.

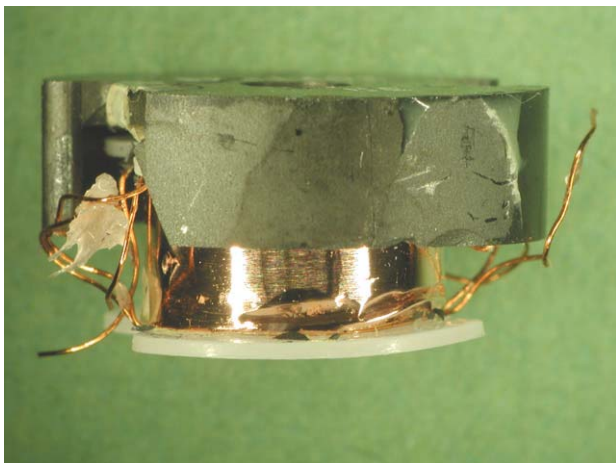
Figure 3. External photo of damaged transformer.

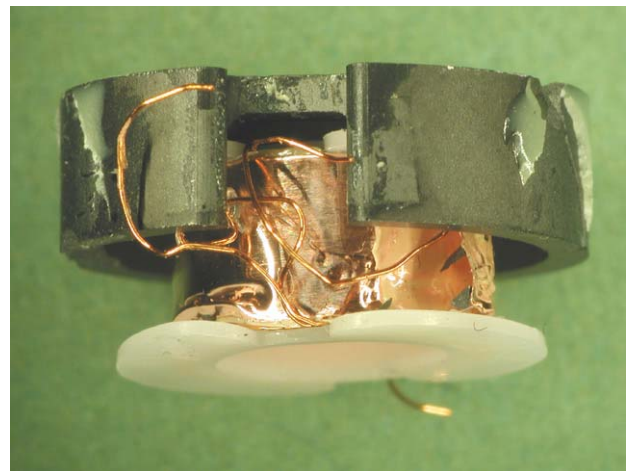
Figure 4. External photo of damaged transformer.

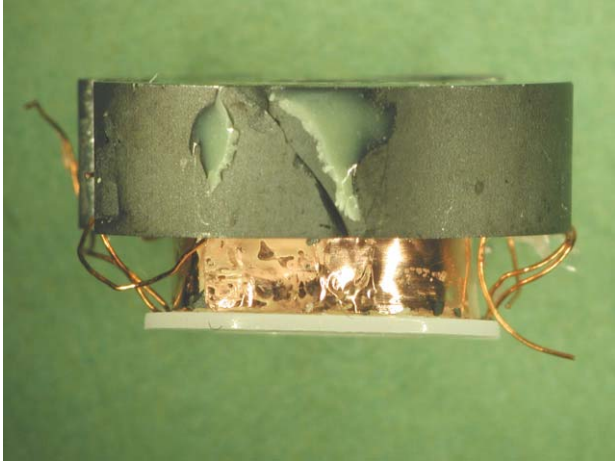
Figure 5. External photo of damaged transformer. Note crack.

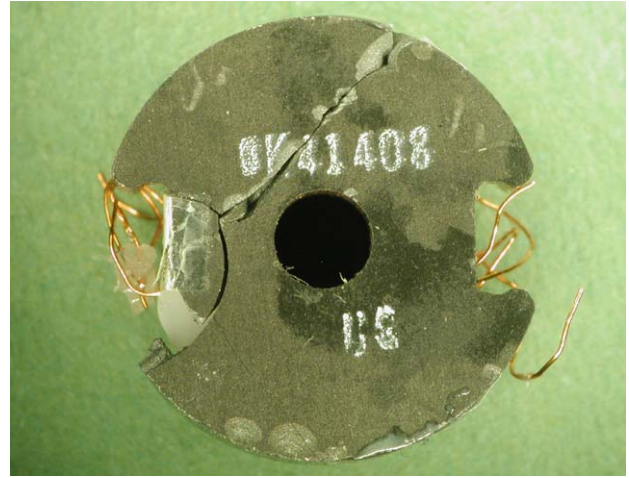
Figure 6. External photo of damaged transformer. Note cracks.

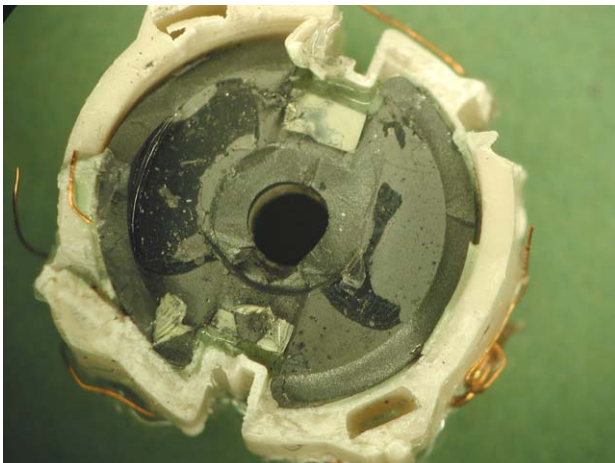
Figure 7. External photo of transformer housing.

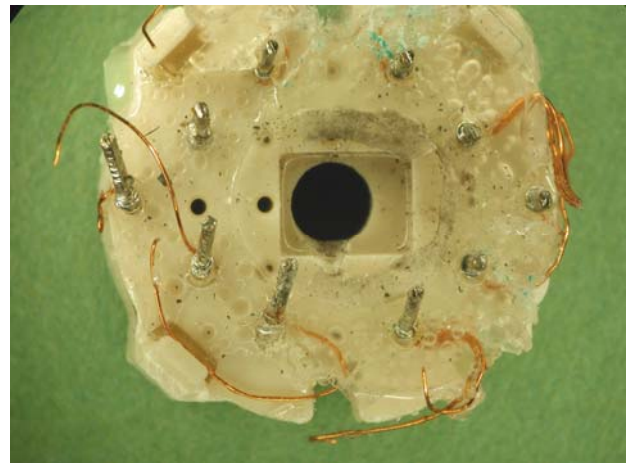
Figure 8. The underside of the transformer housing shows ten pins, each soldered to a copper wire. Wire routing does not appear controlled.

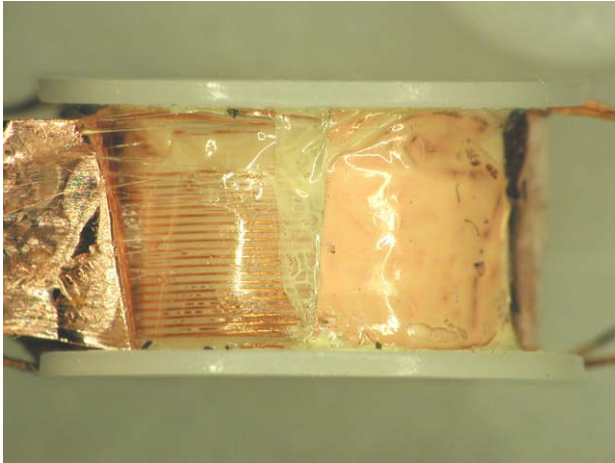
Copper tape around the bobbin was removed and the wire was inspected and photo-documented. The windings consisted of a single outer layer, separated from a three-layer inner winding. The wire diameters of both windings were identical. Optical inspection of top and bottom of wires found no anomalies. (Figures 9 to 11)

Figure 9. The copper tape is peeled back in this image, exposing a section of the outer winding.

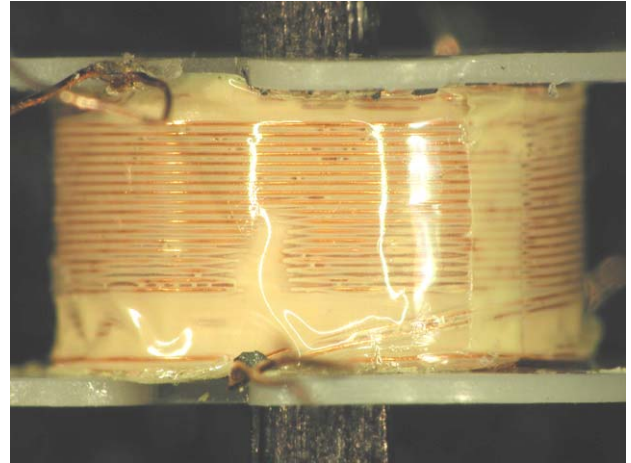
Figure 10. The copper tape has been completely removed, revealing windings covered with a polymer layer.

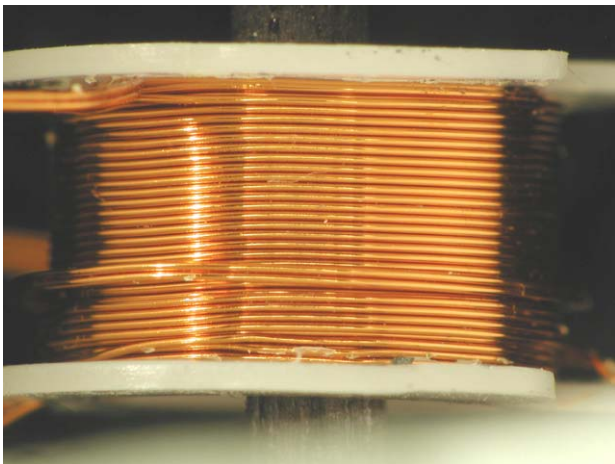
Figure 11. In this image the polymer layer was removed and the wire partially unwound.

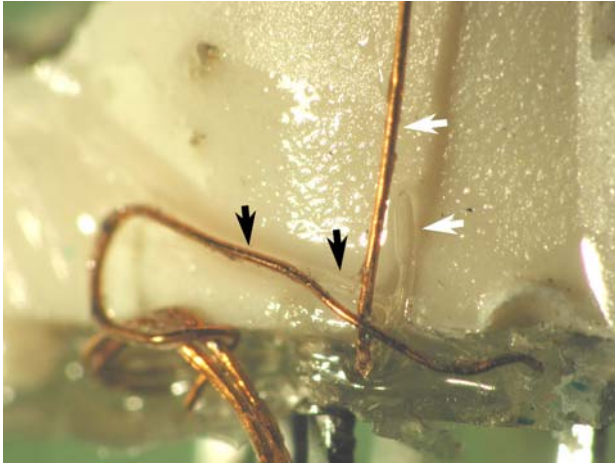
The external housing was re-inspected. The wires soldered to external pins were noted and examined. Two of these wires appeared crossed. Matching grooves were found in the adhesive or coating nearby, indicating that the wires had been touching, or nearly so. One of the grooves was

slightly deeper than the other, by approximately a wire diameter. In addition, close optical inspection found blobs of solder on one wire in the location where the wires crossed. (Figures 13 to 16)

The transformer was received in a badly damaged condition, with the bobbin broken from the external housing. Electrical testing did not confirm the failure. However, grooves in the polymer on the external housing showed that two wires attached externally to pins were routed across each other, and had probably been in physical contact. Bare solder with a rough surface found in the location near where the wires crossed, suggested that the wires may also have been in electrical contact, and intermittently shorted as contact was made. Comparison with the transformer schematic found that the pins involved were either Pin 2 and Pin 3, or Pin 7 and Pin 8.

Figure 13. Crossed wires were found near the transformer pins. Black arrows point to one wire and its matching groove in the conformal coating. White arrows point at a second wire and its groove. The grooves criss-cross, indicating the wires were originally in close, or near contact.

The transformer (STEREO 025) SN001, ref designator T3 was replaced with a spare SN003. The 50V trim capacitors were replaced with 100V parts. That solved the problem, and performance is back to what it was before bakeout. The transformer may have been damaged during the bakeout since it has not been baked out above 60C in the past. We have not baked out any other STEREO electronics that include transformers yet, and will bake the remaining boards with transformers at a lower temperature. The failed transformer was submitted for analysis, but was damaged removing it from the board (to which it was glued). Reference F/A# Q50231 which confirmed that it was likely an intermittent short between 2 wires that may have been in contact with some rough bare solder. The pins involved were either Pin 2 and Pine 3 or Pin 7 and Pin 8.

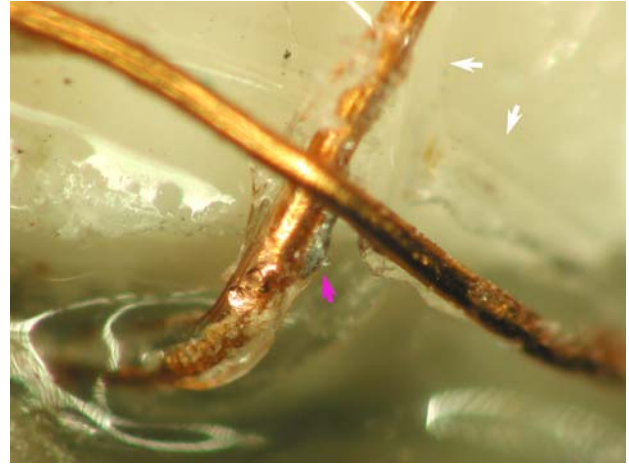
Figure 14. White arrows mark crossing grooves in the background. The pink arrow points to an apparent blob of solder on one wire.

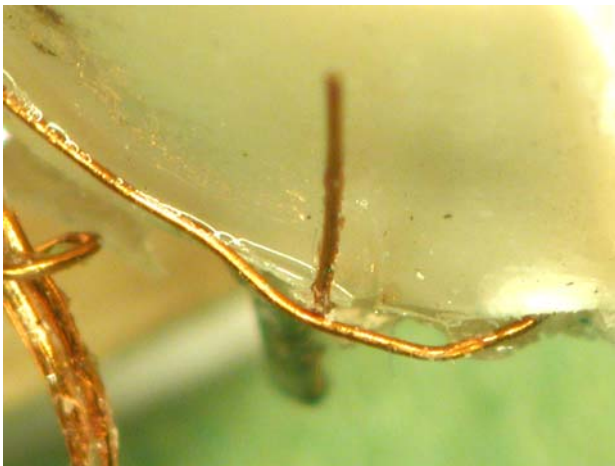
Figure 15. An end view of the crossed wires, showing the wires displaced slightly from their original positions, probably due to removal of the transistor from the board.

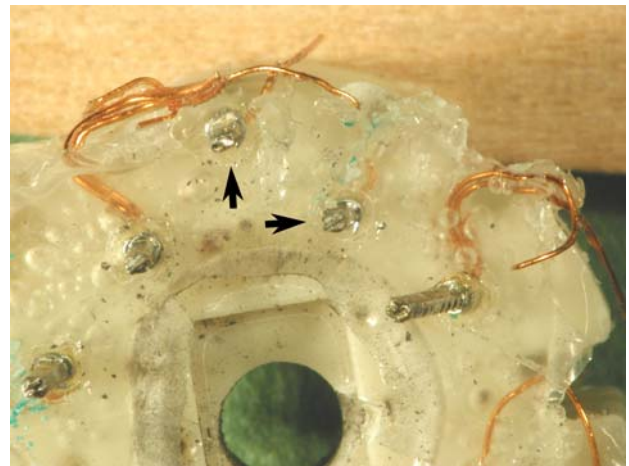
Comparison of the external photographs of the housing to the schematic showed that the pin connecting to the vertical wire was either Pin 3 or Pin 8, and that the crossing wire was either from Pin 2 or Pin 7, respectively.

Figure 16. Black arrows document the two pins attached to the crossing wires. Comparison to the schematic suggests they were either Pins 2 and 3, or Pins 7 and 8.

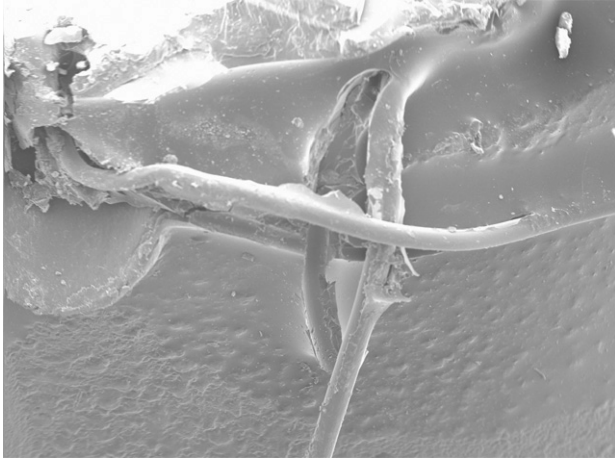
SEM inspection was performed. The position of the grooves confirmed that the crossed wires were originally in close proximity. Displacement during removal of the transformer from the board had shifted the wires' position slightly. Close inspection found that the suspect solder blob on the vertical wire appeared metallic and un-insulated. EDS dot mapping identified the solder as composed of tin. The wire was copper. (Figures 17 to 20)

Figure 17. A SEM micrograph shows the crossed wires and their respective grooves. Note that the polymer at top shows evidence of lateral displacement. Displacement of the vertical wire has affected the other wire, pulling it out of the conformal coating.

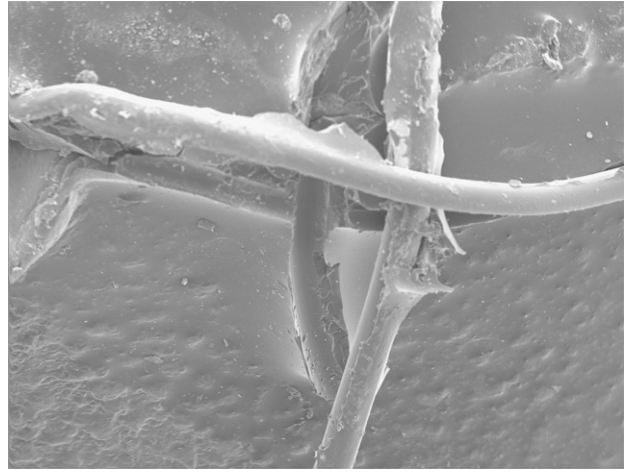
Figure 18. The groove for the vertical wire is seen deeper than the groove for the horizontal wire, and appears to be separated by only a wire diameter.

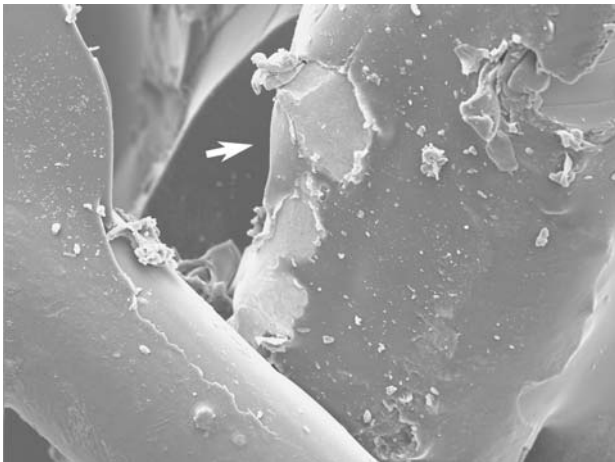
Figure 19. A close-up view of the crossed wires. The arrow points to exposed metal, possibly solder.

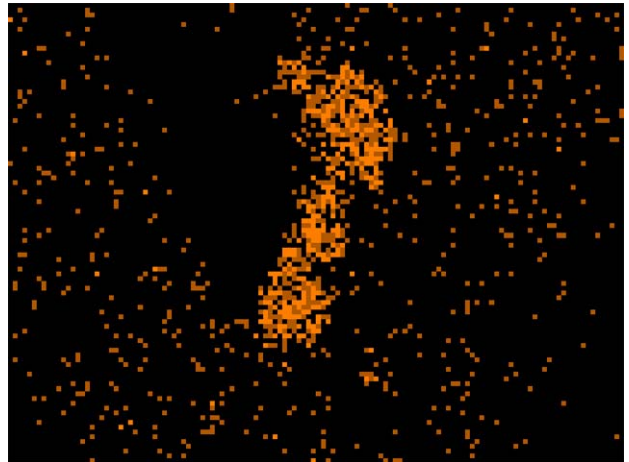
Figure 20. An EDS dot-map of the area of Figure 19 shows tin (Sn) in orange. The area matches the exposed metal seen at left.
