STEREO IMPACT

PROBLEM REPORT

PR-1029

FM1 SWEA Anode 2

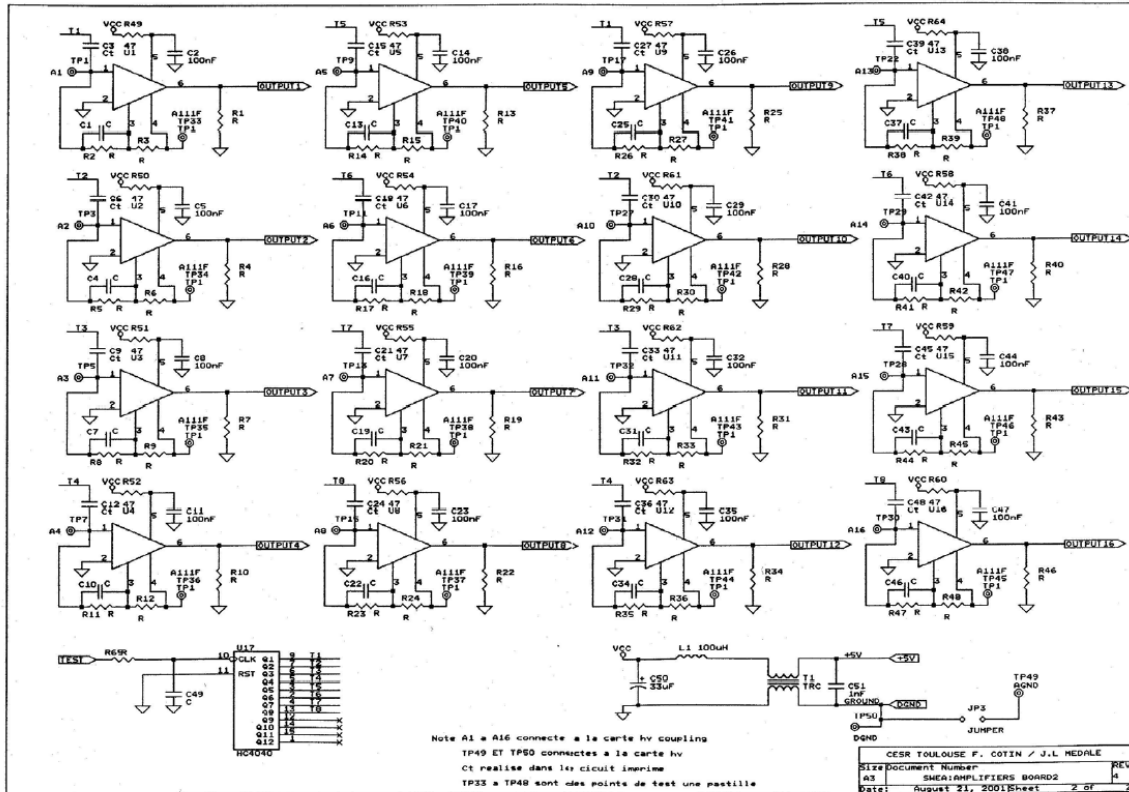
SWEA Amplifier board. Failed/replaced part is U3.

- T3 is the test pulser input, 5V square wave.
- A3 connects to the anode which collects the MCP signal.
- Ct is ~0.3pF, built into the PWB
- R7, R8, R9 are not loaded.

Replace the Amptek A111F preamp for Anode #2 (see schematic below). Test at up to +50C, with no dropout. Send failed preamp to failure analysis. Part removed LDC 0048, serial number 206. New part same LDC, serial number 240.

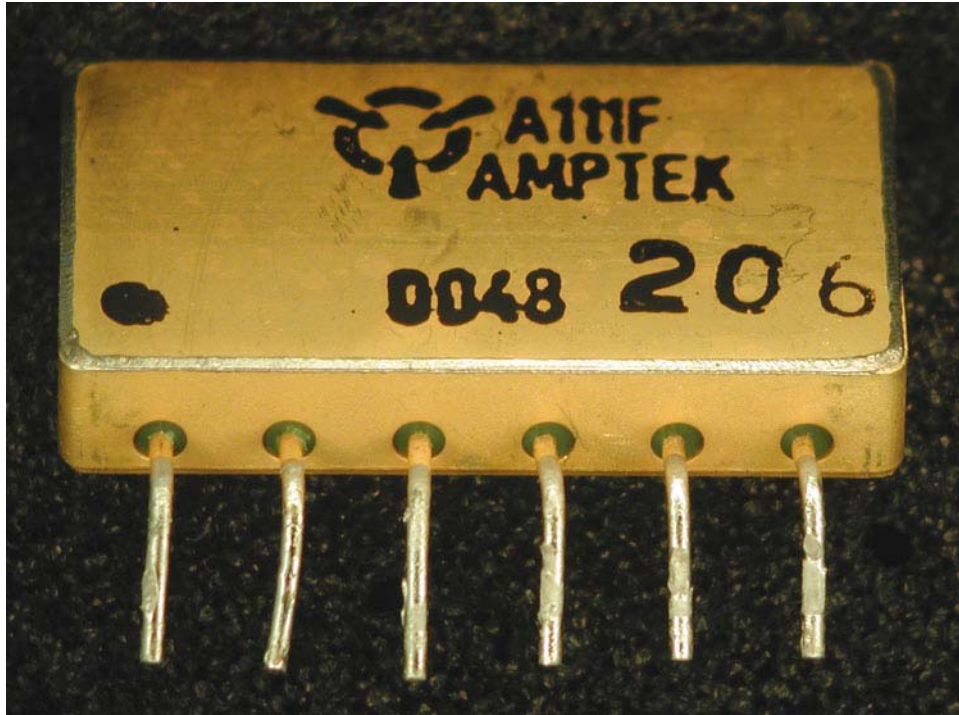
External and radiographic inspections revealed no anomalies. Figures 1 and 2 show external and radiographic images of the device. The device passed fine and gross hermeticity testing and also PIND testing.

Figure 1. External view of the A111F device.

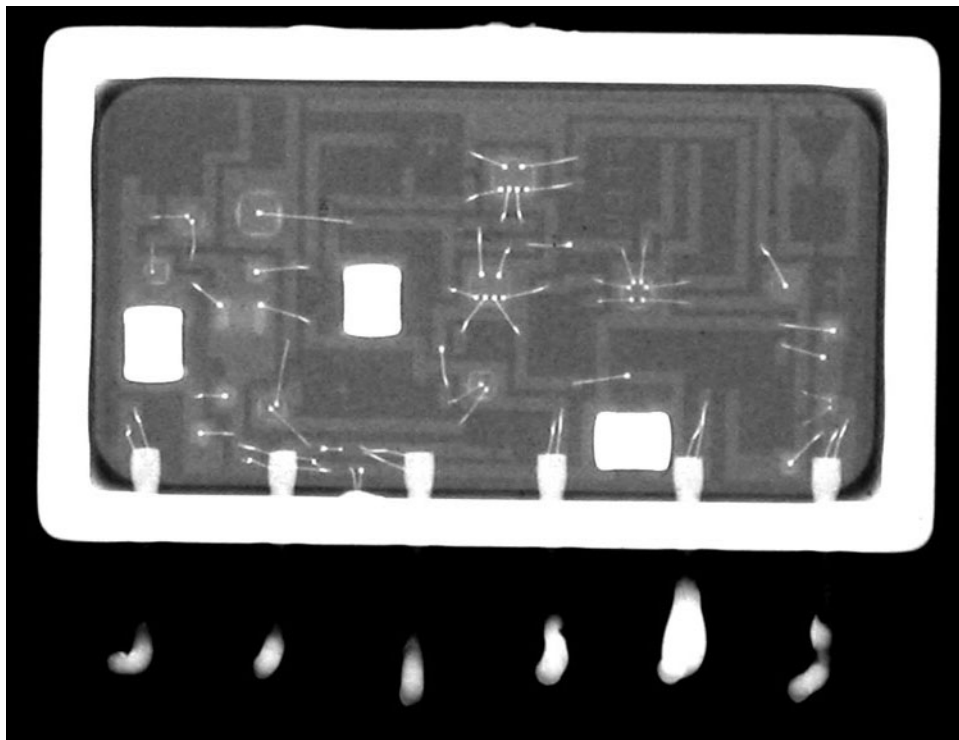
Figure 2. Radiographic view of the device.

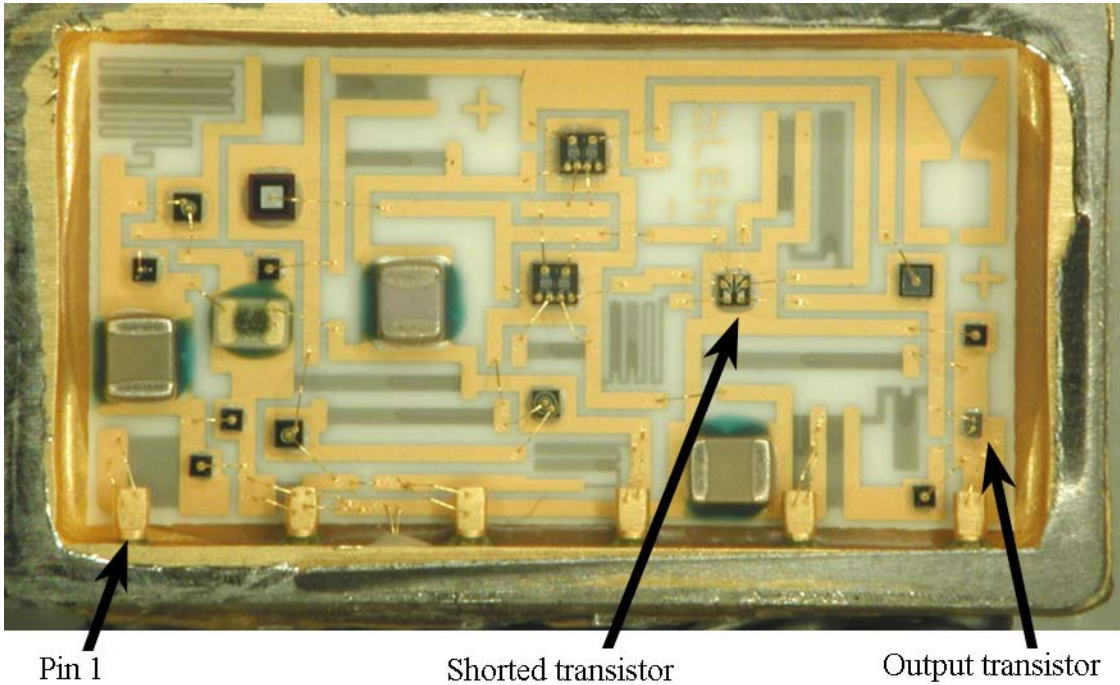
Figure 3. Overall internal cavity view of the failed A111F charge amplifier.

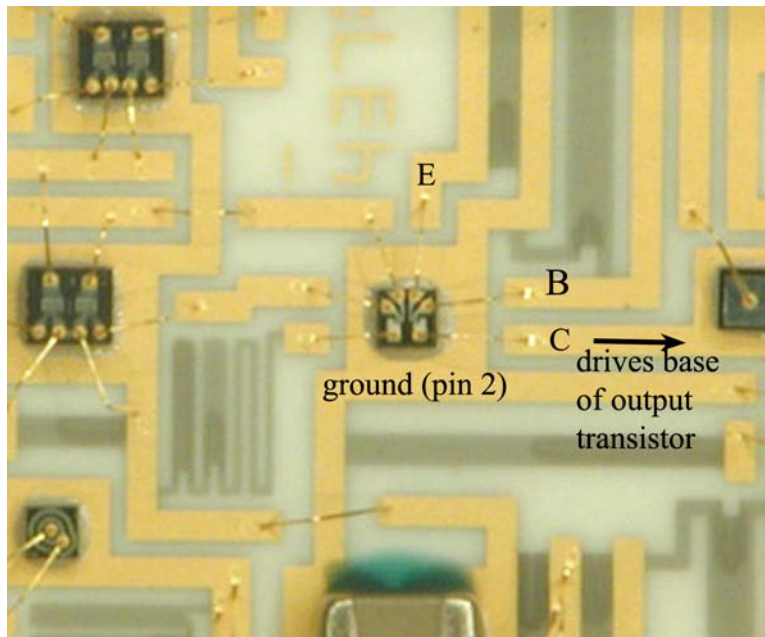
Internal examination revealed interconnect wire ball bonds at one of the transistors were placed such that they touched (and shorted to) the unpassivated die edge. It was noted that the ball bonds at this transistor and other locations within the assembly were quite large in diameter compared to the wire diameter. Some appeared to be larger than 5 wire diameters, which is unacceptable in MIL-STD-750 and 883.

Figure 4. Close-up of area of the shorted transistor. The transistor is mounted directly to pin 2 ground metal. The collector of the shorted transistor directly drives the base of the output transistor.

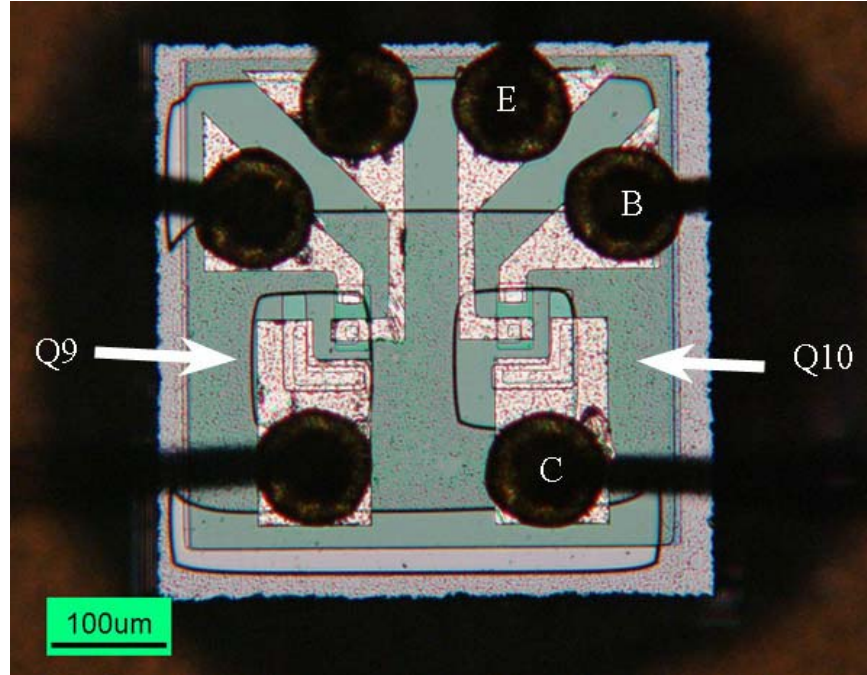
The transistor in question was a dual transistor pair on a single die (of which there are three such dice within the hybrid). For the purpose of this investigation the transistors were designated Q9 and Q10. The emitter ball bonds for both Q9 and Q10 appeared to be touching the unpassivated die edge, while the Q10 base bond appeared extremely close to touching. A study of the circuit layout showed the Q10 collector directly drives the base of the output transistor. Figure 3 shows an overall internal view of the hybrid with the suspected shorted transistor identified. Figure 4 shows a closer view of the Q9/Q10 transistor and local area. Figures 5 and 6 show optical images of the misplaced ball bonds at Q9 and Q10

Figure 5. Optical image of shorted transistor die.

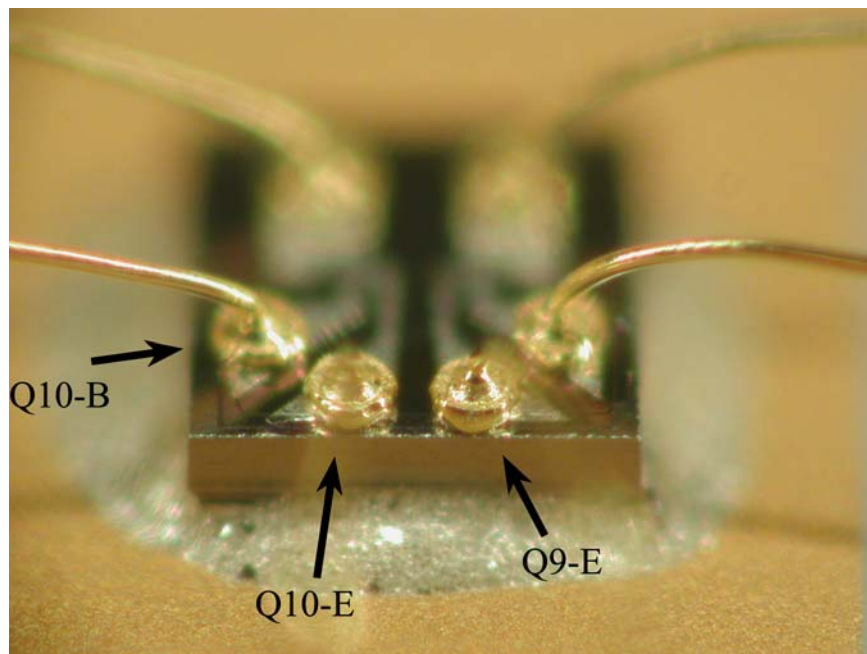
Figure 6. Angled view shows placement of ball bonds.

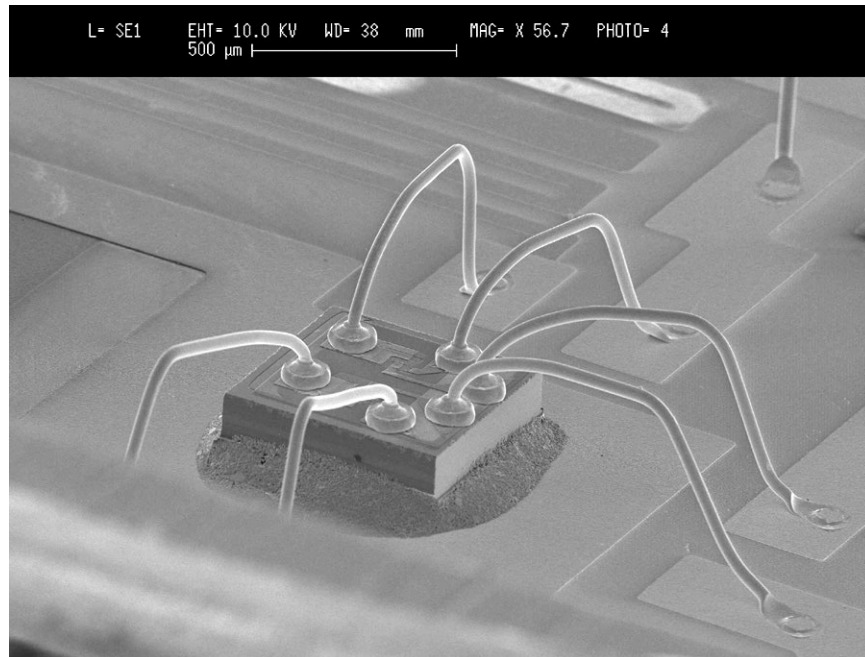
SEM inspection further documented the poorly placed ball bonds, as seen in Figures 7 through 10, and showed that the ball bonds, including the Q10 base (Q10-B) ball bond, was indeed touching the unpassivated die edge. While inspecting in the SEM, EDS was used to confirm the unpassivated die edge. The unpassivated die edge is a very common feature on microelectronic dice.

Figure 7. Macro SEM image shows the Q9/Q10 transistor die.

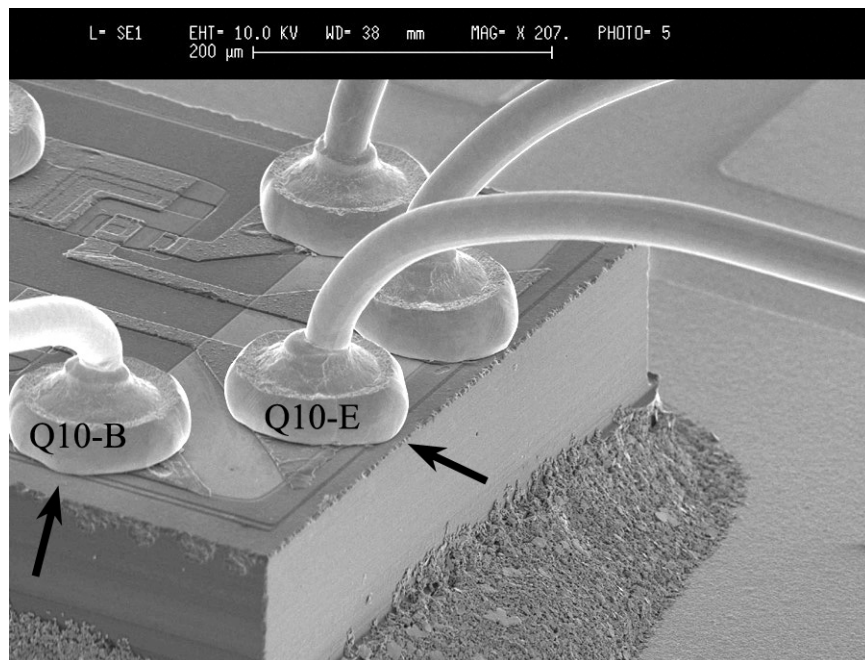
Figure 8. Close-up view shows the relatively large diameter ball bonds touching the unpassivated die edge of the die.

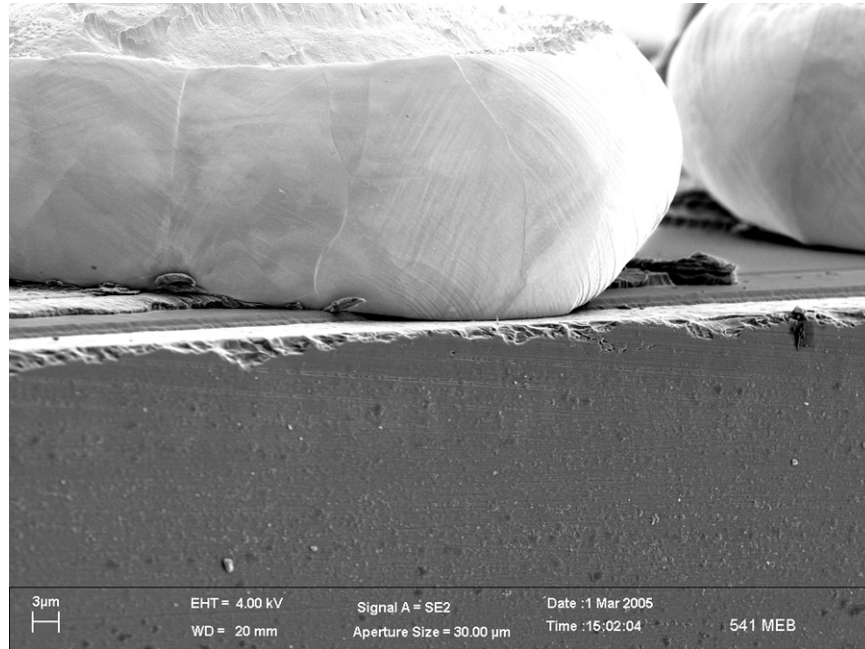
Figure 9. High magnification, high tilt, SEM view of the Q10-E ball bond touching the unpassivated die edge.

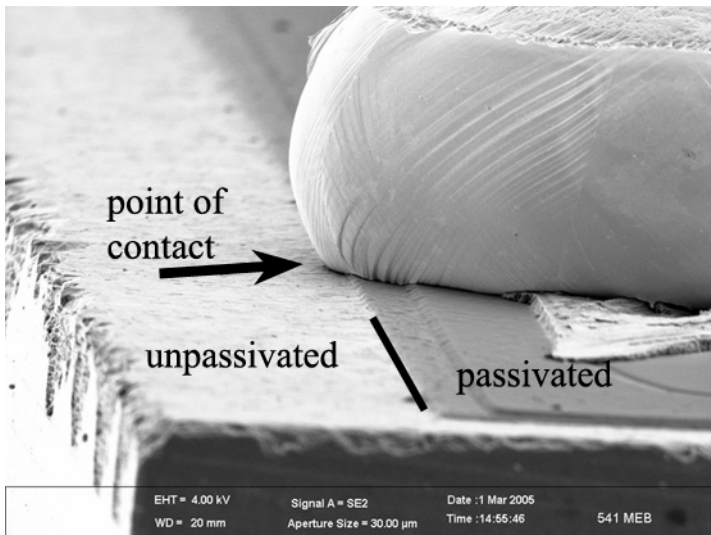
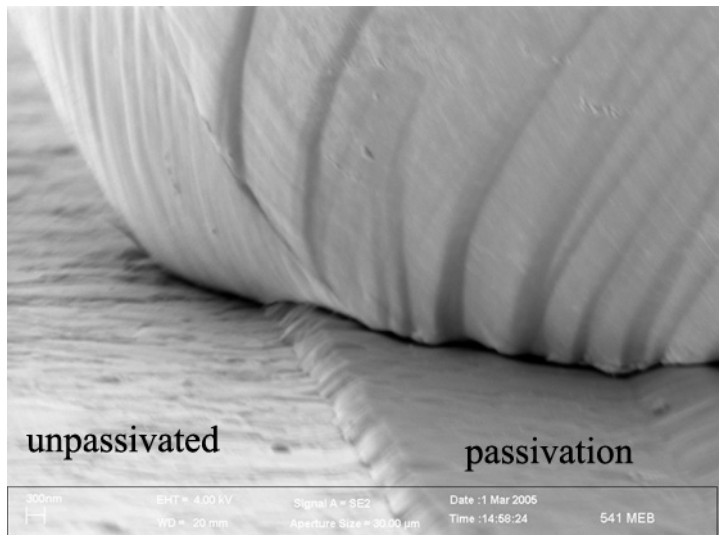
Figure 10. Similar views of Q10-B ball bond. A very small point of contact is suggested.

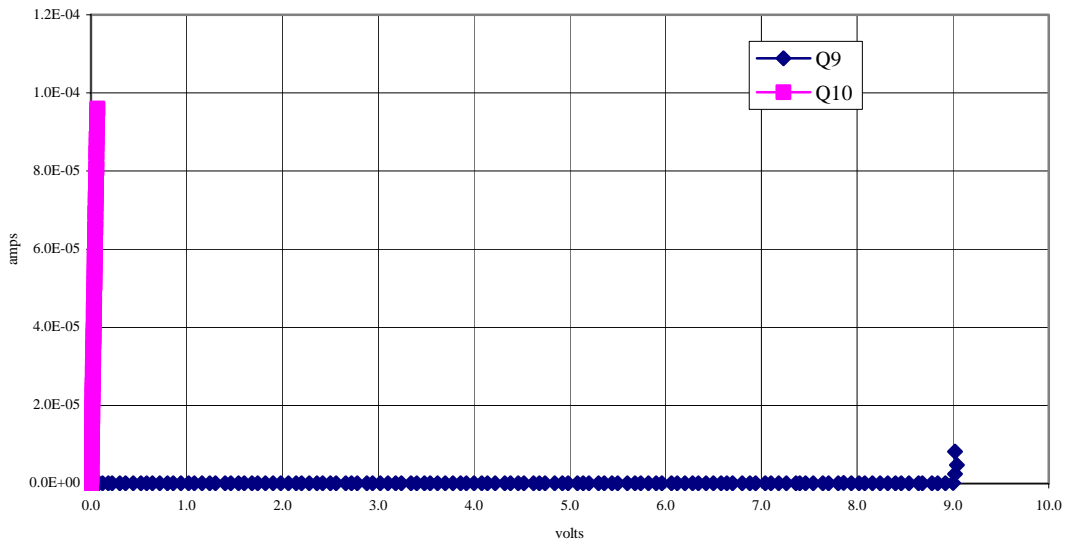
The Q9/Q10 transistors were isolated from the circuit by removing the bond wires (all six of which exhibited excellent pull strengths). Micro-probing the die revealed a 687-ohm short between Q10 emitter and base. Q9 emitter-base diode displayed nominal forward and reverse characteristics. Q9-E, Q10-E and Q10-B displayed nonlinear characteristics to ground (through the bulk/backside of the die).

Figure 11. Emitter-base diode reverse bias [V(br)EBO] characteristic for Q9 and Q10 *prior* to removing the Q10-B ball bond from the die. The slope of the Q10 line is 687-ohms.

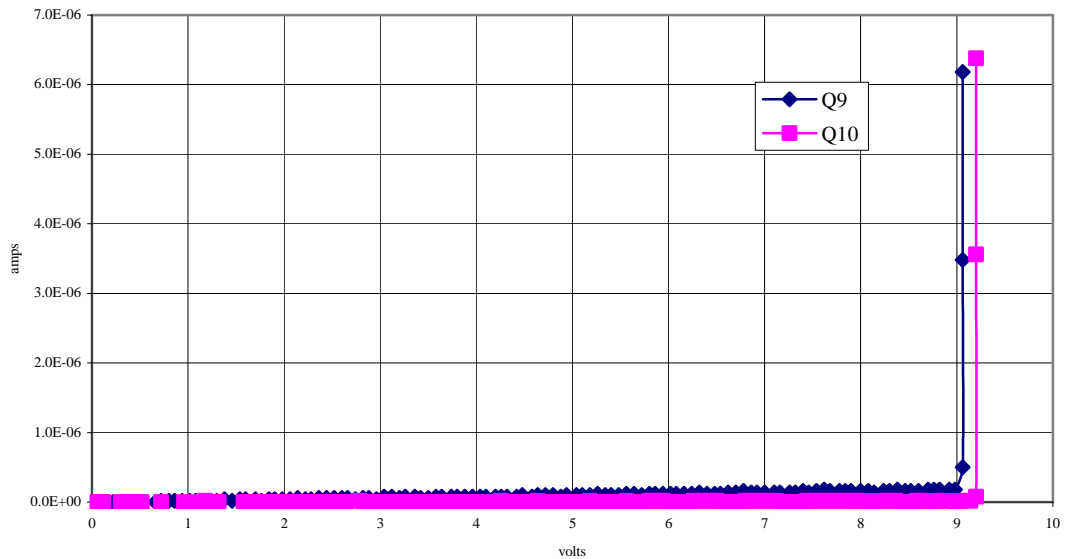
Next, the Q9/Q10 transistor die was removed from the package. The transistors were again characterized and no change was noted. The ball remnant at Q10-B was removed and final micro-probing revealed the emitter-base short was now gone. The Q10 emitter-base diode was again compared to the Q9 emitter-base diode and both were nearly identical. Curve tracer plots for these results are shown in Figures 11 and 12.

Figure 12. Emitter-base diode reverse bias characteristics *after* removing the die from the package and the Q10-B ball bond from the die.

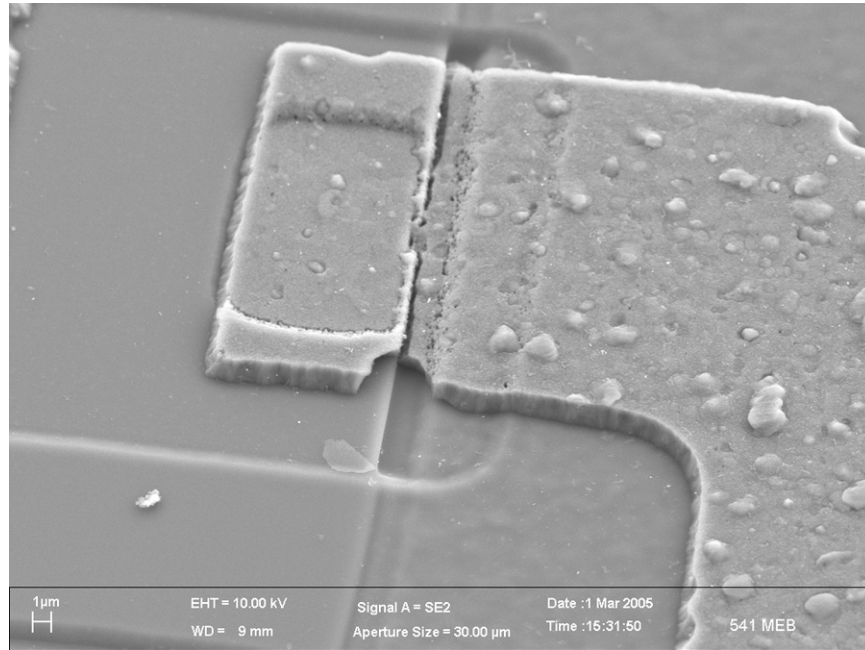
A non-related but nonetheless very serious defect was found on the Q9/Q10 transistor die. The aluminum metallization suffered severe step coverage reduction at oxide steps on the die surface. It appeared that the metallization was nearly open circuit. Figures 13 and 14 show this condition.

The secondary finding of unacceptable metallization on the Q9/Q10 transistor is also of serious concern. Optical inspections would not reveal this defect, but a destructive physical analysis (DPA) is expected to find this type defect.

Figure 13. SEM micrograph image shows unacceptable metallization step coverage on the Q9/Q10 transistor.

As is, these device would not be recommended for space flight use. It is recommended that the lot date code for all A111F devices used on the STEREO-IMPACT/SWEA instrument be identified and several pieces of each date code be submitted for DPA. Replacing these device may be necessary.

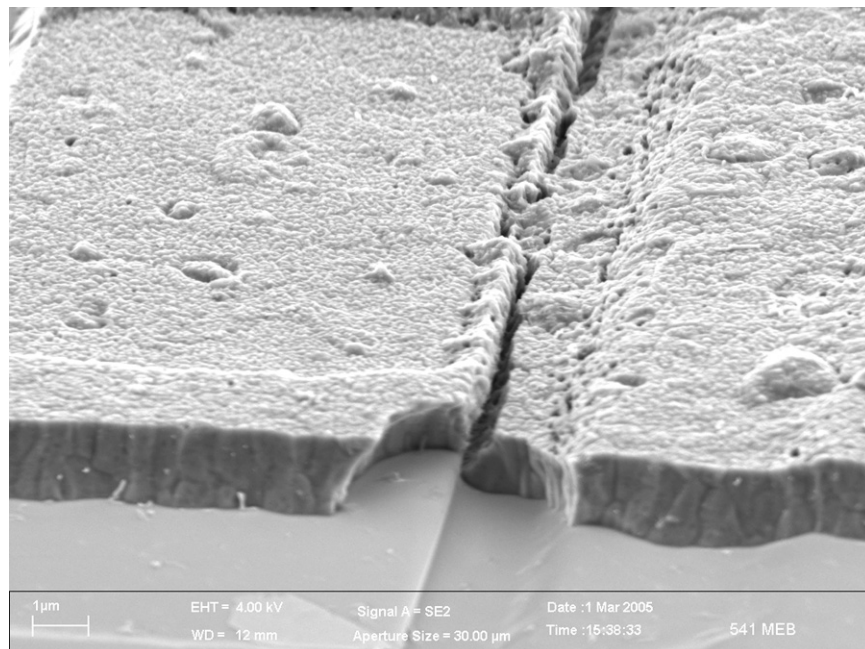
Figure 14. Close-up view of the step coverage shown above.

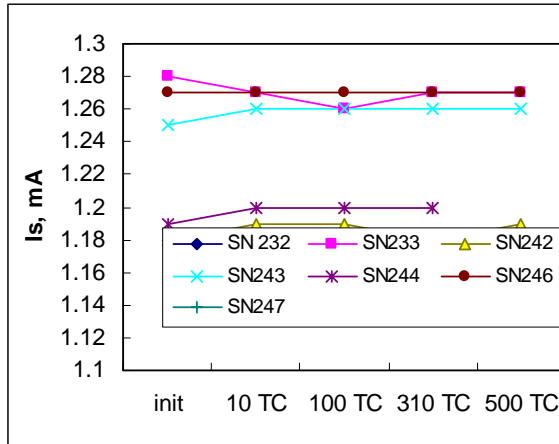
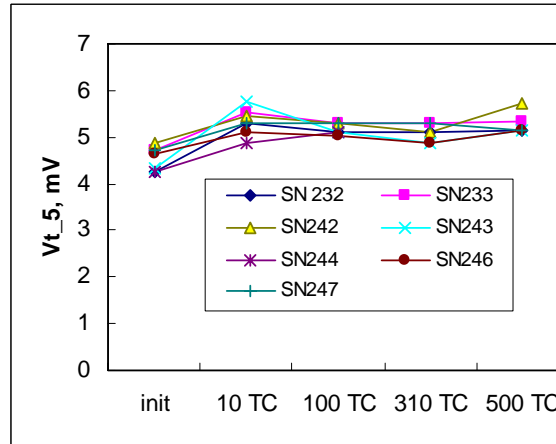
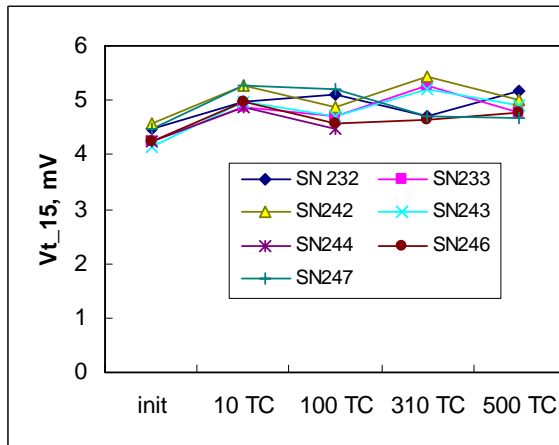
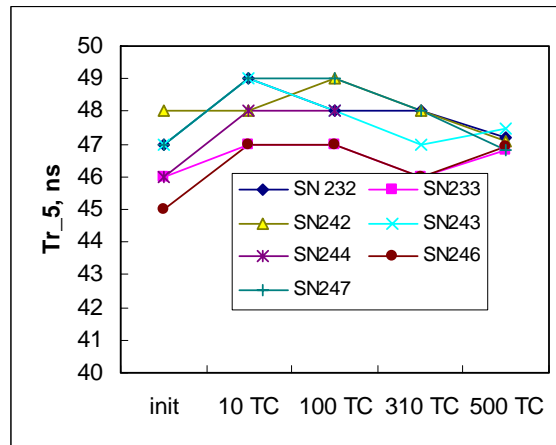
Electrical measurements (see Figure 1) did not reveal significant variations of the parameters of the parts during temperature cycling. All parts passed measurements after 10 and 100 TC; however, one part, SN 244, failed functional testing with no output after 310 cycles. However, the device did provide an analog monitor output and its power supply current was within the specification limits.

Figure 1. Variation of electrical characteristics during temperature cycling.

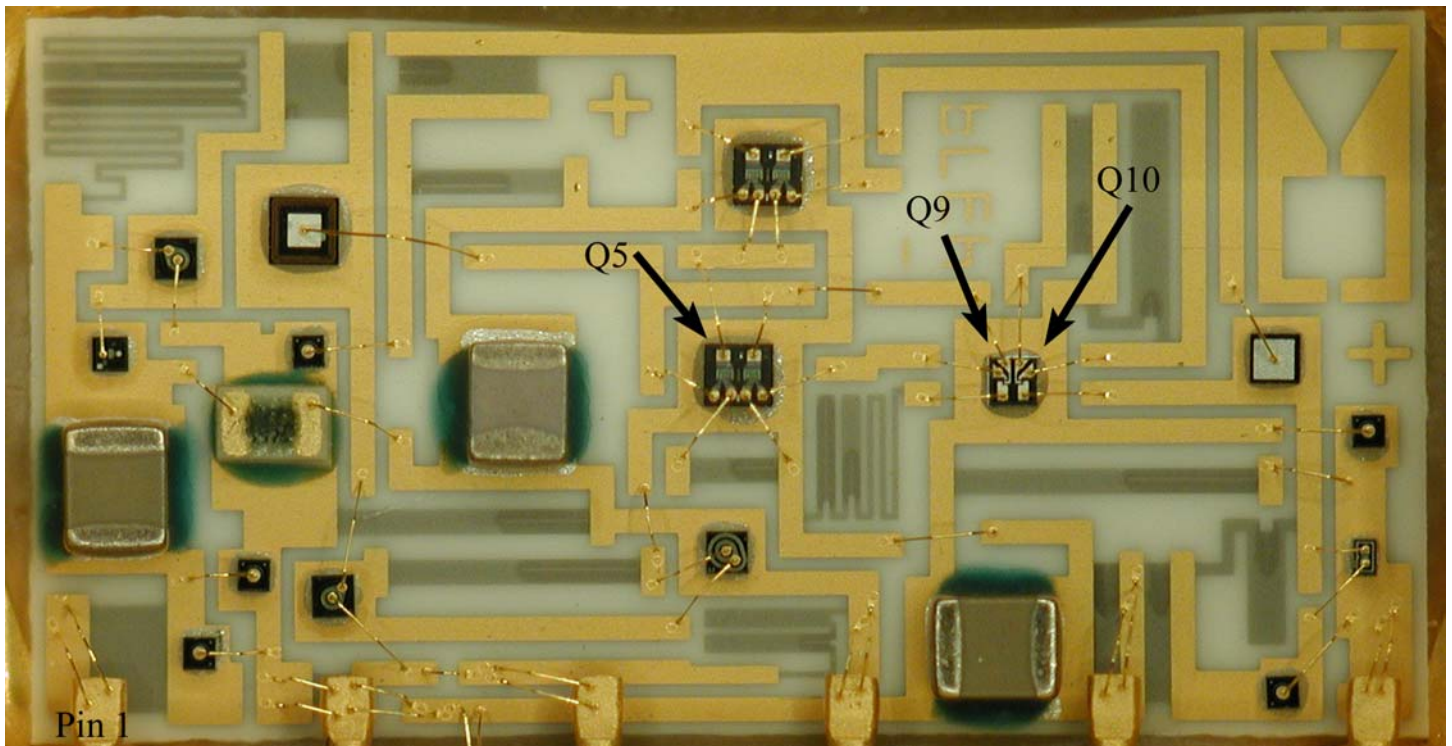
External and radiographic inspections of SN 244 revealed no anomalies. The device passed hermeticity and PIND testing. Pin to pin curve tracer testing revealed no anomaly. An overall internal view of the part is shown in Figure 2.

Figure 2. Internal view of the A111F SN 244 device.

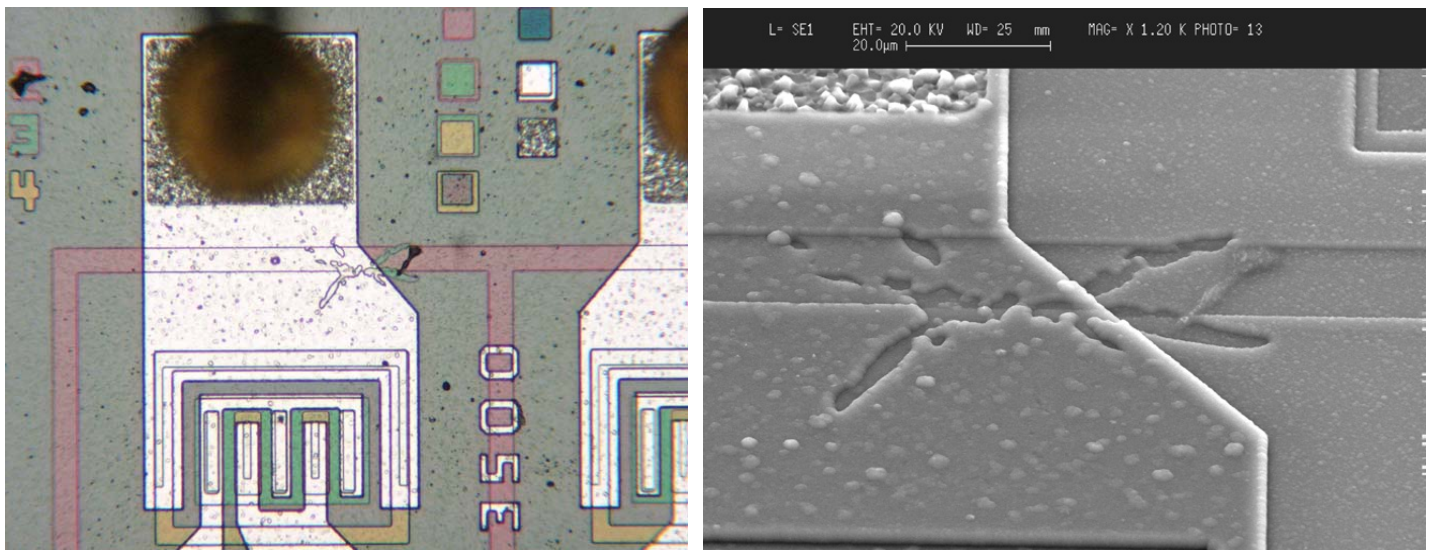
Initially, transistors Q5 and Q6 were suspected of causing the failure due to a photolithography defect revealed during internal examination, see Figure 3. This defect appeared to bridge the collector tub to the die substrate through an isolation diffusion, which is rejectable per MIL-STD-750, Method 2072 inspection criteria.

The backside of Q5 die is connected to V+ terminal through a 100-ohm resistor. Transistors Q5 and Q6 were isolated from the circuit by removing the interconnect bond wires. Probing the individual transistors revealed no anomalies. The characteristics of each pin combination, including each pin to the substrate, were nearly identical, suggesting that this defect was not involved in the device failure.

A serious photolithography-related defect was observed on another transistor within this hybrid. This defect, while rejectable, did not appear to play a part in the device failure.

Figure 3. Optical and SEM images show defect on Q5. Probing revealed no anomaly at this device; however, this defect is rejectable per MIL-STD-750 inspection criteria.

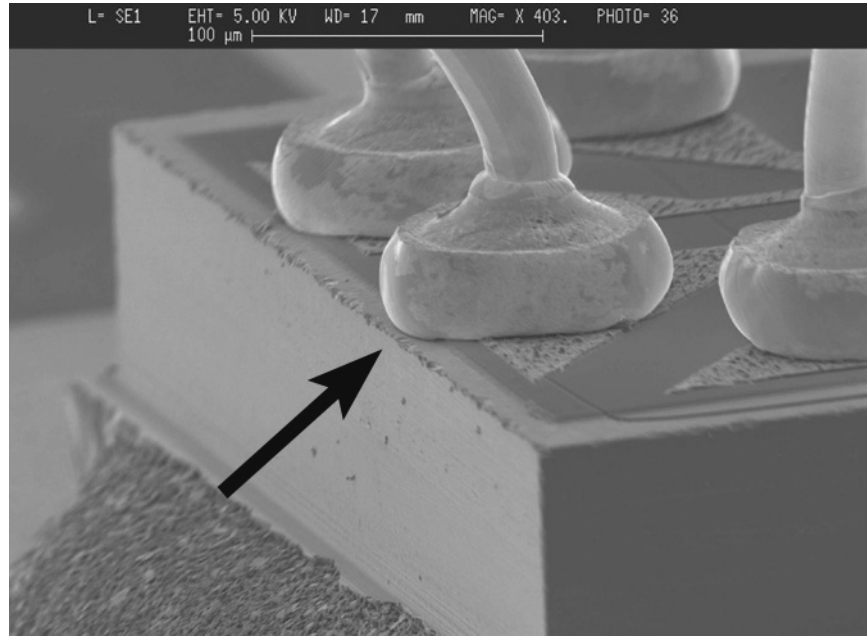
Internal examination revealed a misplacement of the ball bond at Q9, which was apparently sufficient to cause the ball to contact the unpassivated die edge (see Figure 4). However, electrical probing revealed no anomaly with Q9 but instead showed an open circuit at the base of Q10 (see Figure 5). Close inspection of Q10 in the SEM showed that the base metallization at an abrupt oxide step was cracked and discontinuous. The same step on Q9 looked very bad as well; however, electrical probing showed no discontinuity at this step. Figures 6 through 9 show these findings.

A poor placement of the wire bond, which created a risk of shorting between the ball and the edge of the die was also observed in SN244. Similar unacceptable workmanship has been documented in other FA reports on A111F devices, and was attributed to a failure of at least one device.

Figure 4. SEM image shows poorly placed wire bond at Q9-base.

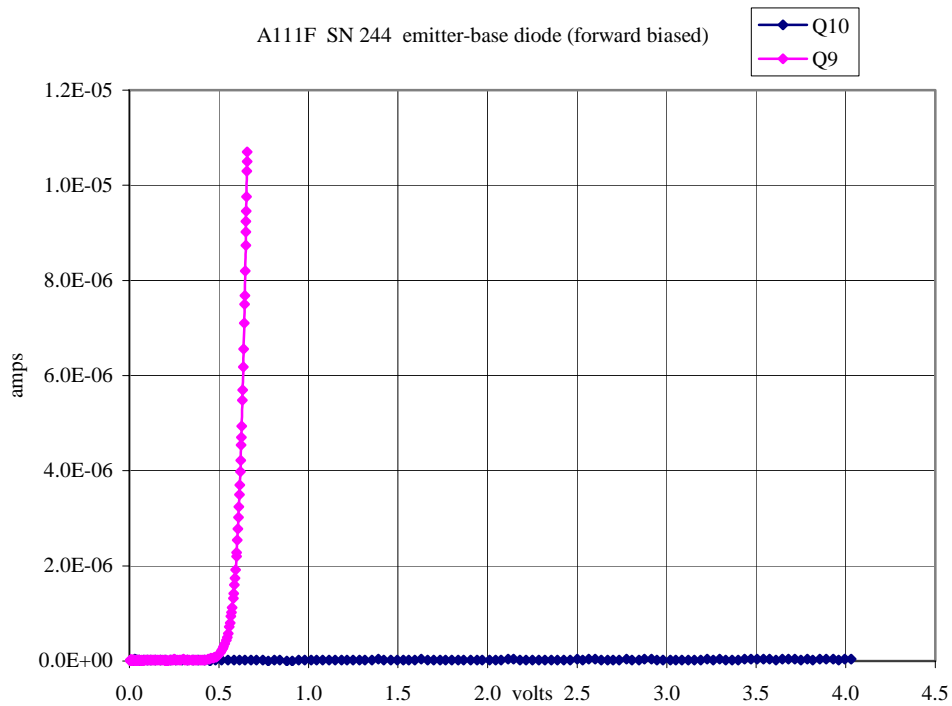
Figure 5. Curve tracer data shows normal emitter-base diode (forward bias) for Q9, while Q10 shows an open circuit. Collector-emitter characteristics were OK for both transistors.

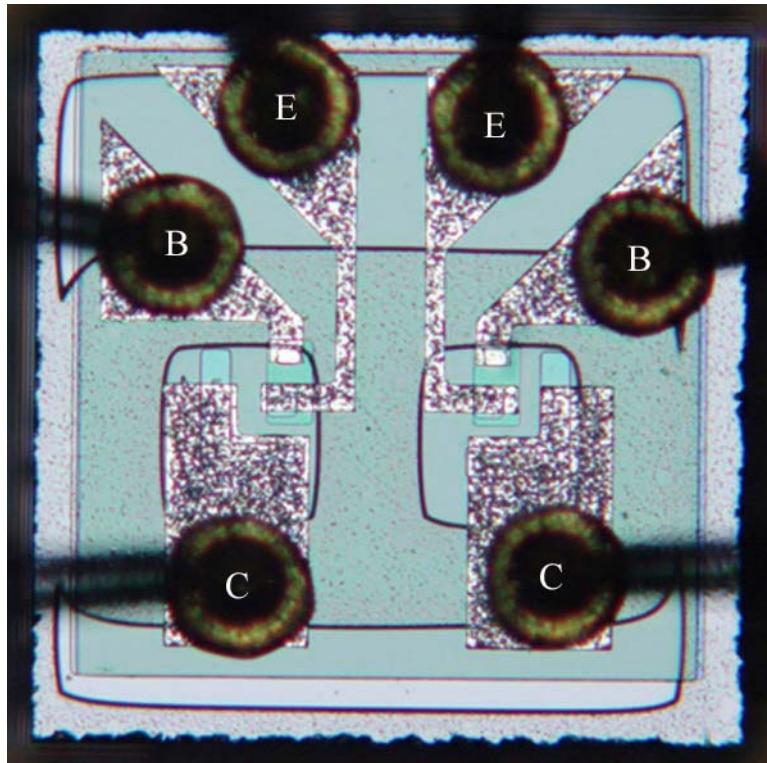
Figure 6. Optical images of Q9/Q10 die. Q9 is on the left, Q10 on the right.

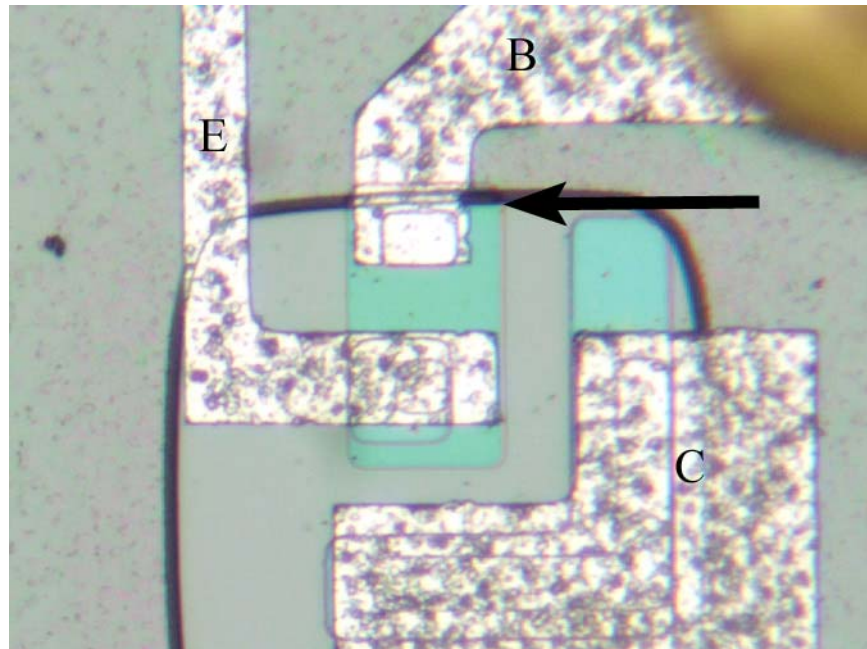
The failure was due to open circuit in the base metallization of transistor Q10. It appears that the thermal cycling induced enough plastic deformation in the metallization that eventually an open circuit developed at a relatively steep oxide step. Based on examination of another transistor on this die and findings of prior failure analyses, it is suspected that this die, and most likely the whole lot of these transistors, had poor step coverage metallization initially.

Figure 7. Close-up of Q10 with arrow showing location of open base metallization.

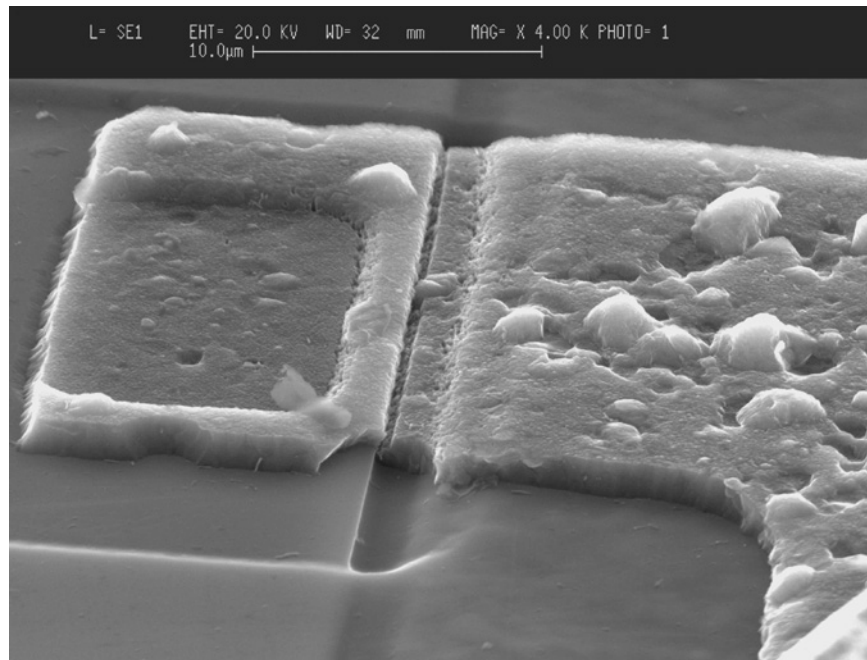
Figure 8. SEM image shows open Q10 base metallization at oxide step.
(Same step as shown in Figure 7).

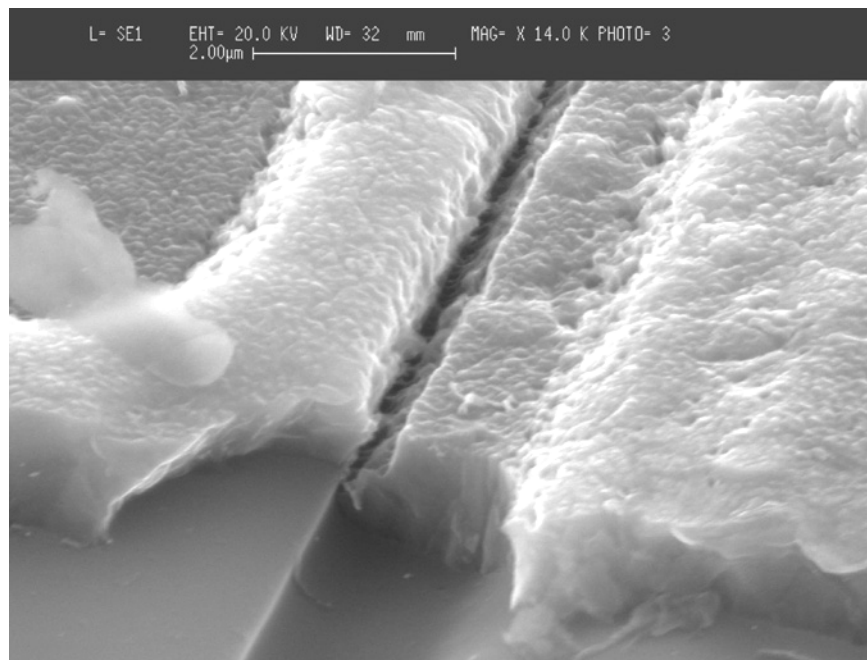
Figure 9. Close-up SEM image shows detail of separated Q10 base metal at the oxide step.
