STEREO IMPACT

PROBLEM REPORT
PR-1032
FM2 IDPU Cold Start 2
2005-01-14

Assembly : IDPU	SubAssembly :
Component/Part Number:	Serial Number: FM2
Originator: David Curtis	Organization: U.C. Berkeley
Phone : 510-642-5998	Email : dwc@ssl.berkeley.edu

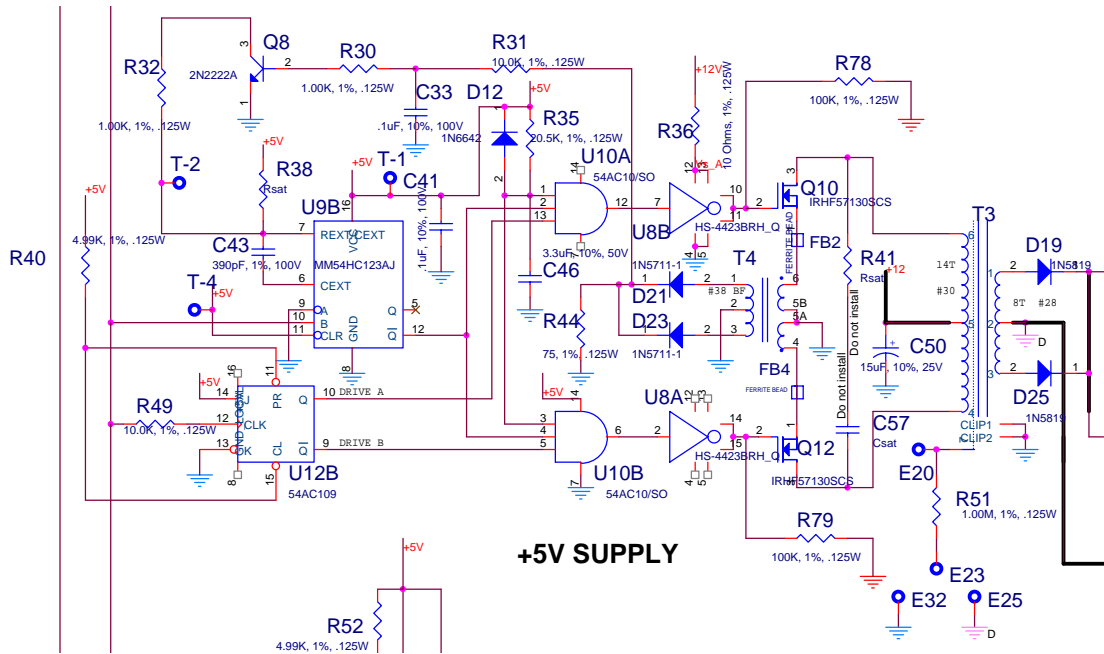
After the chamber was vented the instrument was returned to the bench and operated correctly. It continued to function properly after cycling in a thermal chamber and extensive operations on the bench. The low current indicates that part of the converter did not start. The unloaded supply takes more than 100mA (due to current being delivered to limiting zeners). We know the digital supplies were not working because the processor did not come up, and we verified with the ETU that the 100mA is consistent with the digital supply not starting. Inspection of the digital supply indicates a reverse biased Tantalum capacitor in the circuit – C46, see schematic below. Note in the schematic that the polarity is not indicated; early on in the design the capacitor was a ceramic part, but when the value increased it changed to tantalum without the part symbol changing. This resulted in an ambiguous input to the layout program and incorrect polarity indications on the silk screen. If C46 were to short (or at least increase its leakage to ~100uA) the digital supply would not start, resulting in the symptoms seen. Extended exposure to warmer conditions could have allowed the part to heal itself. The part is a CWR06NH335KC 3.3uF 50V part, LDC P017196332. Review of all IMPACT/PLASTIC power converter designs show that the SEP LVPS has the same problem (see PFR 1025). Shortly after this problem was identified but before the solution was implemented, the IDPU FM1 unit started showing similar symptoms. It was disassembled and the capacitor was measured before any further thermal cycling. It was found that the C46 capacitor bias had dropped from 5V to 2.3V due to increased leakage current (caused by being reverse biased). This validates the analysis above.

IDPU LVPS schematic, digital supply section. C46 is the suspect part.

Rework
 Repair
 Use As Is
 Scrap
 Replace the reverse-biased capacitors and retest (CPT, workmanship vib, 4 cycles thermal vac). Redlined drawing includes polarity identifiers. The circuit was not stressed due to this error.
