STEREO IMPACT

PROBLEM REPORT

PR-1033

FM1 SWEA I/F Errors

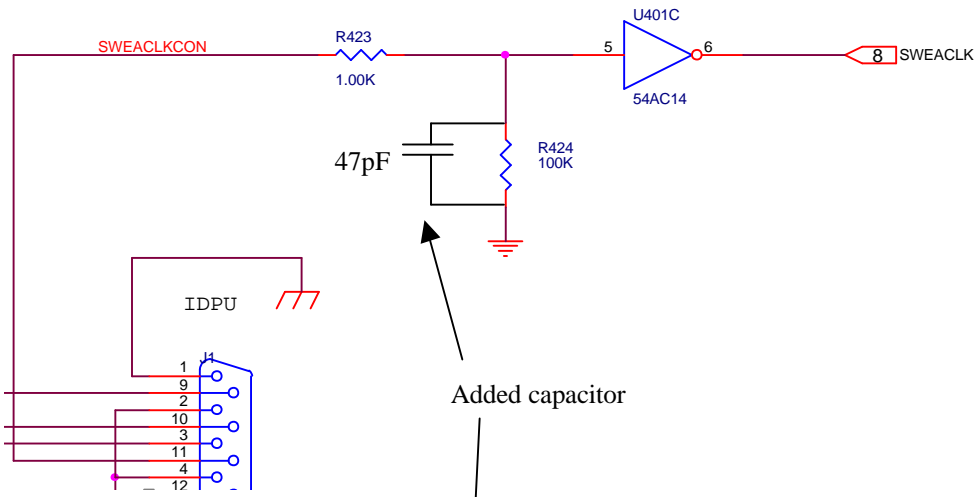
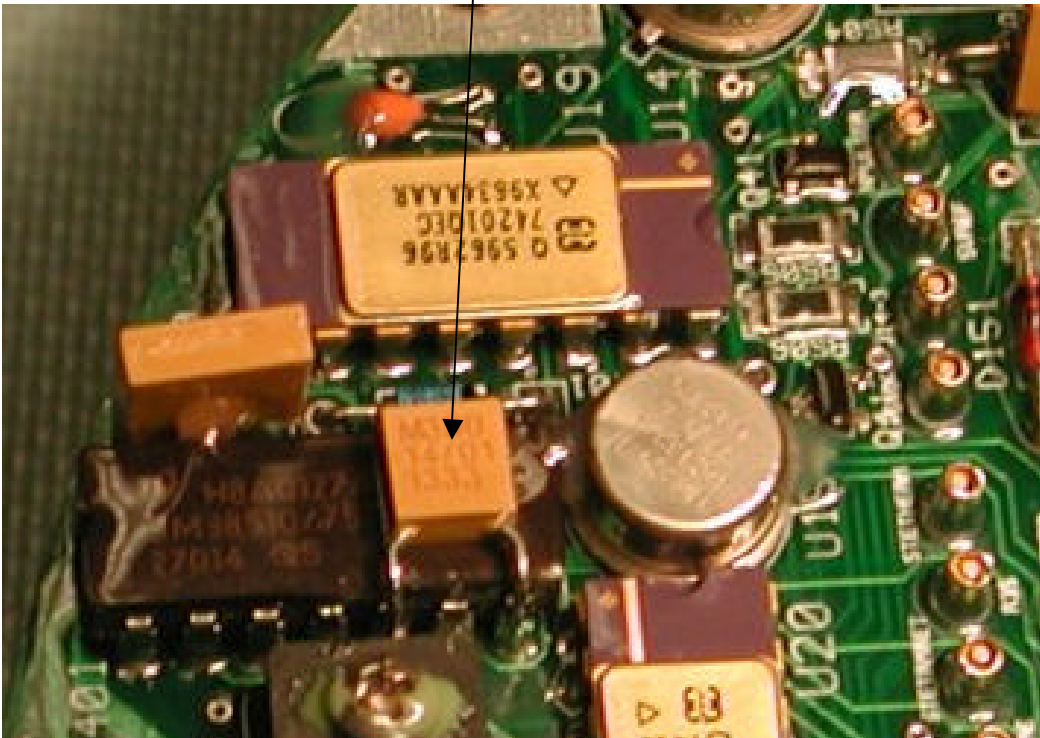
The interface errors are caused by noise on the serial interface clock line. The noise seems to be the result of a number of things. First there is some ringing on the serial interface clock line. It is not enough to cause a problem by itself because of the hysteresis of the receiver (54AC14), but it is ~75% of the minimum data sheet hysteresis, so it increases the sensitivity to other noise on the line. Next there is some cross talk between the clock and other signals in the harness due to the extenders we used to get through the thermal vac wall, which were not shielded like the flight harnesses. Finally there is a small amount of cross-talk between the clock and power lines in the harness or harness extenders results in noise on the clock when switching on/off the SWEA operational heater. All these have to occur at the same time to cause the problem, which explains how infrequent it is.

It is hard to replicate exactly what we saw in thermal balance on the bench, but we do see the combination of these effects approaching being large enough to cause extra clock signals. We could probably solve the problem by using shielded harness extenders, but we would like to increase the noise immunity.

We find that if we add a small (47pF) capacitor between the 1Kohm series resistor at the input to the receiver and ground we can significantly reduce all noise sources while not significantly slowing down the clock (there seems to be adequate timing margins on the serial interface).

Rework Repair Use As Is Scrap
Capacitors added and tested. Noise levels at the clock signal receiver are reduced. Thermal Vac test prove that the margins are adequate over temperature.
