STEREO IMPACT

PROBLEM REPORT

PR-1042

FM2 IDPU EMC

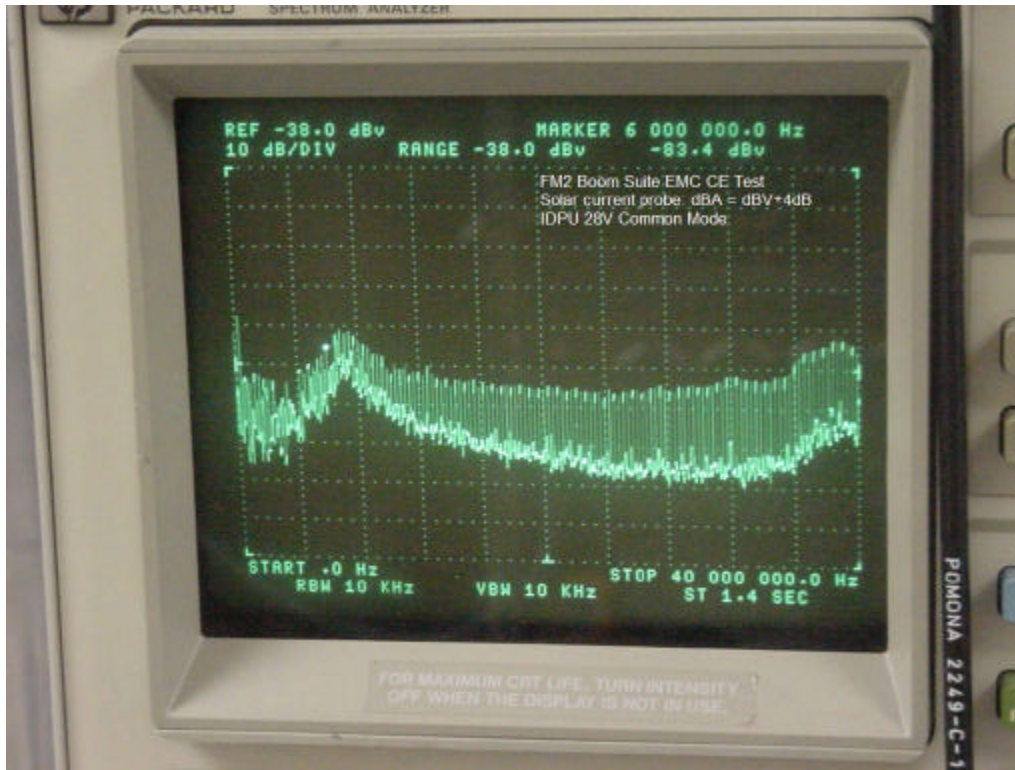
During the IMPACT FM2 boom suite EMC acceptance test (CE only) the IDPU was found to have excessive common mode noise at power converter harmonics (up to 20dB over spec going all the way out to 40MHz, at least 15dB above FM1 IDPU measurements). Some of this noise was also picked up on the MAG heater circuit at high frequencies.

The unit was disassembled and diagnosed. The common mode filter was found to be installed incorrectly (as a differential mode choke instead of a common mode choke). This only effects the common mode emissions. Disassembly was limited to removal of 6 box screws to allow access to the IDPU LVPS.

FM2 IDPU Common Mode Conducted Emissions before fix

The wires from the choke were not able to reach the correct pads, so a new choke was wound, tested, installed, staked, and inspected. The unit was then reassembled and functionally tested OK. Then the EMC test was repeated, and the results now look like FM1, with only a few exceedances at power converter harmonics. The IDPU screws that were removed were re-torqued and staked.

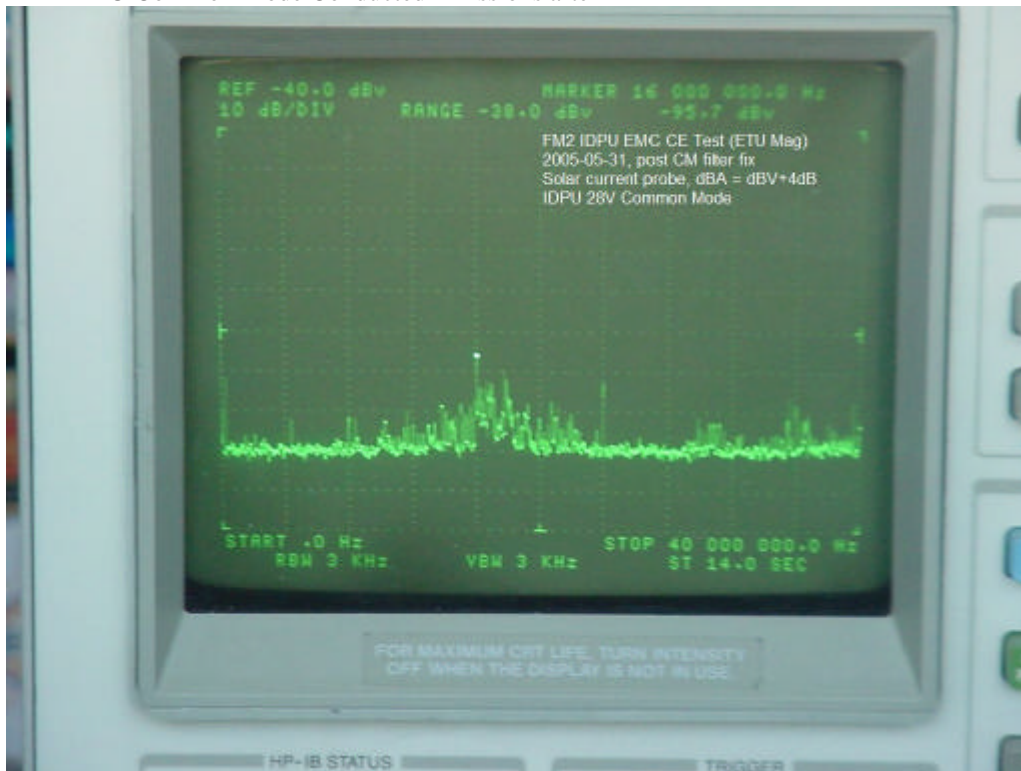
FM2 IDPU Common Mode Conducted Emissions after fix
