STEREO IMPACT

PROBLEM REPORT

PR-2006

LET Upside-down

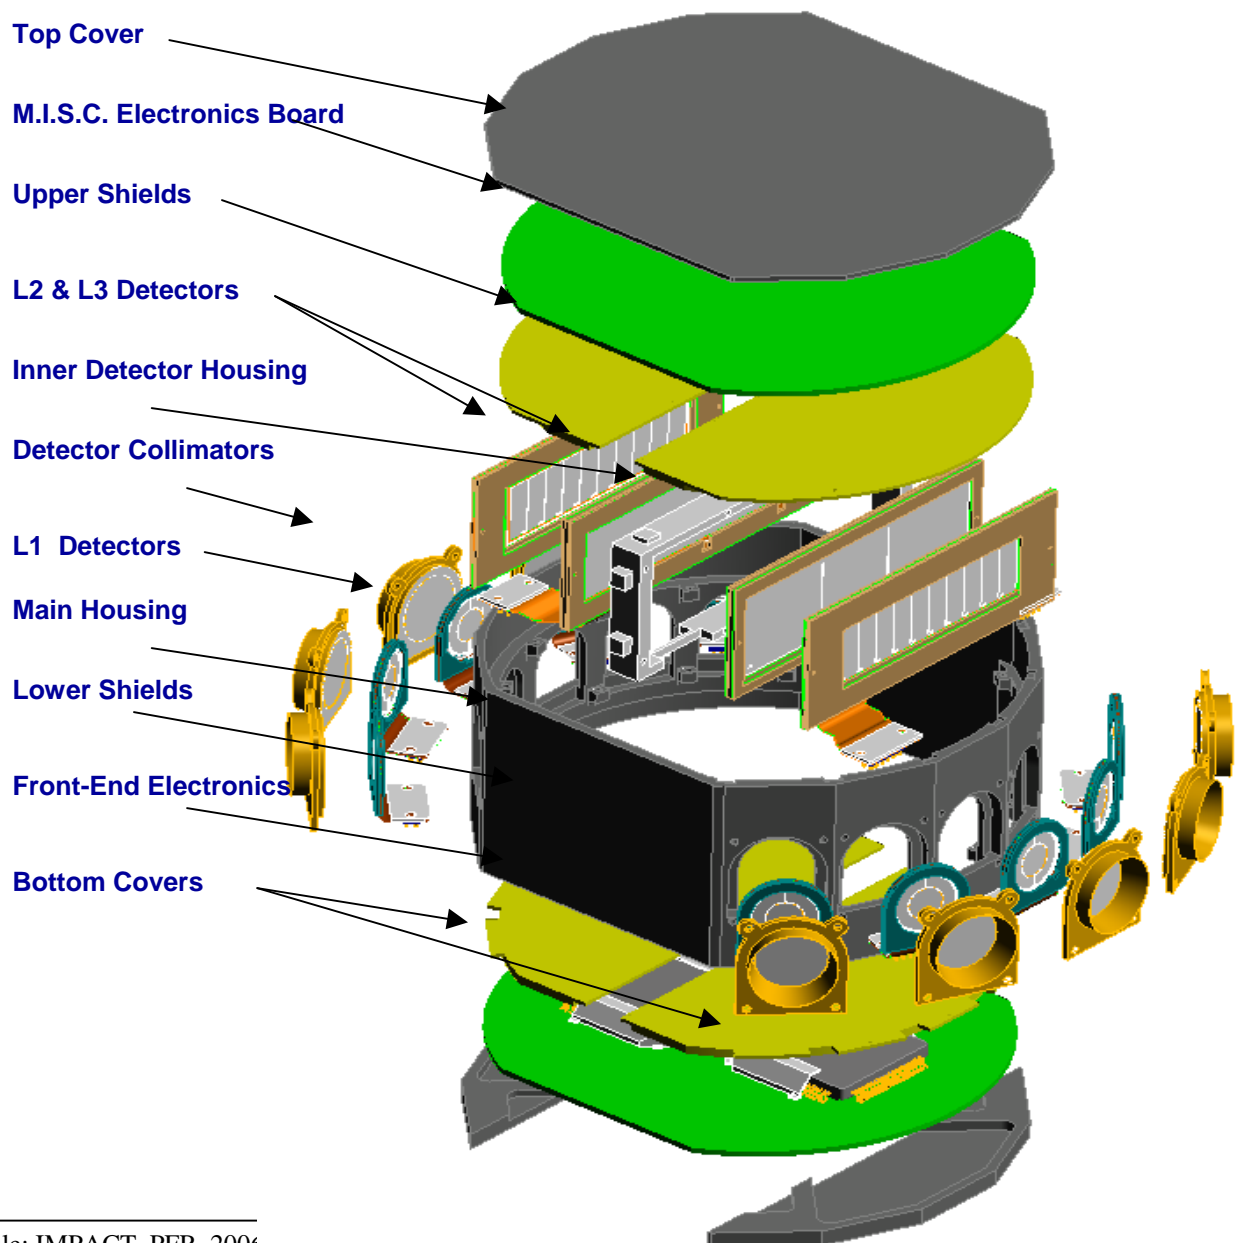
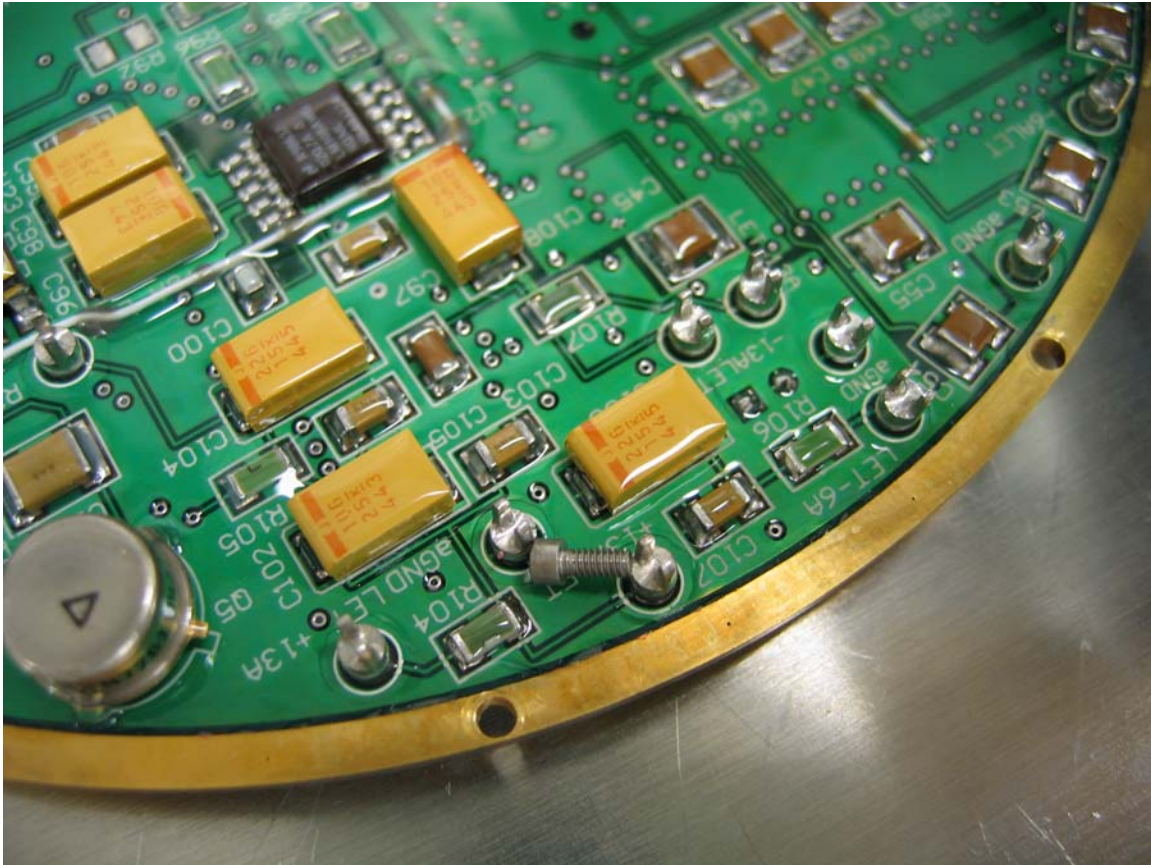
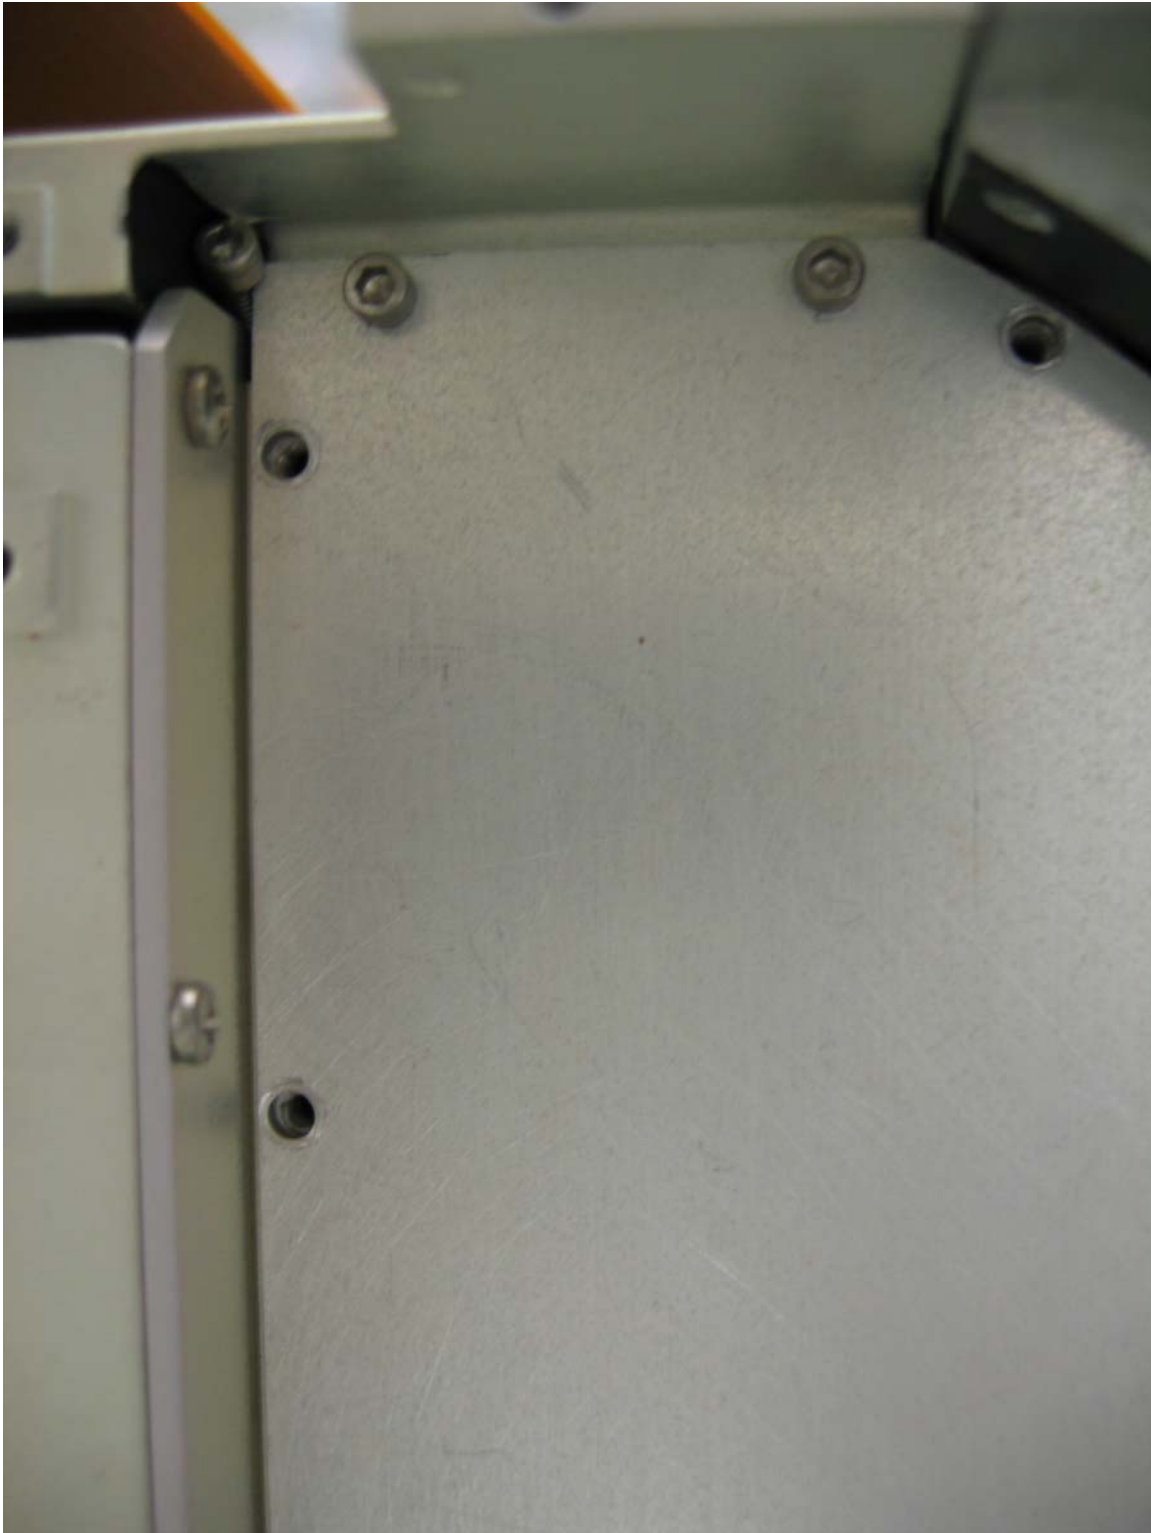
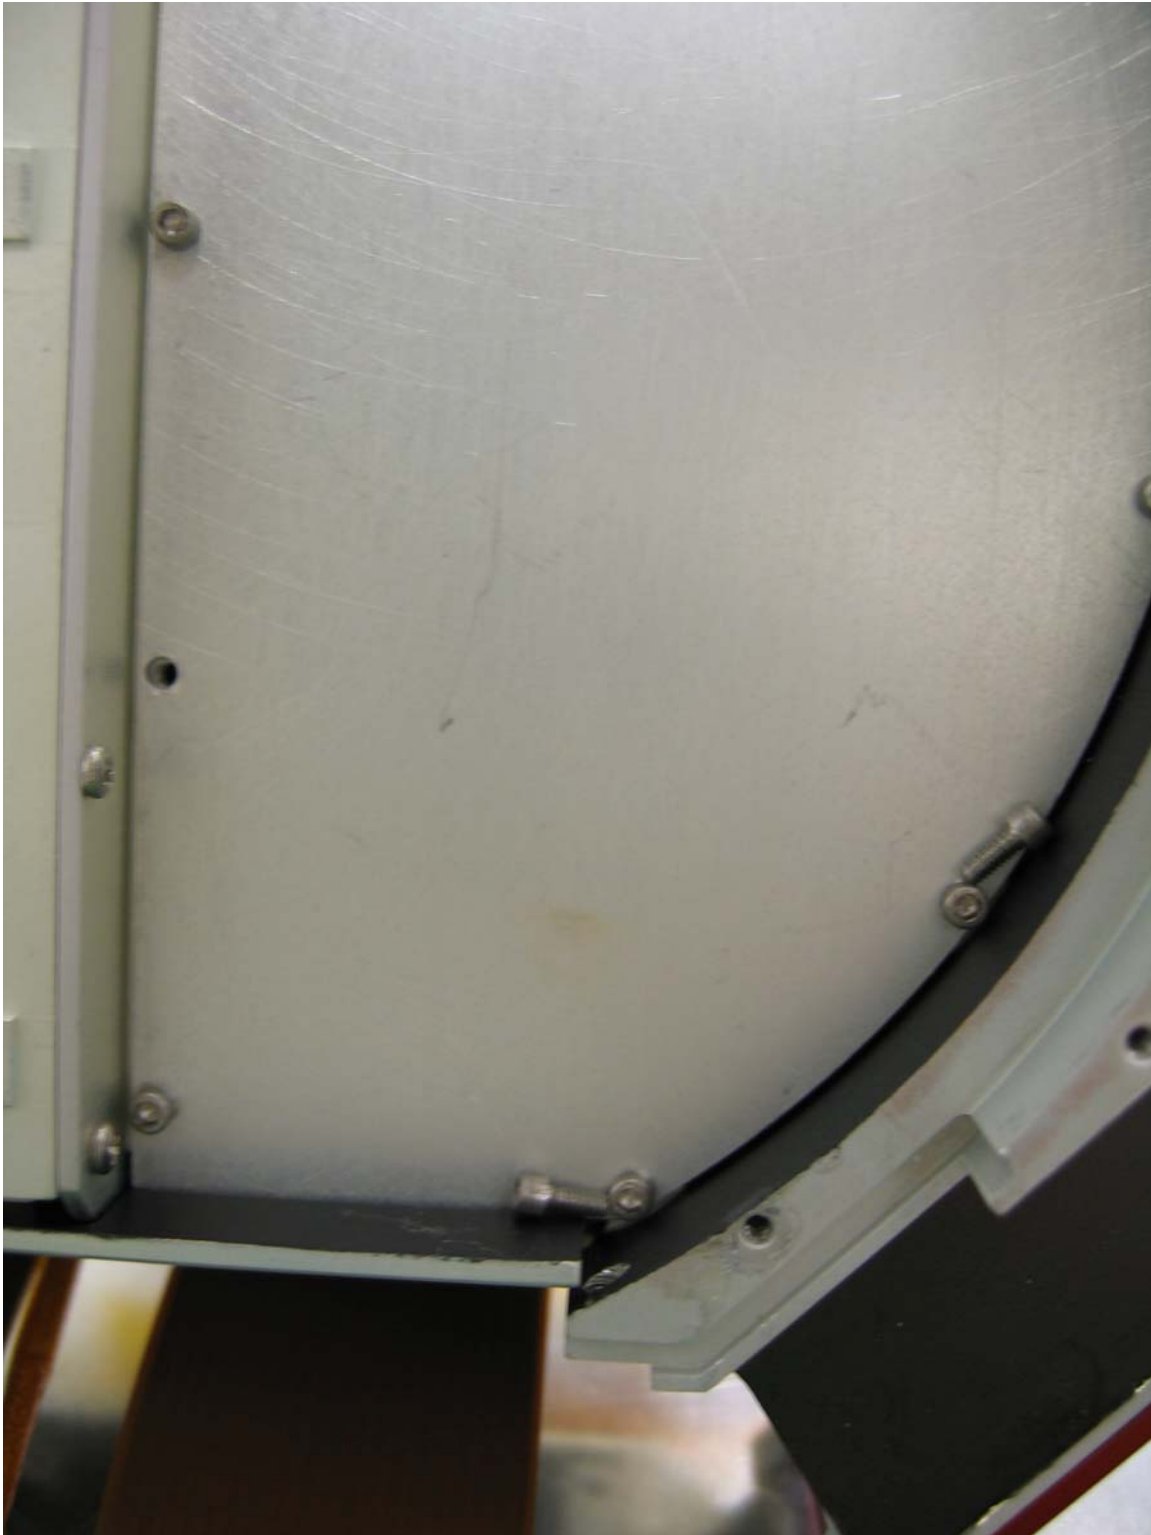
Four 0-80 screws holding down the shield had backed out and were loose inside LET. One of them had lodged between two test points for GND and +13V and was responsible for the short. The screws in the SEP/HET/LET assembly screws were torqued (but this is unverified). All of the screws in LET and HET were not staked. The screws in SEP Central were staked at the heads. There is no other locking feature on the screws used in this assembly. The 0-80 screws were torqued to 2 in-lb.

Four 0-80 screws holding down the shield had backed out and were loose inside LET. One of them had lodged between two test points for GND and +13V and was responsible for the short. All loose screws have been accounted for. We will need to replace the one filter resistor in LET FM1 that saw 350 mA and 3.3 W. (See attached pictures)

1. Completed a visual inspection of the unit and all four loose screws were accounted for.
2. Stress analysis was performed and 27.4-ohm filter resistor R104 in LET FM1 (P/N D55342K07B27D4S) was replaced with the same P/N. UCB reviewed the LVPS design and believes it was not stressed. (email dated 5/5/2005 from D.C.)

3. Disassembled and replaced all of the screws in SEP Central, HET and LET. Reference assembly procedures: LETAssemblyProcPartial_revB.doc, SEP-fastener-replace-proc.doc, HETAssemblyProcParital.doc

- a. Applied a locking feature (Poly-Lok) to all of the hardware.
 - b. Through analysis and test determined the proper torque value to use for the new hardware.

- c. When possible, staked the threads of all of the screws with EC2216. (Reference procedure to the screws that were not staked.)
 - d. Carefully reassembled, following a detailed procedure, which included the documentation and verification of each screw in the all of the assemblies. The "buddy system" was required during all assembly.
