STEREO IMPACT

PROBLEM REPORT

PR-3004

ATO HV Discharge Test
with Reference Board

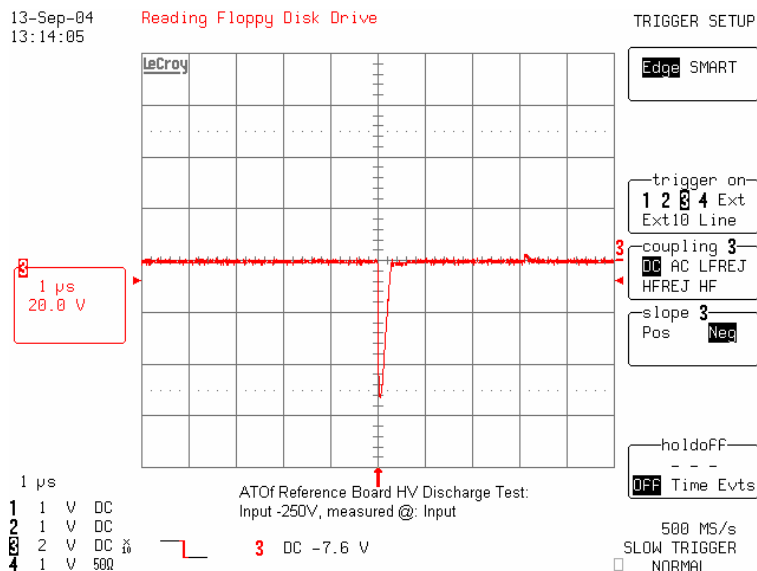
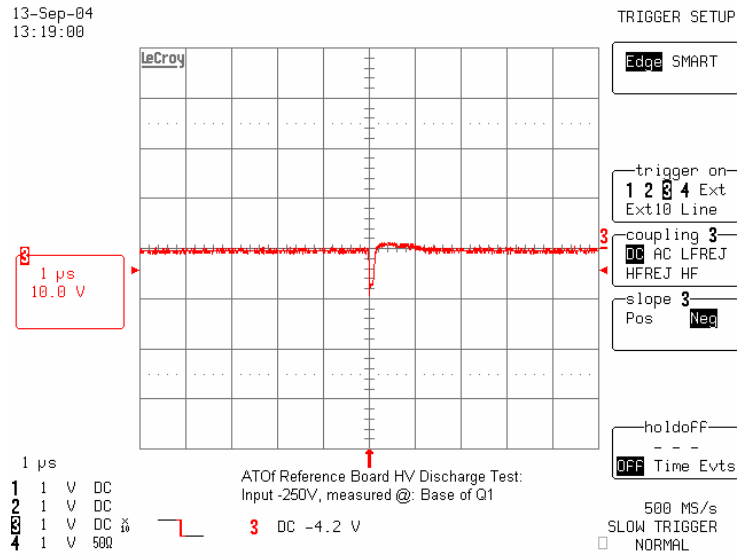
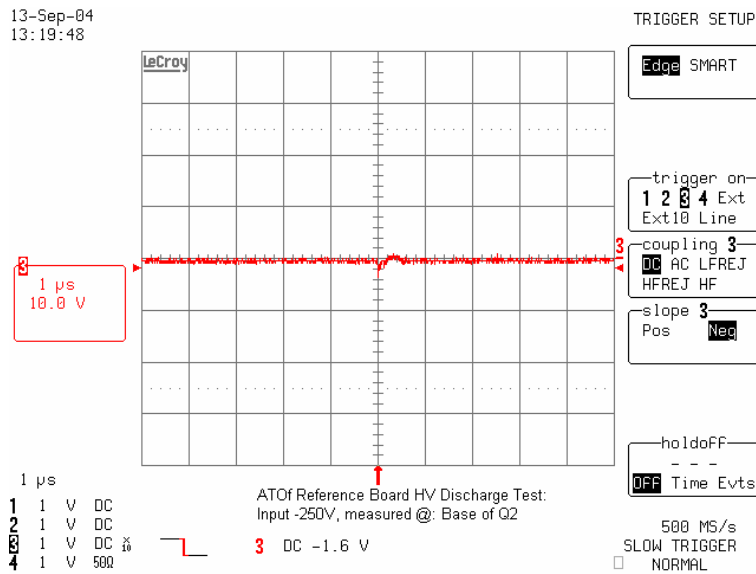
Figure 1: Measured discharge pulse at input when applying -250V charge to input

Figure 2: Measured discharge pulse at base of Q1 when applying -250V charge to input

Figure 3: Measured discharge pulse at base of Q2 when applying -250V charge to input

Result: The Protection Diodes for the negative rail got some damage. They showed a (high impedance) resistive behavior even when reverse polarized after the test. The diode function still worked and the input transistors were still working as expected. The complete channel was still performing nominally.

The two diodes D2 and D3 were replaced for the following tests.

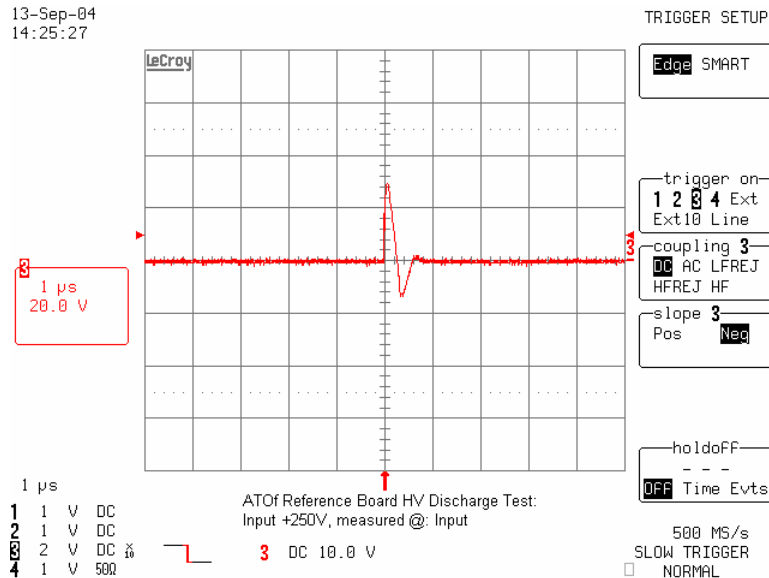
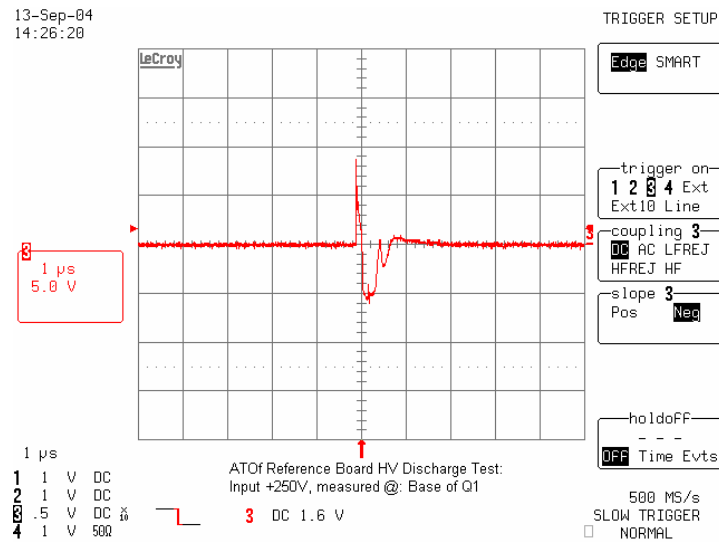
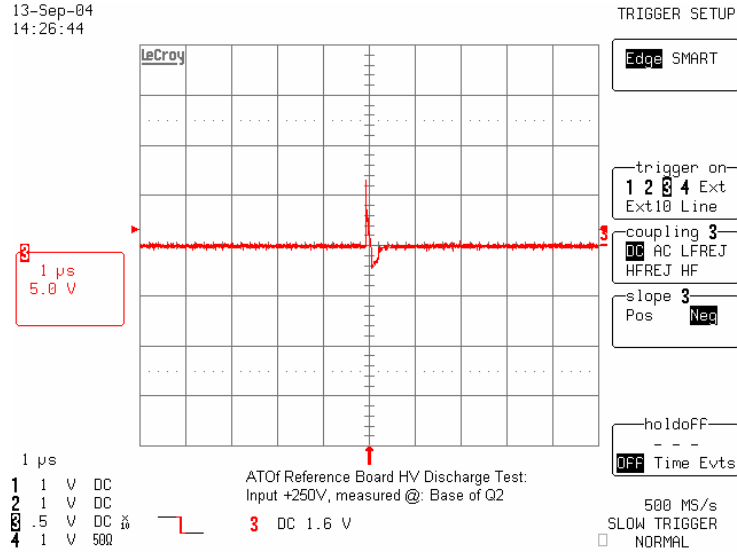
Figure 4: Measured discharge pulse at input when applying +250V charge to input

Figure 5: Measured discharge pulse at base of Q1 when applying +250V charge to input

Figure 6: Measured discharge pulse at base of Q2 when applying +250V charge to input

Result: The Protection Diode for the positive rail showed damage. A (high impedance) resistive behavior was measured when forward polarized. The diode function was still working. The input transistors still worked nominally and the complete channel performed still well.

The diode D1 was replaced for further tests.

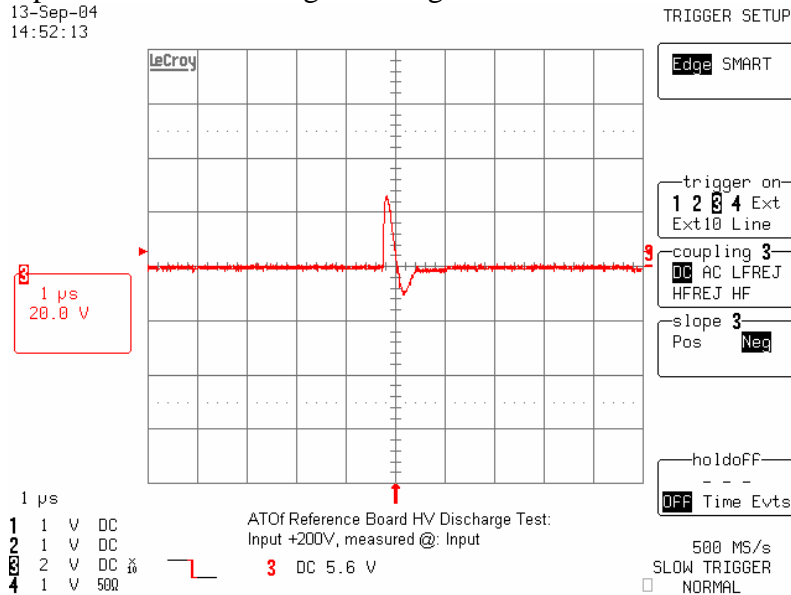
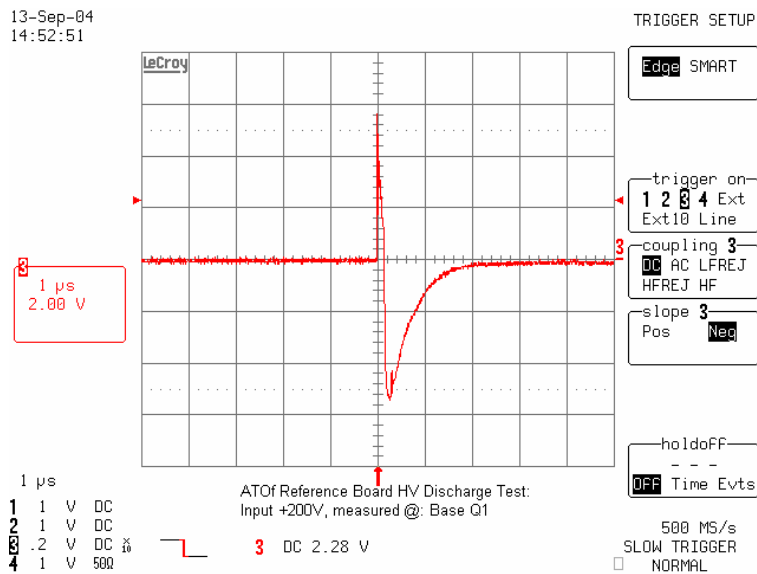
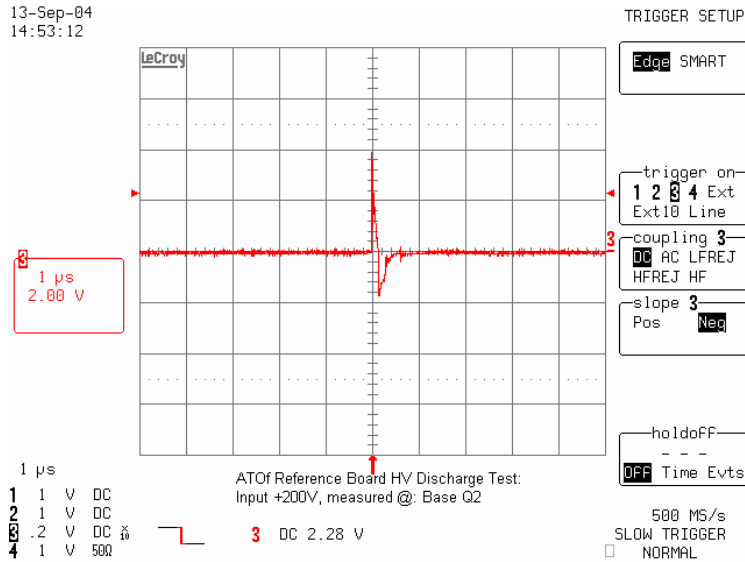
Figure 7: Measured discharge pulse at input when applying +200V charge to input

Figure 8: Measured discharge pulse at base of Q1 when applying +200V charge to input

Figure 9: Measured discharge pulse at base of Q2 when applying +200V charge to input

Result: The Protection Diode for the positive rail had a complete failure (300 Ohm resistance in both directions). The negative rail protection diodes were still working and measured resistive values behaved like before. The input transistors were still working and the complete channel performed still nominally. The diode D1 was again replaced.
