STEREO IMPACT

PROBLEM REPORT

PR-3006

Problem Description

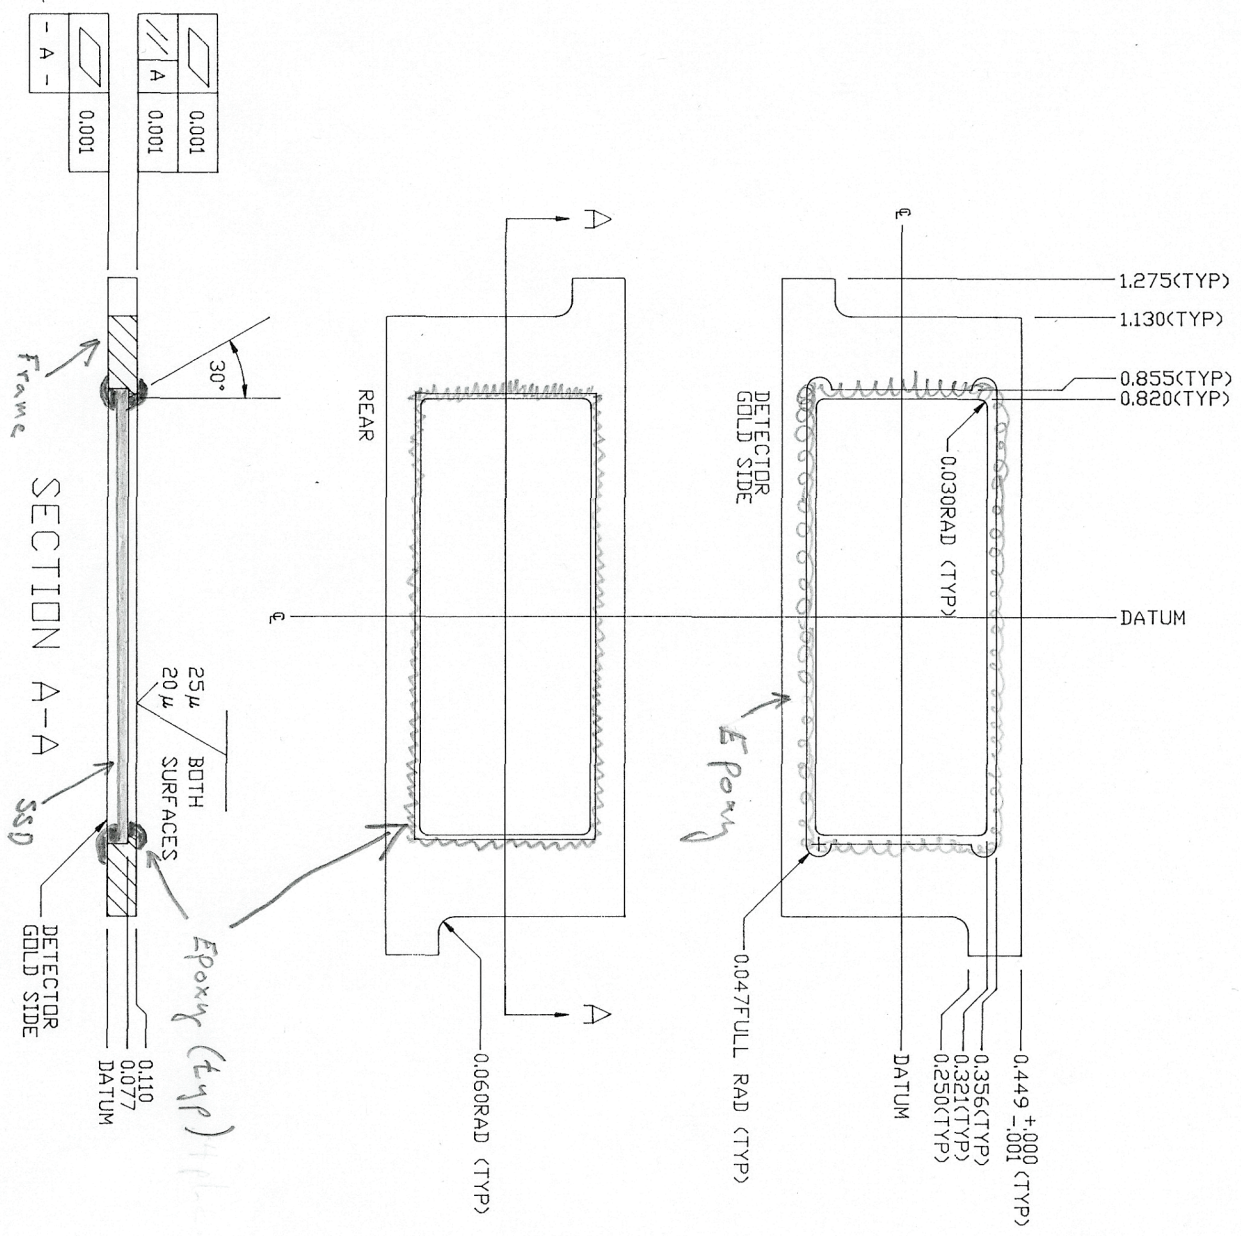
We inspected the SSD and found that an irregular bead of epoxy holding the SSD to its ceramic frame had overflowed its intended channel and had deposited on the top and bottom surfaces of the detector frame. The epoxy bead as designed is shown in Fig 2a. The excess epoxy is shown in Fig 1 and Fig 2b. As can be seen from the figures, the excess epoxy interferes with the stacking of the detector components and with electrical contact between the detector, the focuser (ground) and the contactor (signal & bias).

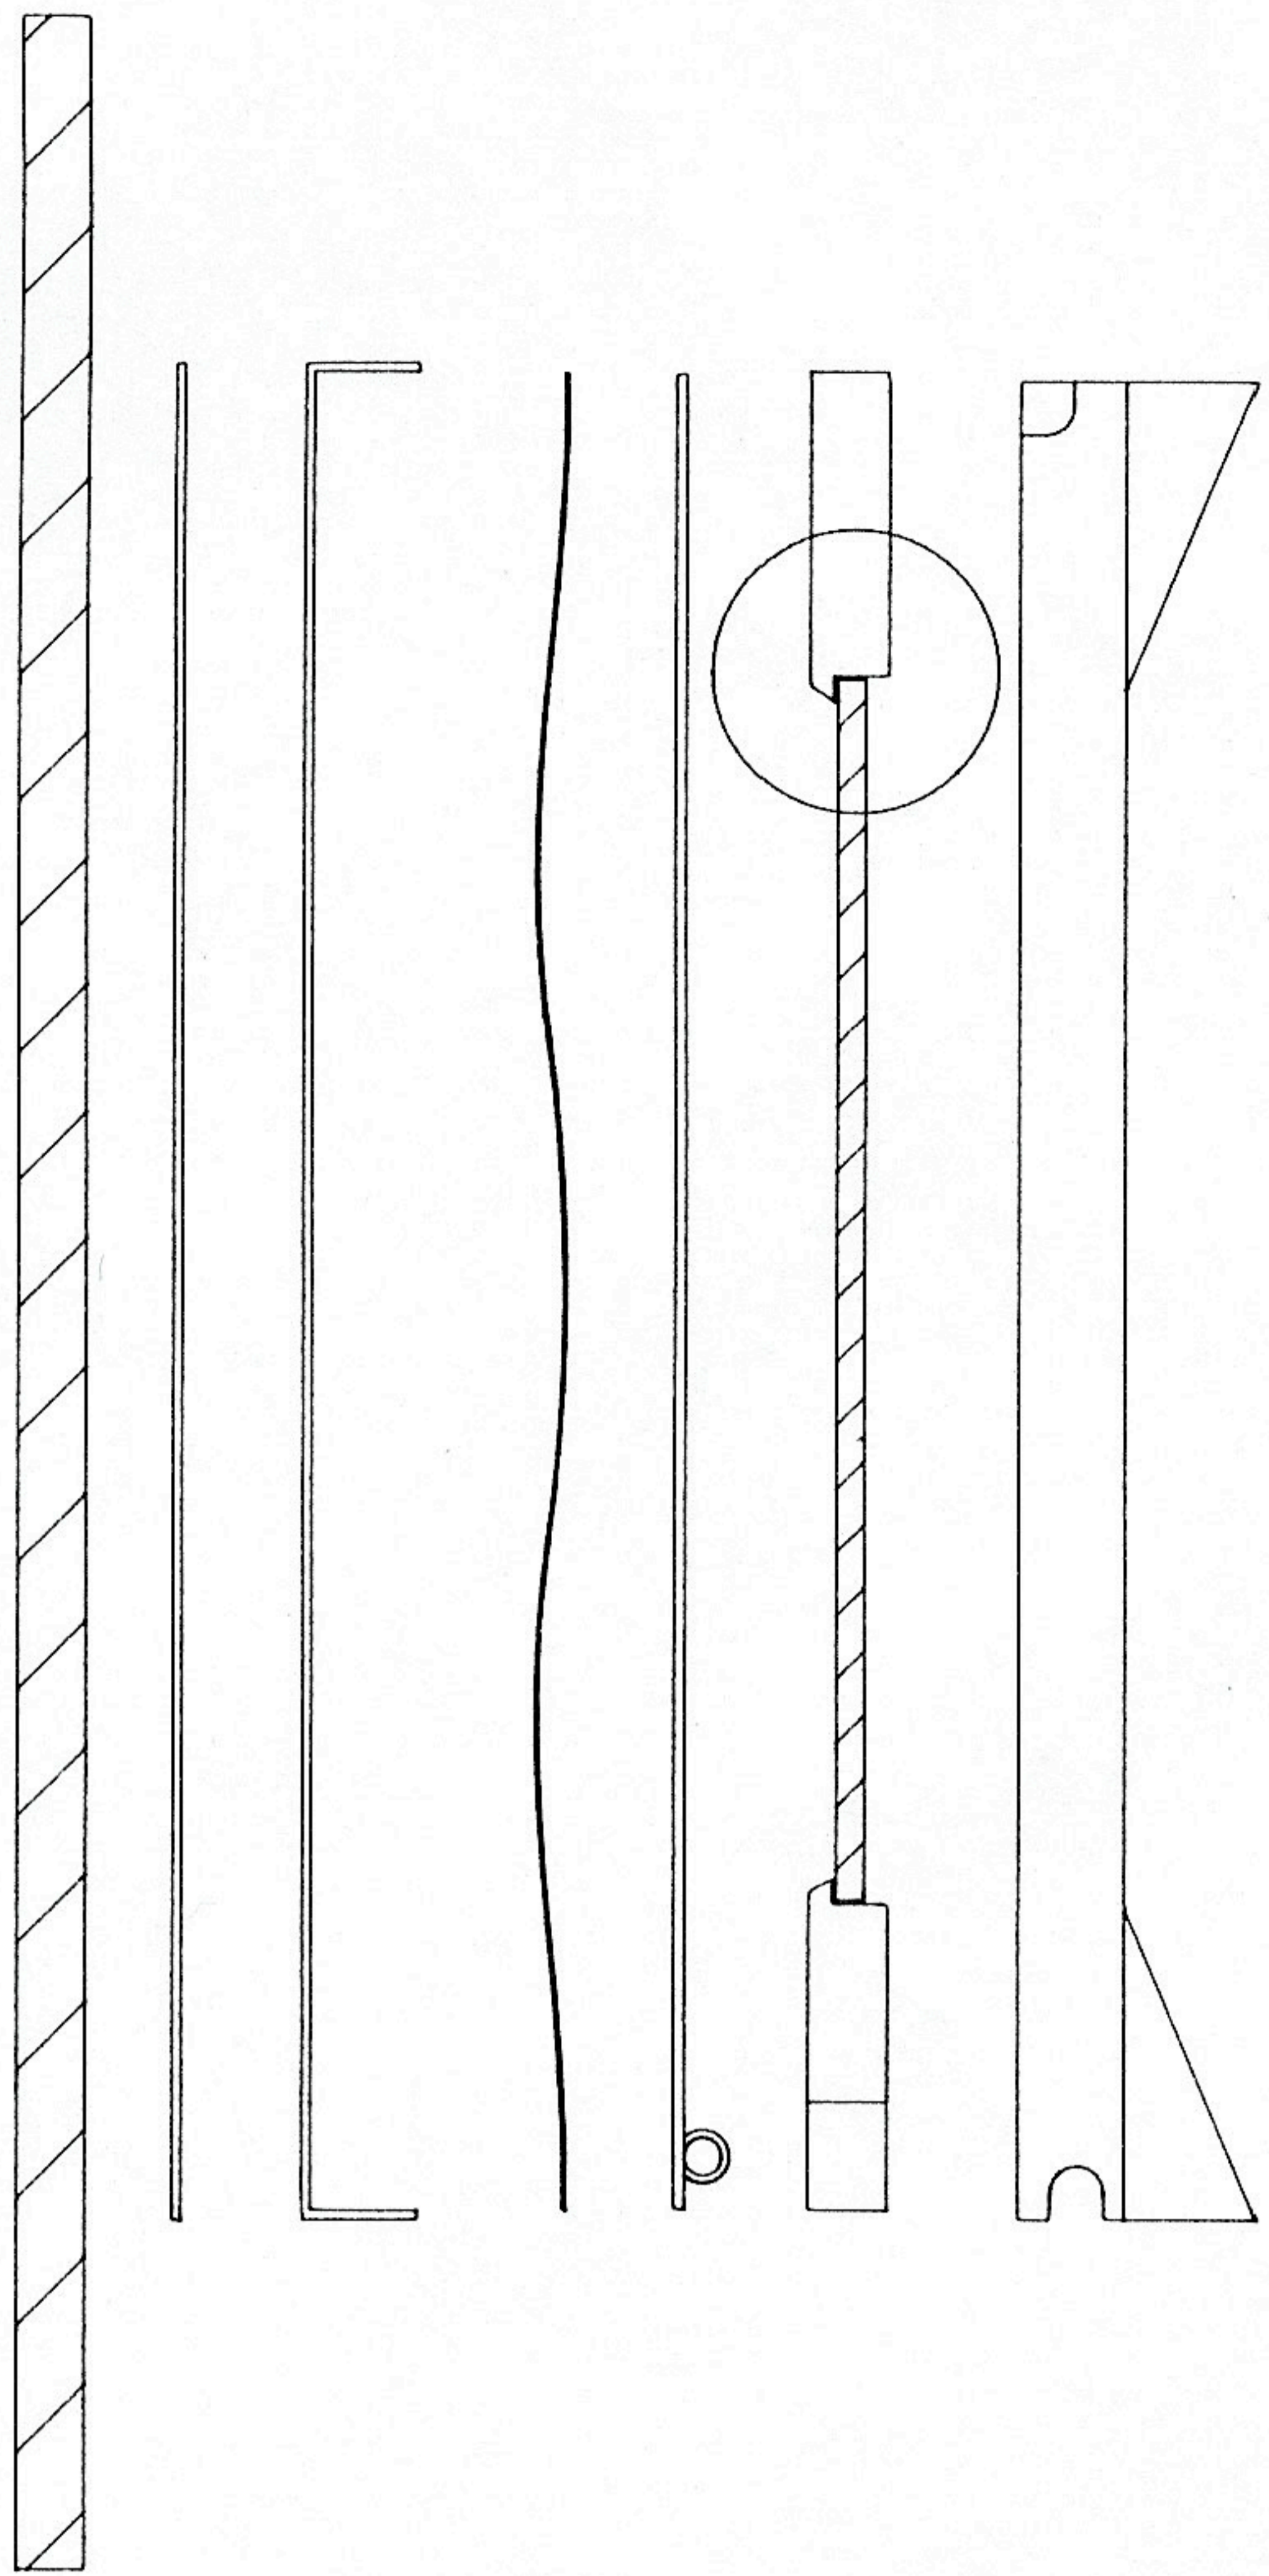
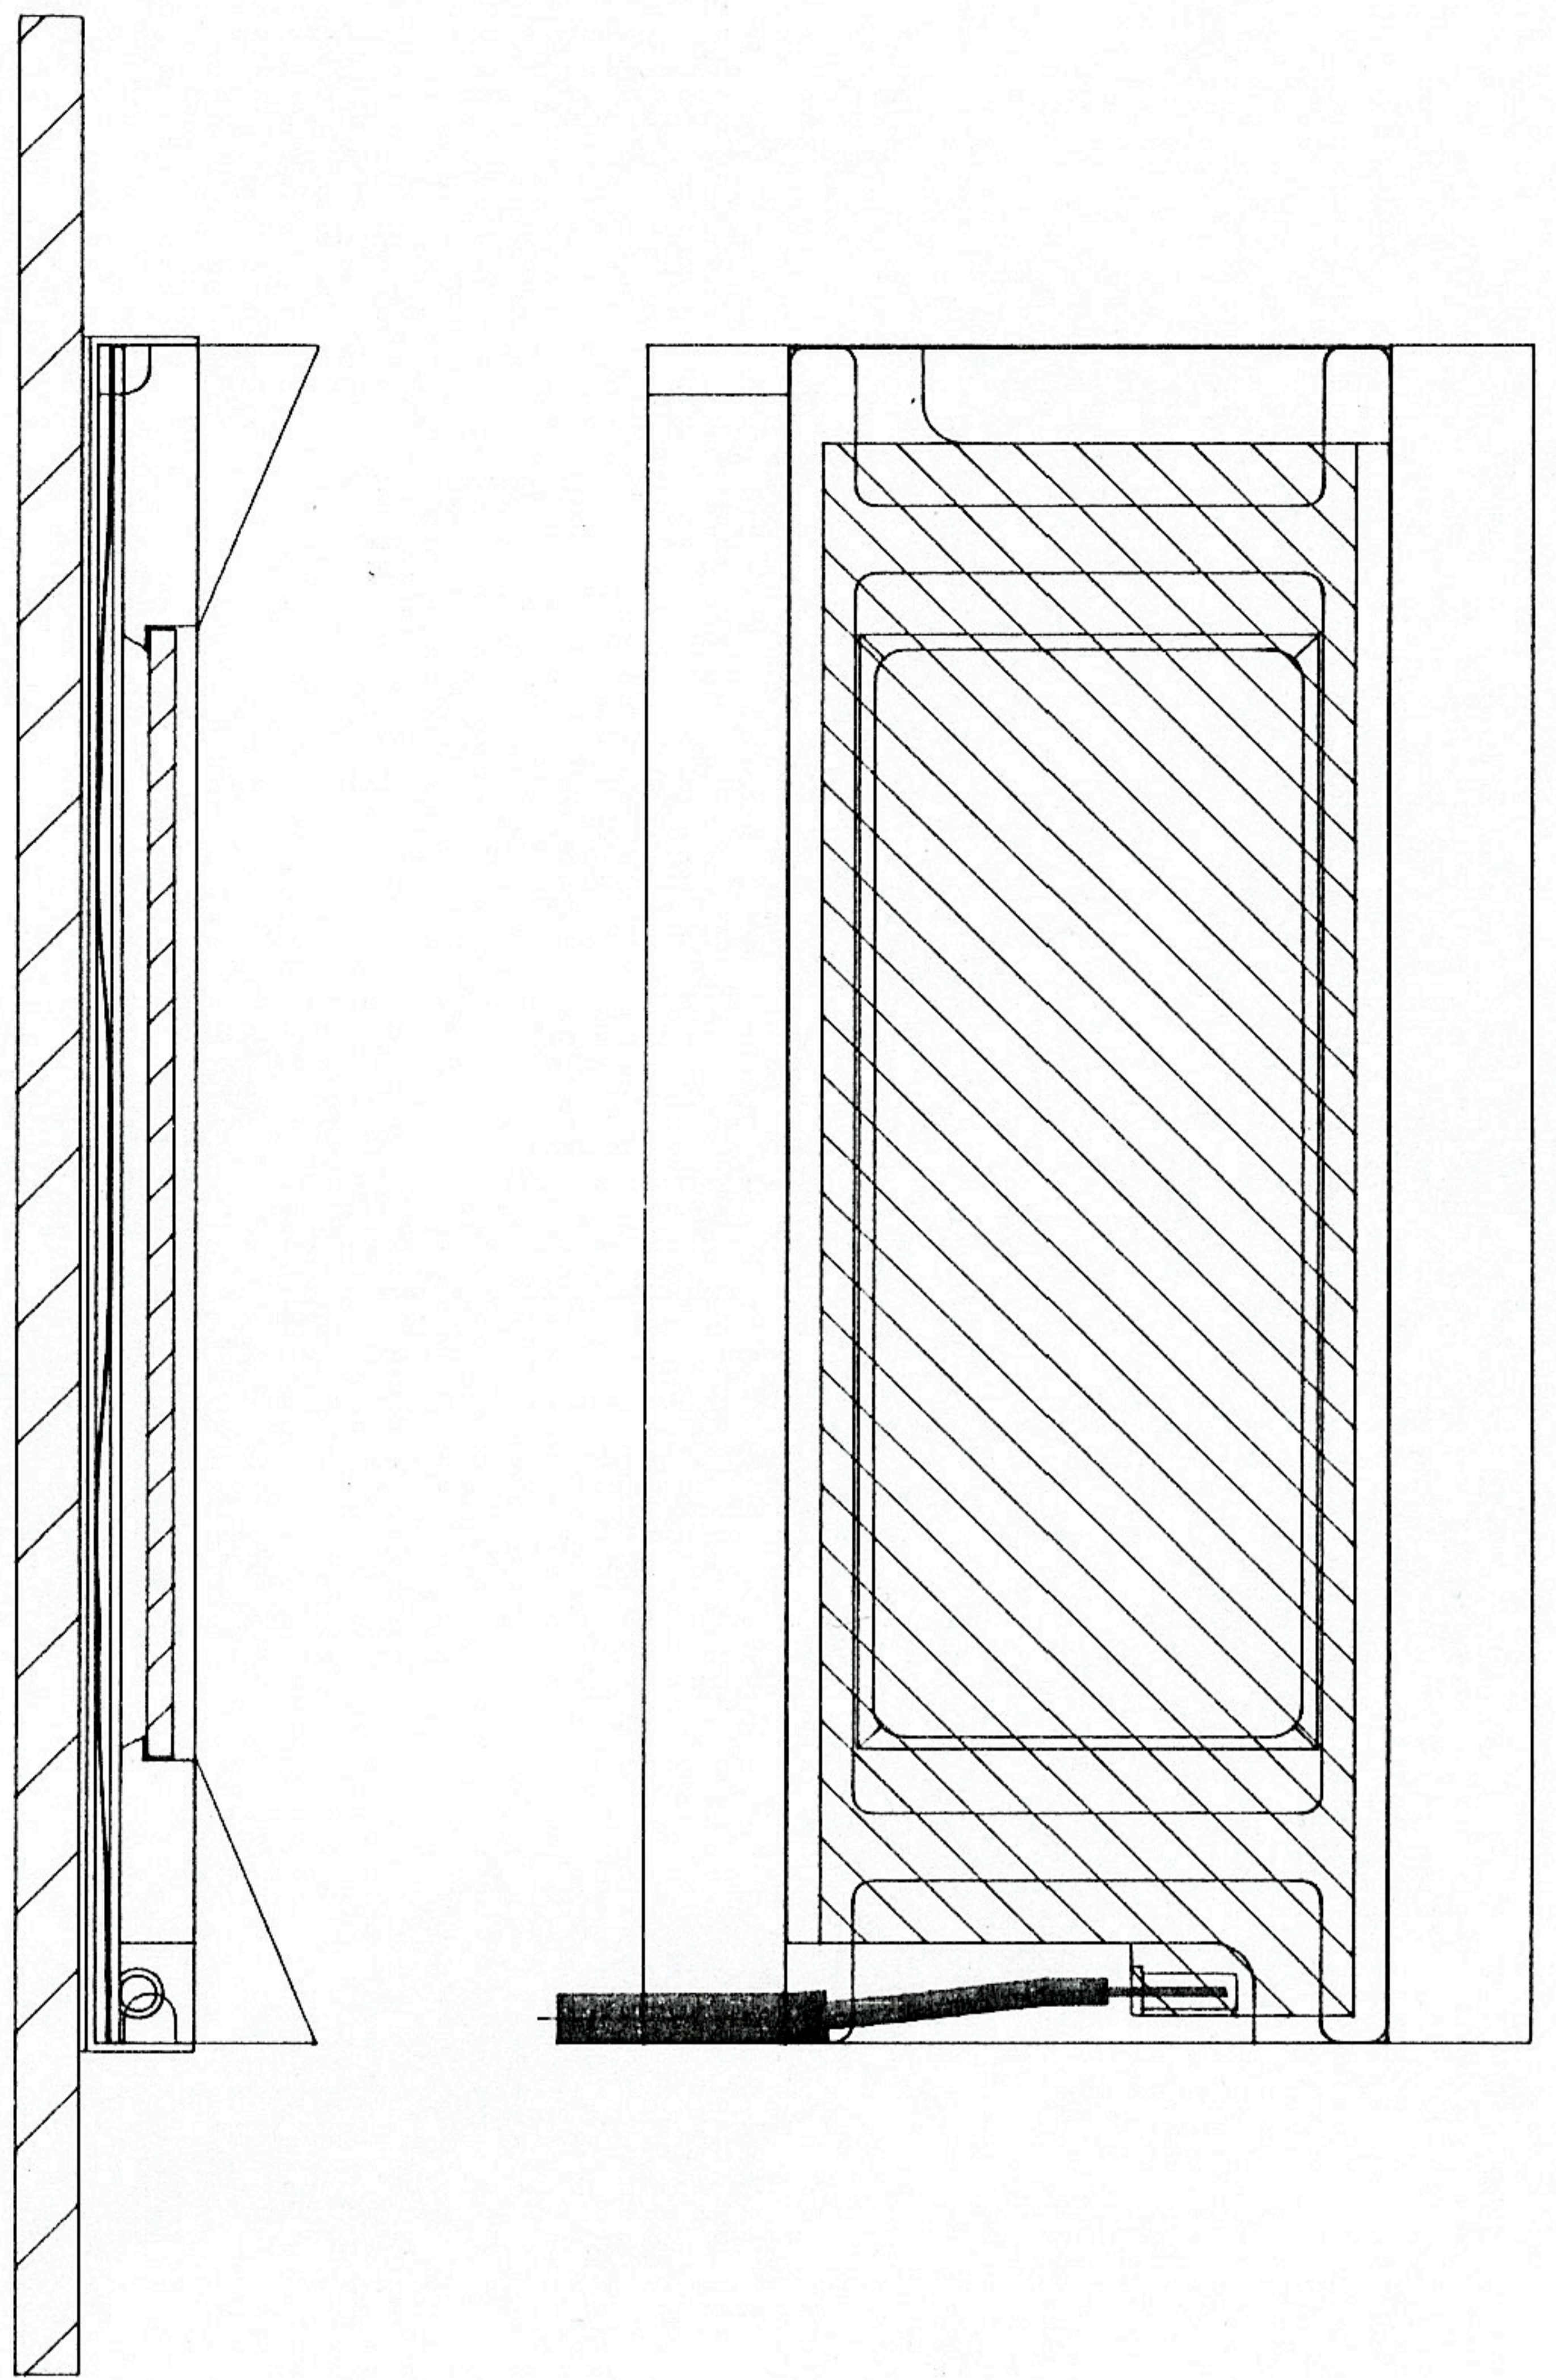
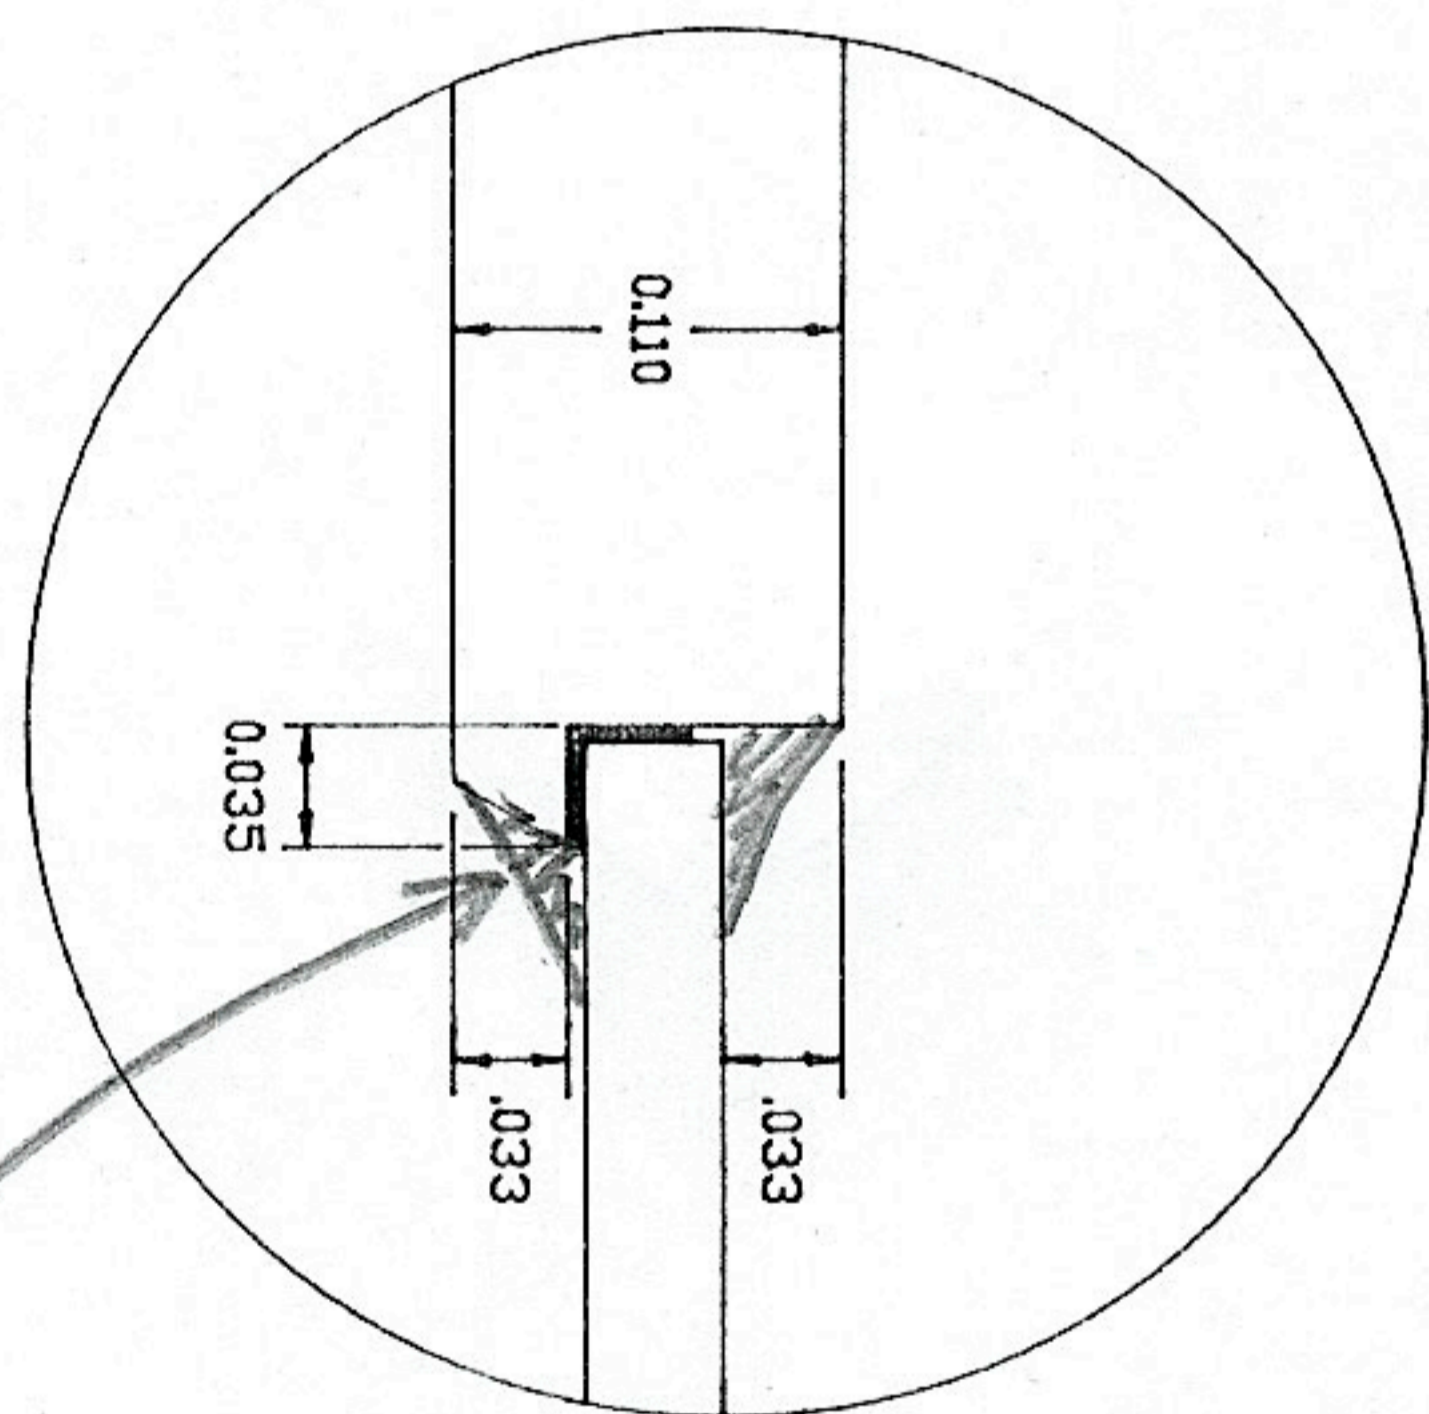
Fig 2a As Designed

as designed
 Epoxy
 Bead

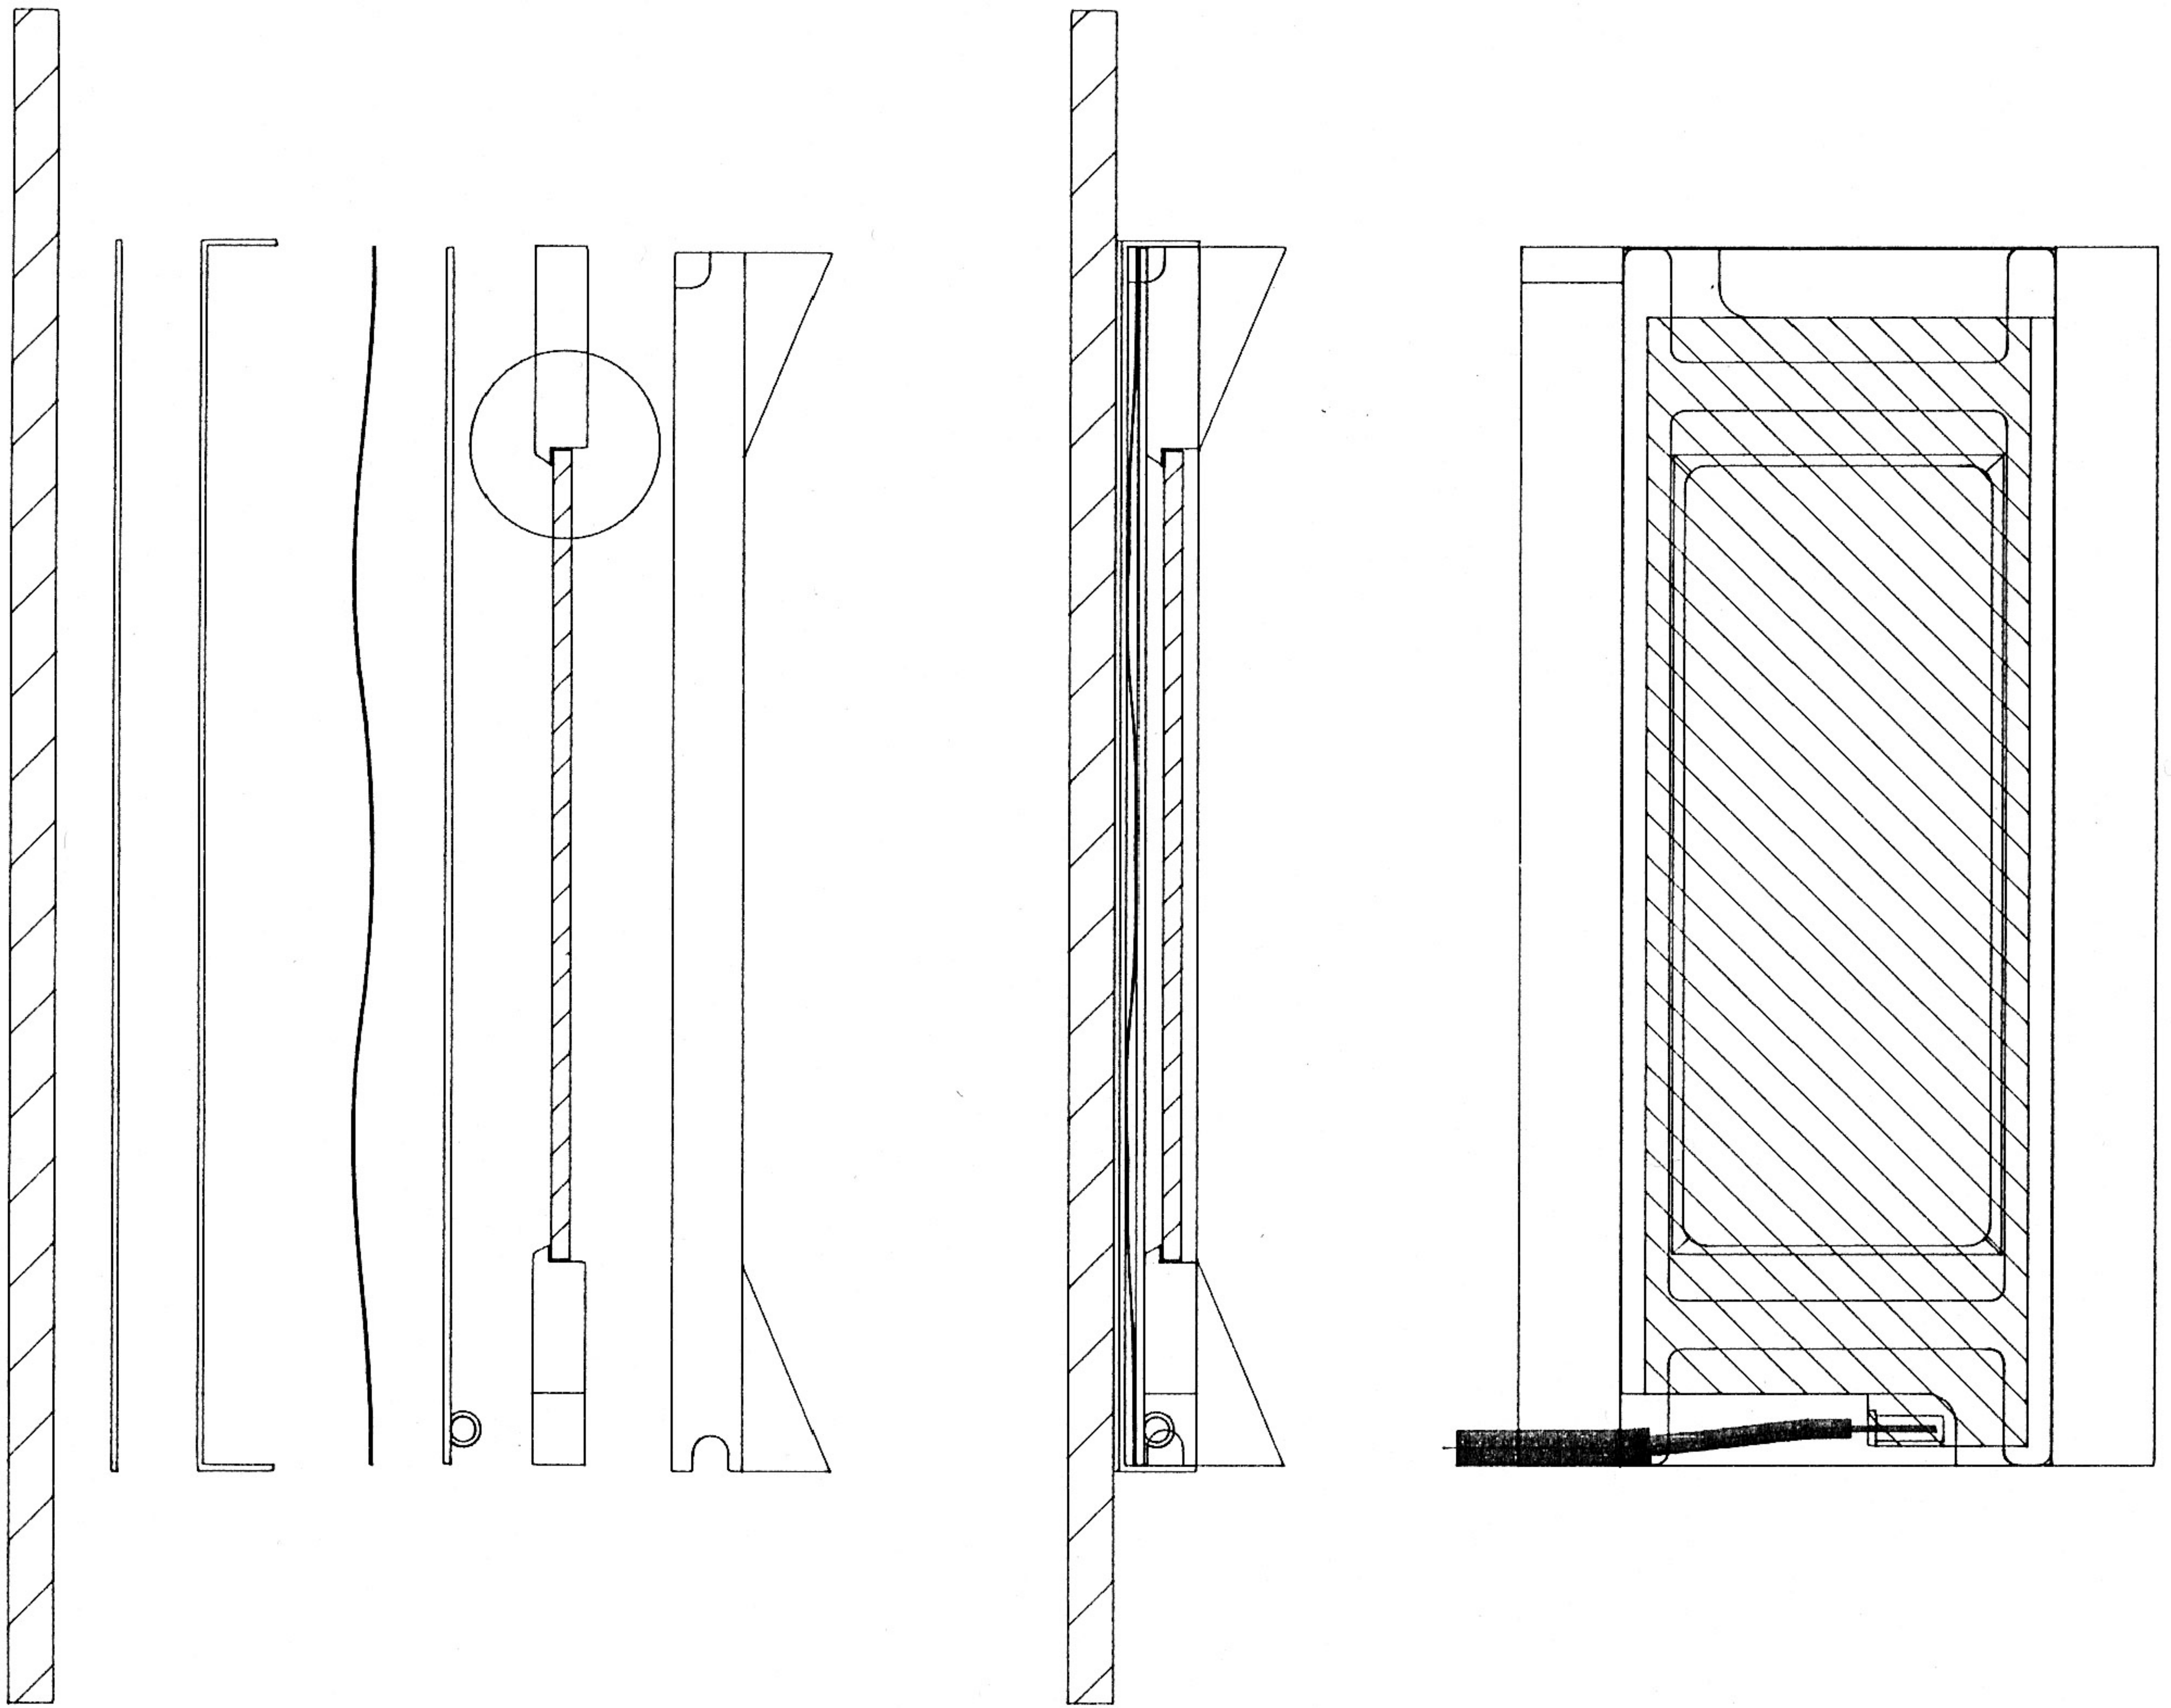
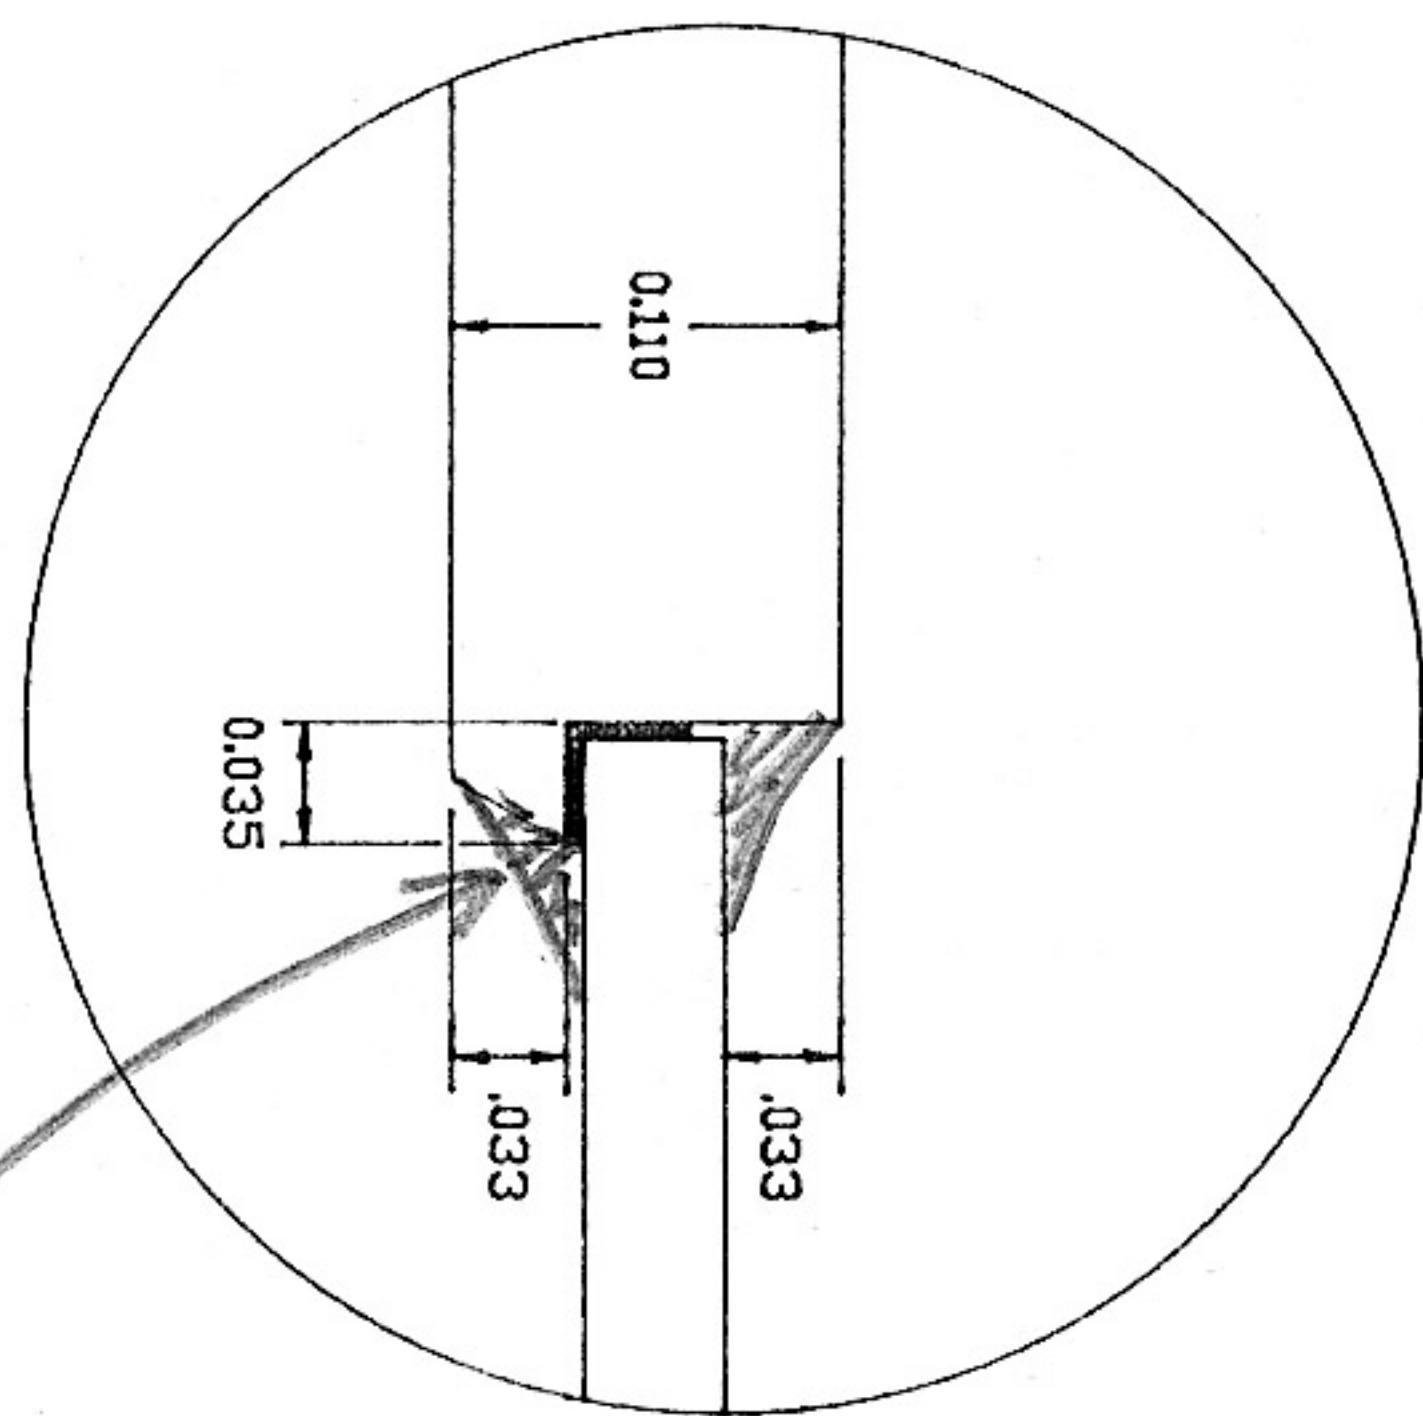
Fig 2a AS DESIGNED

as designed
Epoxy
Bead

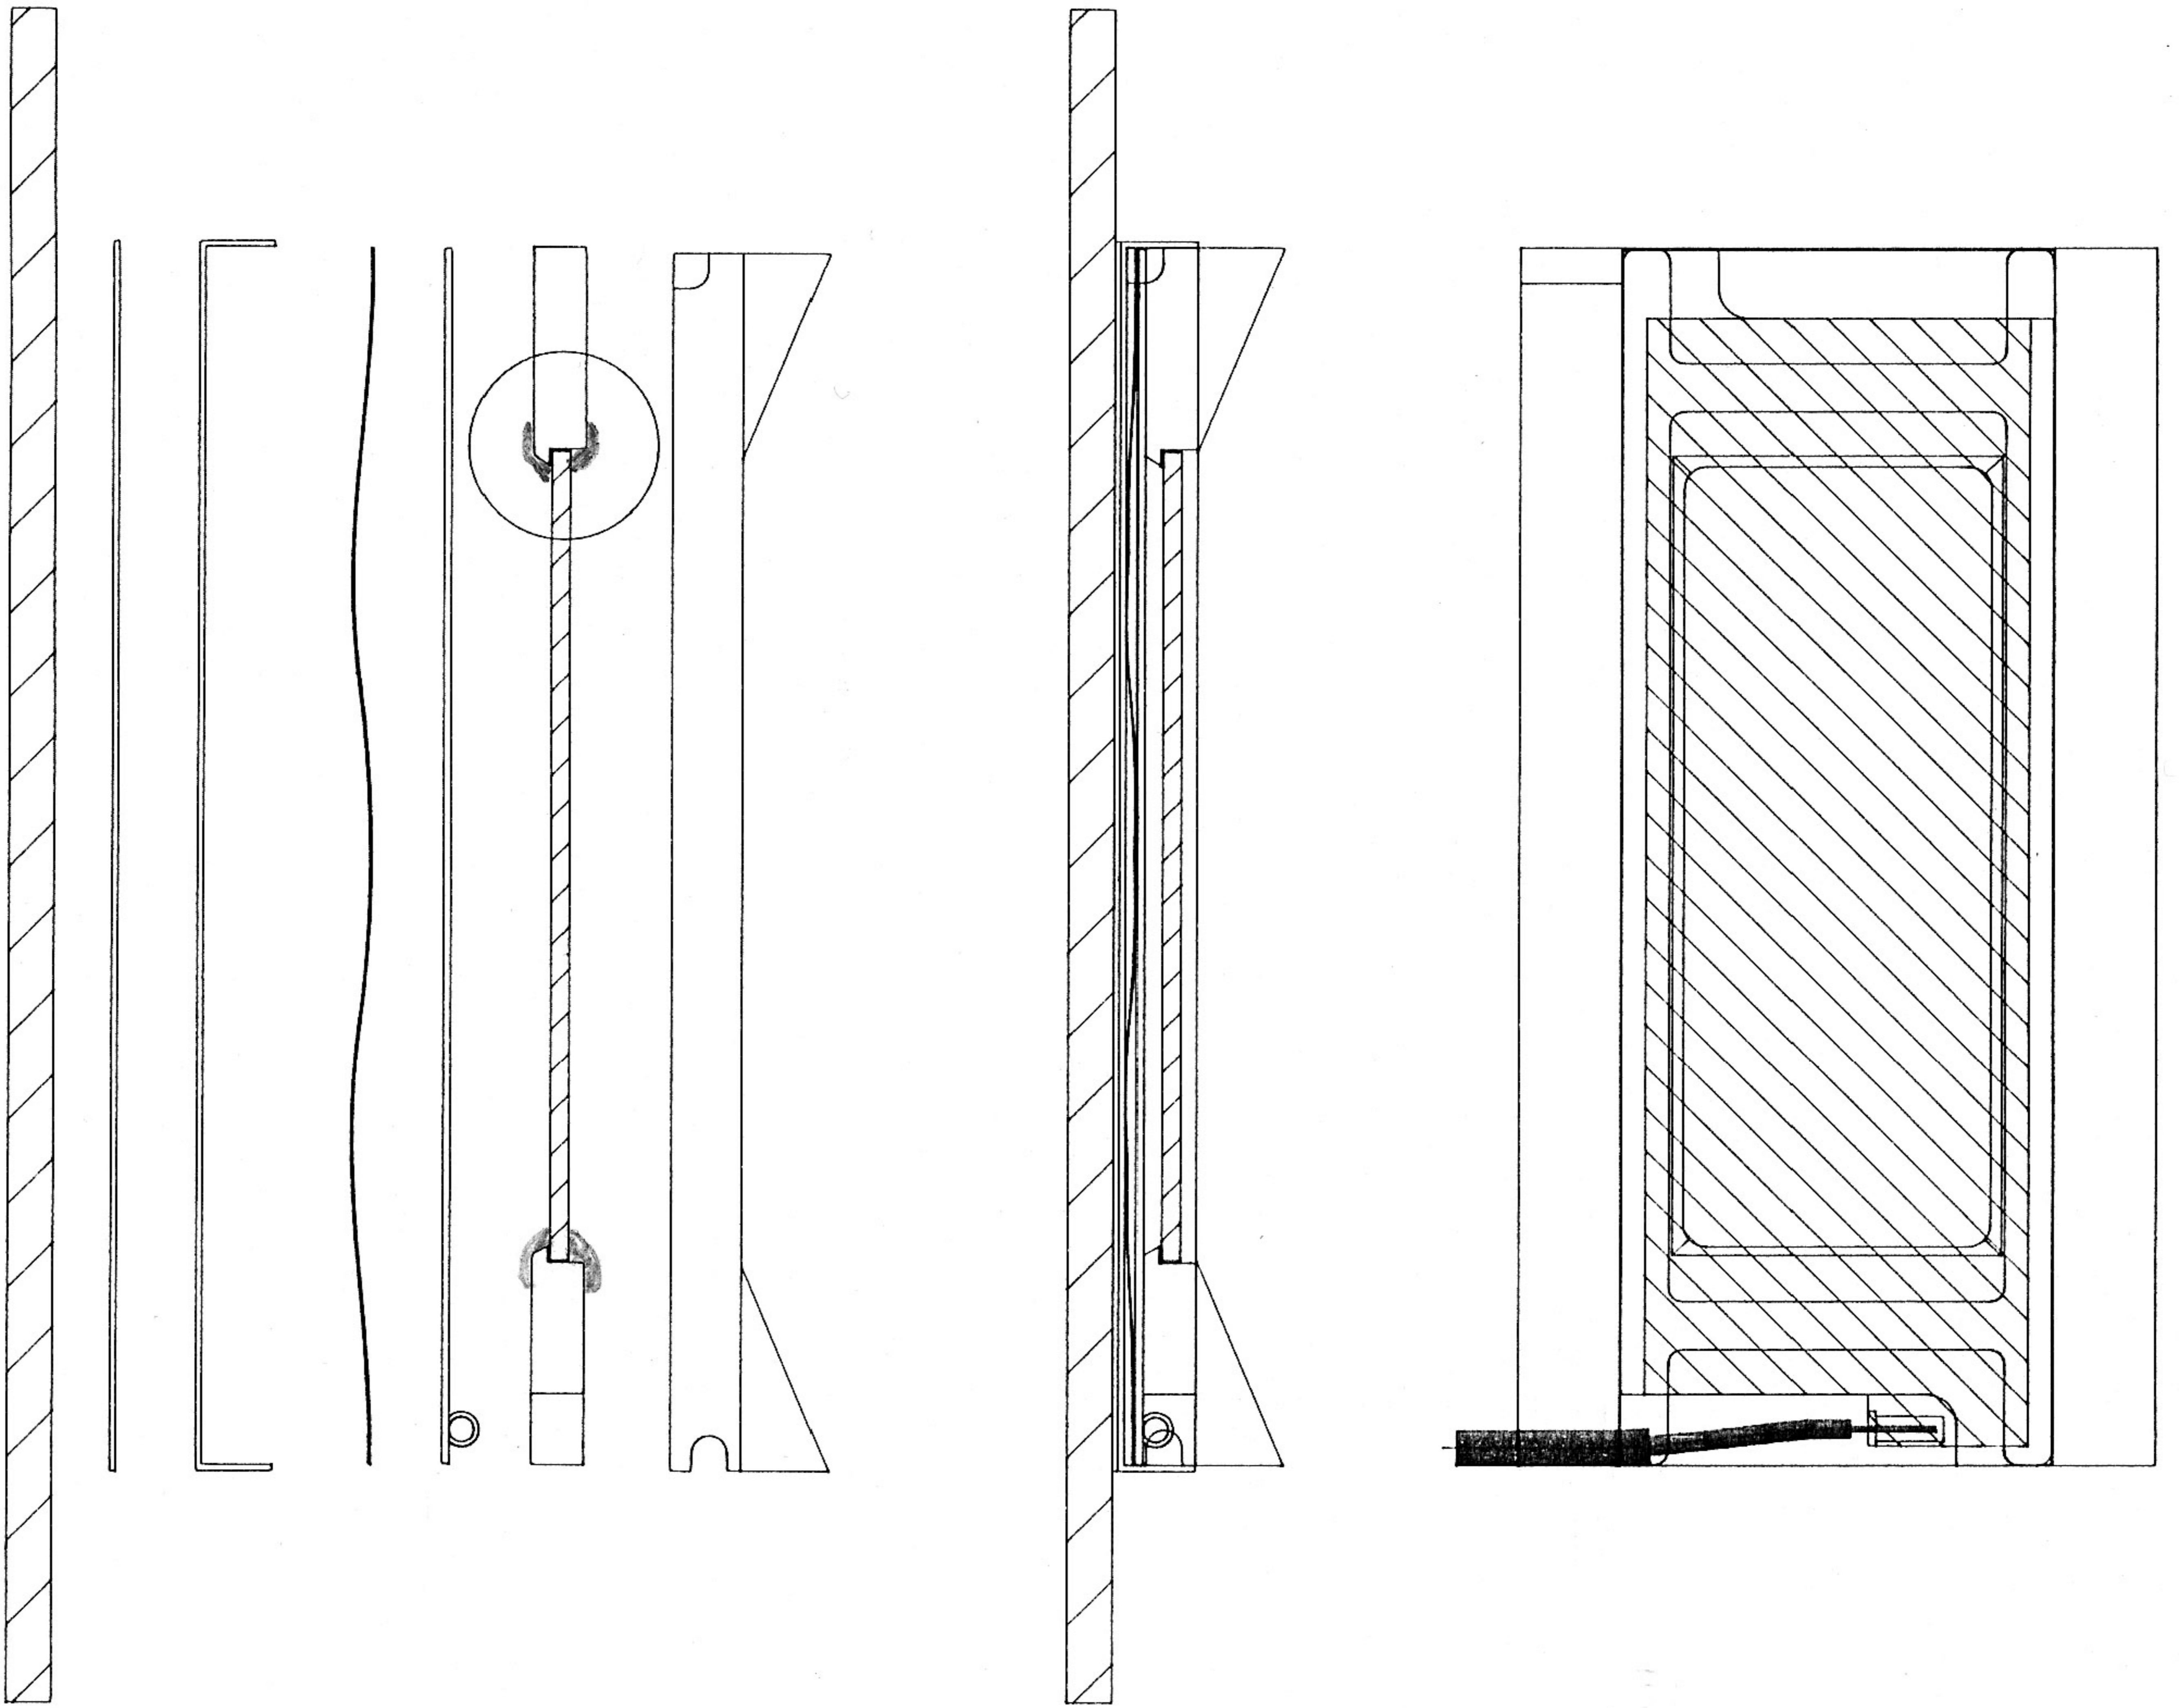
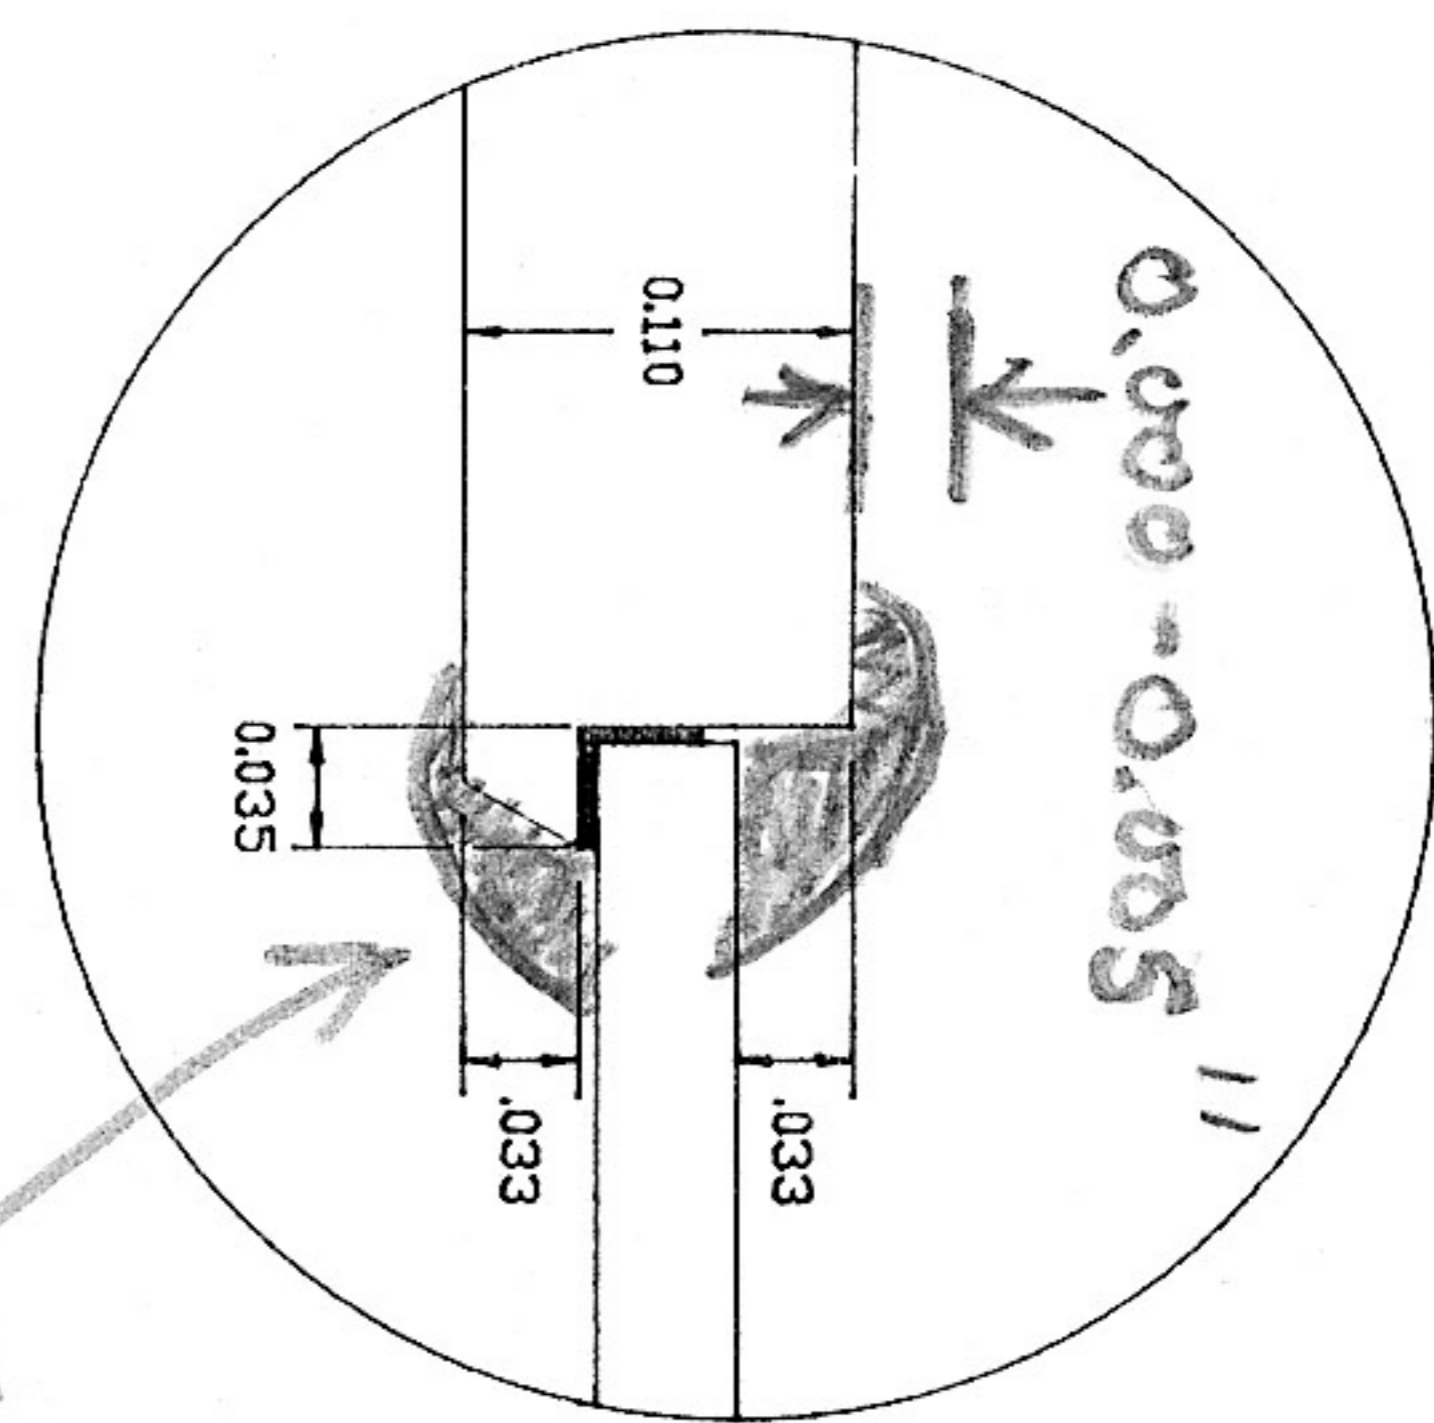
Fig 2b AS DELIVERED

as delivered
Epoxy
bond
