# STEREO IMPACT

PROBLEM REPORT

PR-3007

<b>Assembly : SIT Instrument</b>	<b>SubAssembly :</b>
<b>Component/Part Number:</b>	<b>Serial Number: 01</b>
<b>Originator: Walpole</b>	<b>Organization: UMd</b>
<b>Phone : 301-405-6217</b>	<b>Email : Walpole@sampex.umd.edu</b>

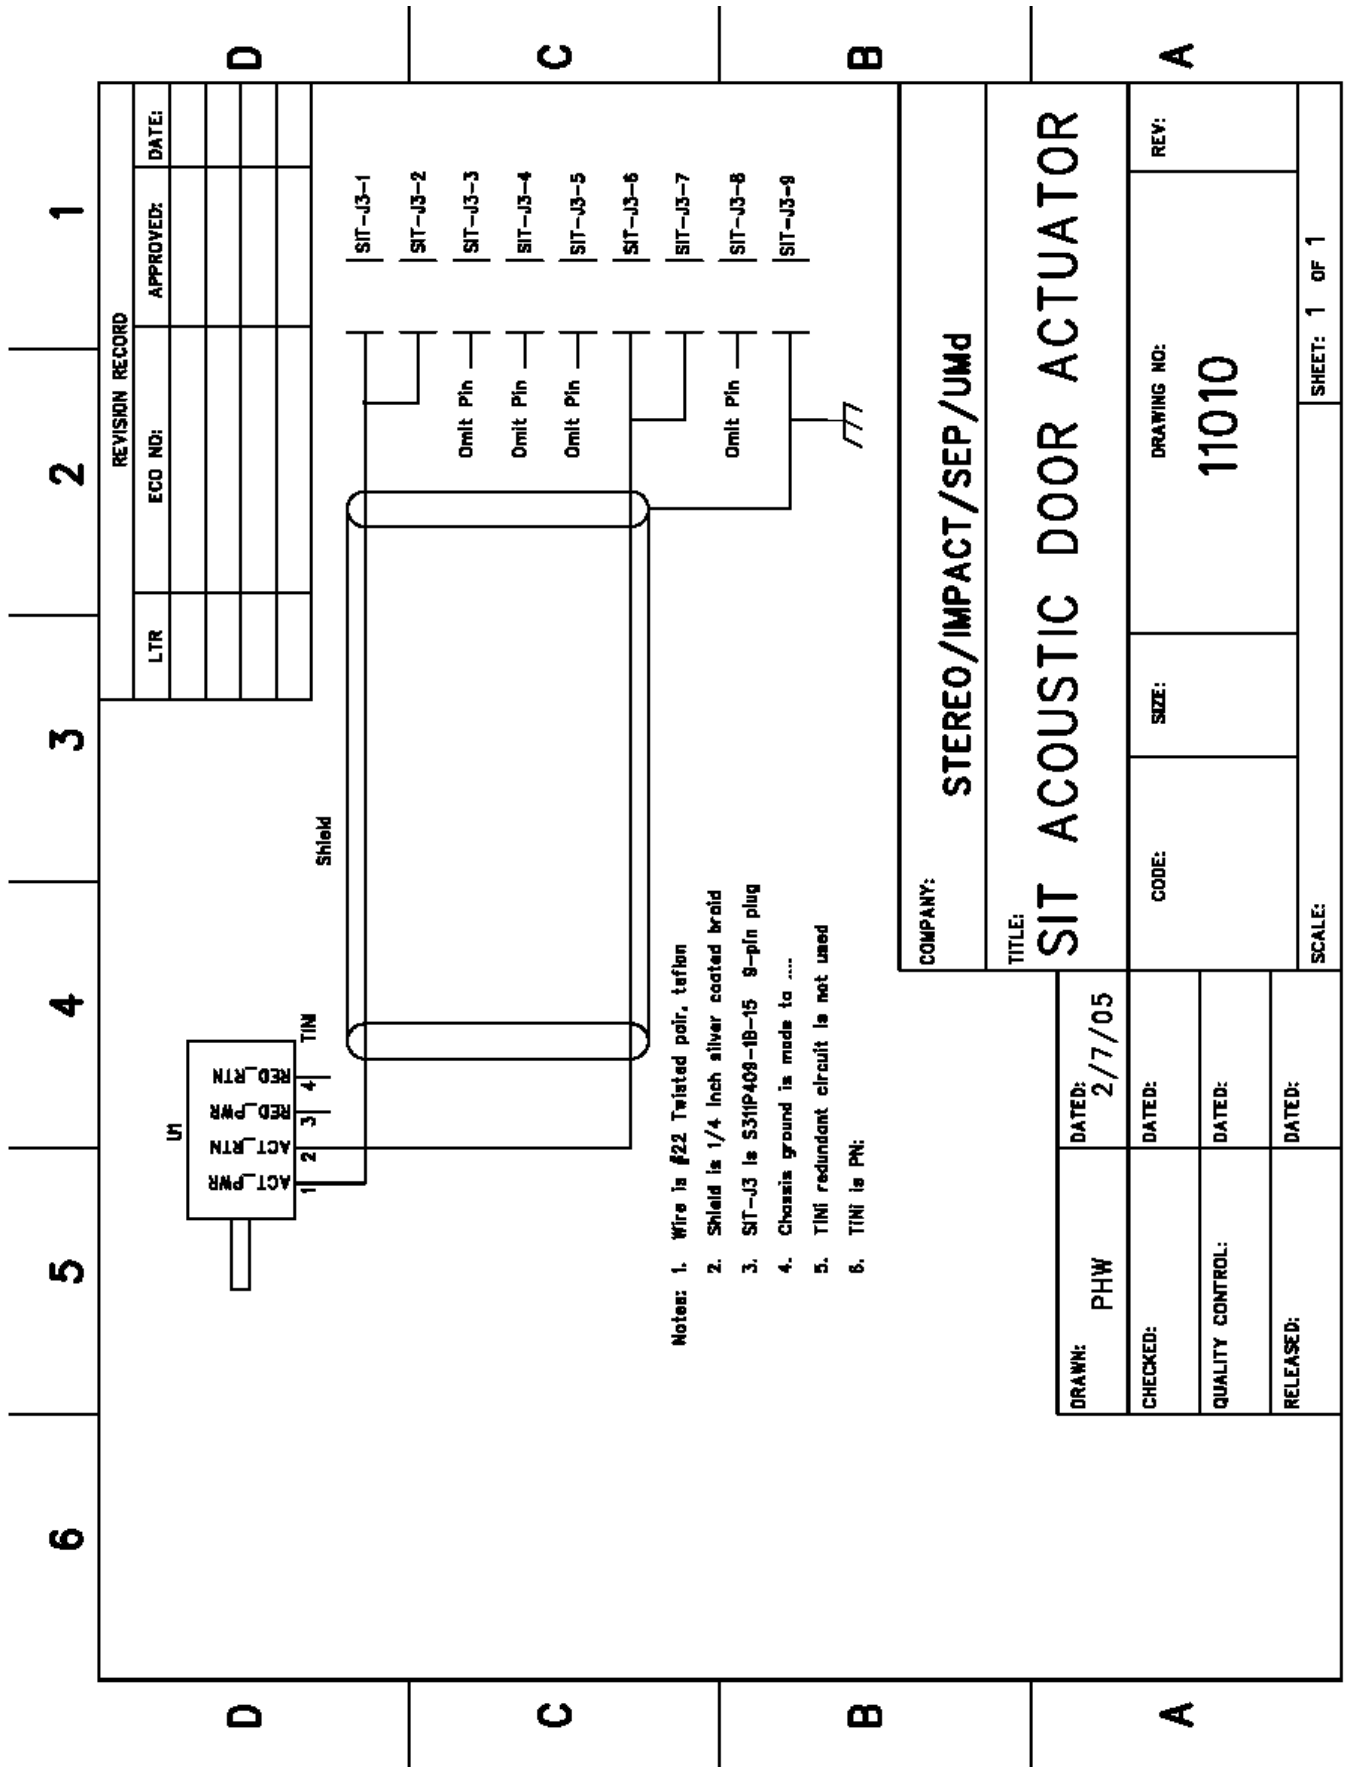
COMPANY: <b>STEREO/IMPACT/SEP/UMd</b>	
TITLE: <b>SIT ACOUSTIC DOOR ACTUATOR</b>	
CODE:	DRAWING NO: <b>11010</b>
SIZE:	REV:
SCALE:	SHEET: 1 OF 1

During thermal balance testing, a check of the wiring of the SIT Acoustic Door actuator showed that from the outside of the chamber, the wiring was incorrect. We expected to see about 5 ohms between pins 1 and 6 and between 2 and 7 per table 4.8.3 below taken from the Harness Specification document. We expected pins 1 and 2 to be shorted to each other. Likewise pins 6 and 7.

What we found was 5.5 ohms between pins 1 and 2 and between 6 and 7. Pins 1 and 6 were shorted together, as were pins 2 and 7.

We consulted the technician who wired the SIT actuator onto J3 on the SIT box. She confirmed that the wiring error was on SIT and was the result of misunderstanding the wording on the Table.

To allow the SIT door to be opened during TB, a 9 pin – 9 pin adaptor was made correcting the pinout. SIT FM1 harness has been corrected and verified according to the updated drawing. To prevent the problem from occurring on SIT FM2 we have supplied a clarifying schematic (below).
