STEREO IMPACT

PROBLEM REPORT

PR-3011

Assembly : SIT Instrument	SubAssembly : ATOF electronics board
Component/Part Number:	Serial Number: 01
Originator: Walpole	Organization: UMd
Phone : 301-405-6217	Email : Walpole@umd.edu

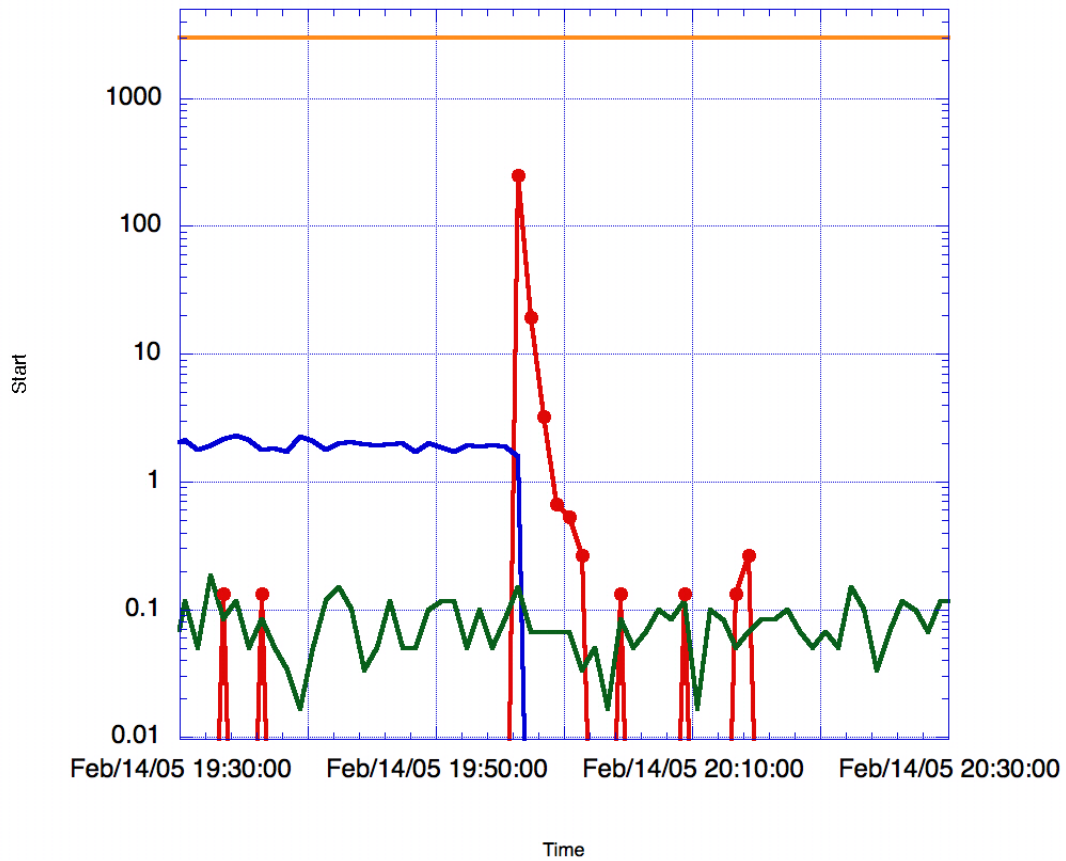
TB021405_PAYLOAD.RATES;4

Looking in detail at the thermal balance data, the failure was around 19:56 UT (see attached plot). There is a burst in the START rate that decays over a period of time -- possibly there was spark that took out the STOP channel, and produced some ionization that was counted by the START (which continued to operate). The HV shows no change, and the MISC continued as before. At the time of this discharge, the telescope had been under HV for about 10 hours at the nominal operating state ("b8").
