# STEREO IMPACT

PROBLEM REPORT

PR-3012

<b>Assembly : SIT Instrument</b>	<b>SubAssembly : telescope</b>
<b>Component/Part Number:</b>	<b>Serial Number: 01</b>
<b>Originator: Walpole</b>	<b>Organization: UMd</b>
<b>Phone : 301-405-6217</b>	<b>Email : Walpole@umd.edu</b>

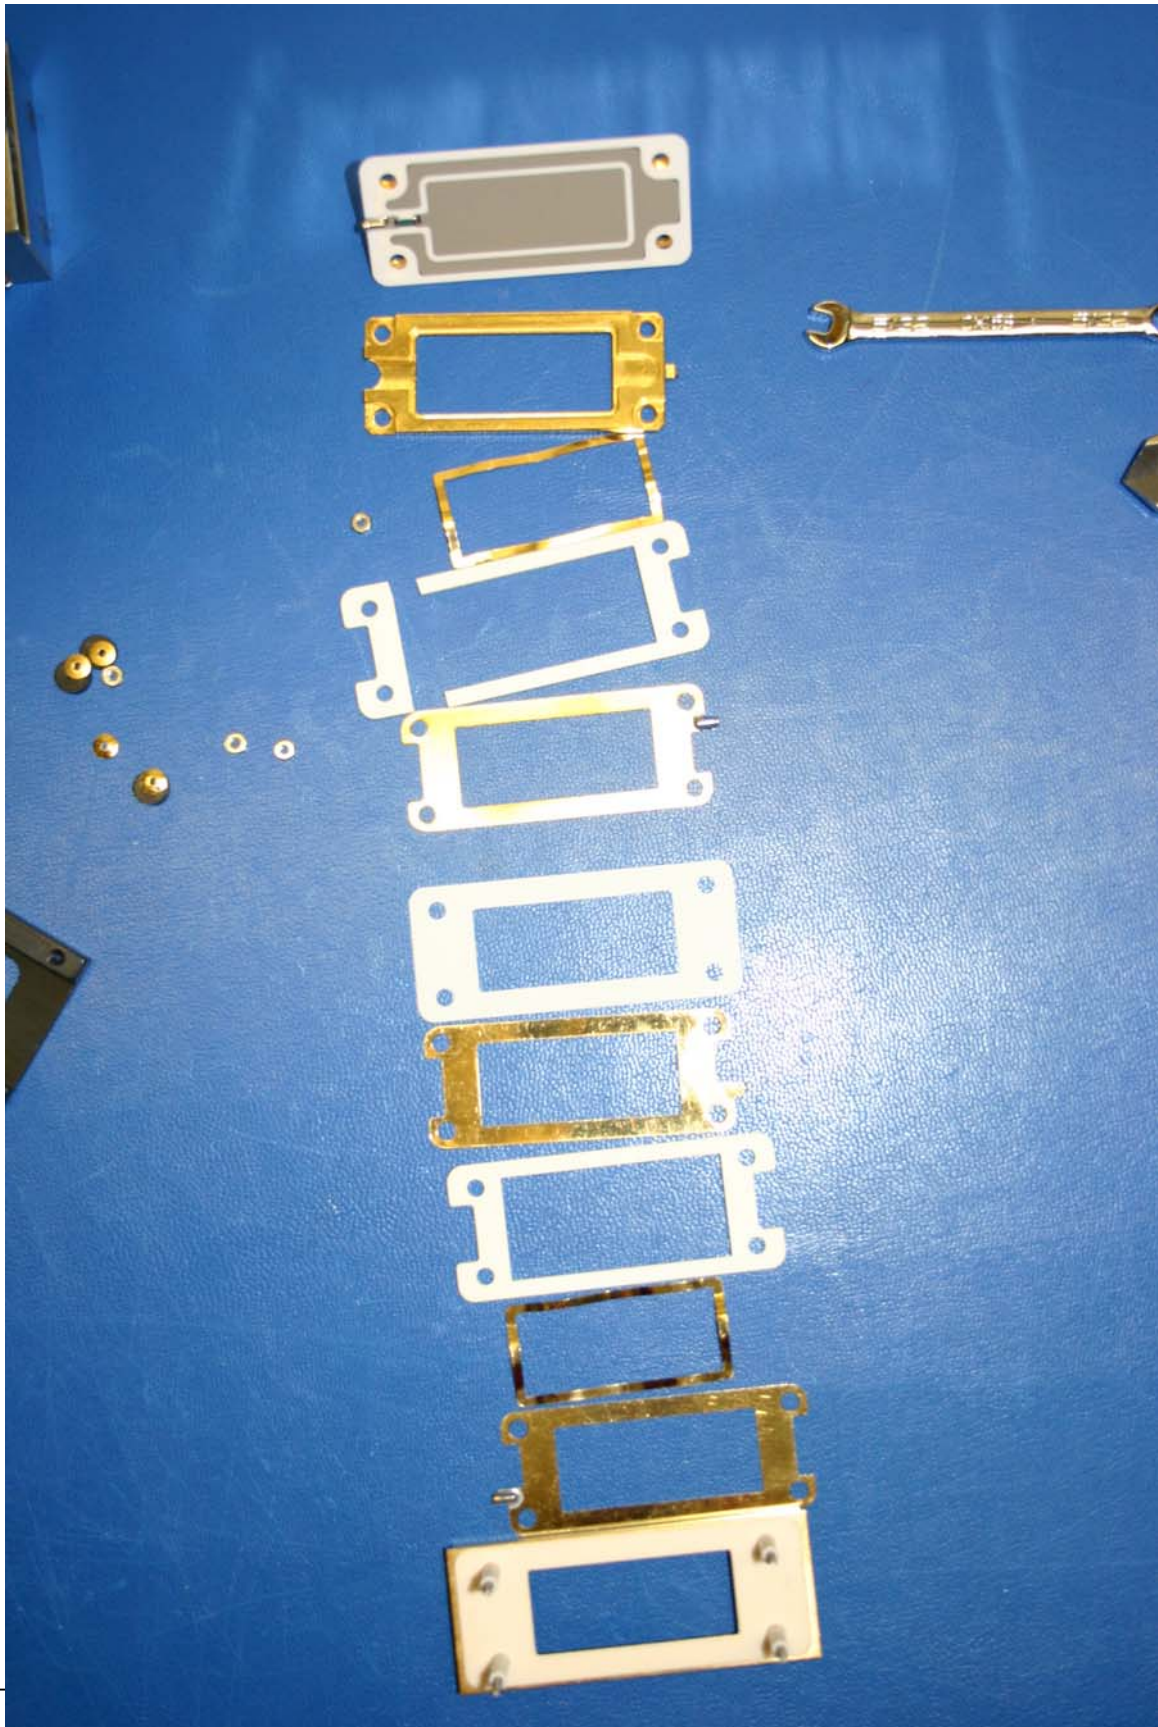
A cracked ceramic piece, drawing S11a, was found in the FM1 telescope STOP MCP stack. During disassembly of the FM1 telescope to inspect for something that might have caused the large signal (or HV breakdown) that damaged the FM1 ATOF STOP channel during thermal balance testing, we found that a thick (.070") ceramic was broken into two pieces. The piece is essentially picture frame shaped. The break occurred at one end of the frame where the sides meet the end. Both sides were broken at the same spot. The break looks clean and there is no evidence of blackening from HV breakdown. The piece had about 1kv across it (2200 v – 3200v) and acted as the holder for the rear MCP in the stack. No other ceramic pieces in the stack were broken but some microscopic cracks were evident in the thinnest pieces. Examination of unused spare parts of the same design showed some of the same small cracks, but not as many.

I did not see any indication of electric discharge. The cause of the failure is apparently mechanical over load, likely local bending over load due to over clamping. The microstructure of the material can be seen at the fracture surfaces -- attached images. Very large grains (tens of microns) are mixed with small grains (1 to 2 microns). This is not a desirable structure. Charles He is our ceramic expert. He pointed out that such microstructure indicates the material experienced a secondary grain growth during the sintering, which will substantially drop the strength of the material. The material was made during the time when secondary grain growth control technique was not widely available, probably in the 70's, as Steve told us. We had similar problem with HST gyro rotors and thruster plates that were made of the alumina during the 70's with large grains and showed poor mechanical performance.

Alumina with such microstructure can only be used under compressive load, It can only sustain very limited bending or tensile load if there should be any. Extreme care must be taken during the assembly. Over clamping, as Steve told us, will cause local bending and tensile stress that could fail the part. Mis-alignment, hard contact, or particle contaminants will also cause local bending or indentation and could potentially fail the part.

- 1) Reassembled STOP stack replacing all of the ceramic pieces for which spares exist.
- 2) Reassembled the STOP stack using 2 Belleville washers and compressing the Belleville pair half way. No action was taken on the START stack nor the stacks in FM2 because the ceramic parts are captured and in compression, and there was no indication of any electrical degradation found in the stack with the cracked ceramic piece.
