STEREO IMPACT

PROBLEM REPORT

PR-3016

Assembly : SIT Instrument	SubAssembly :
Component/Part Number:	Serial Number: 02
Originator: Reichenthal	Organization: UMd
Phone : 301-286-5634	Email : Lillian.S.Reichenthal@nasa.gov

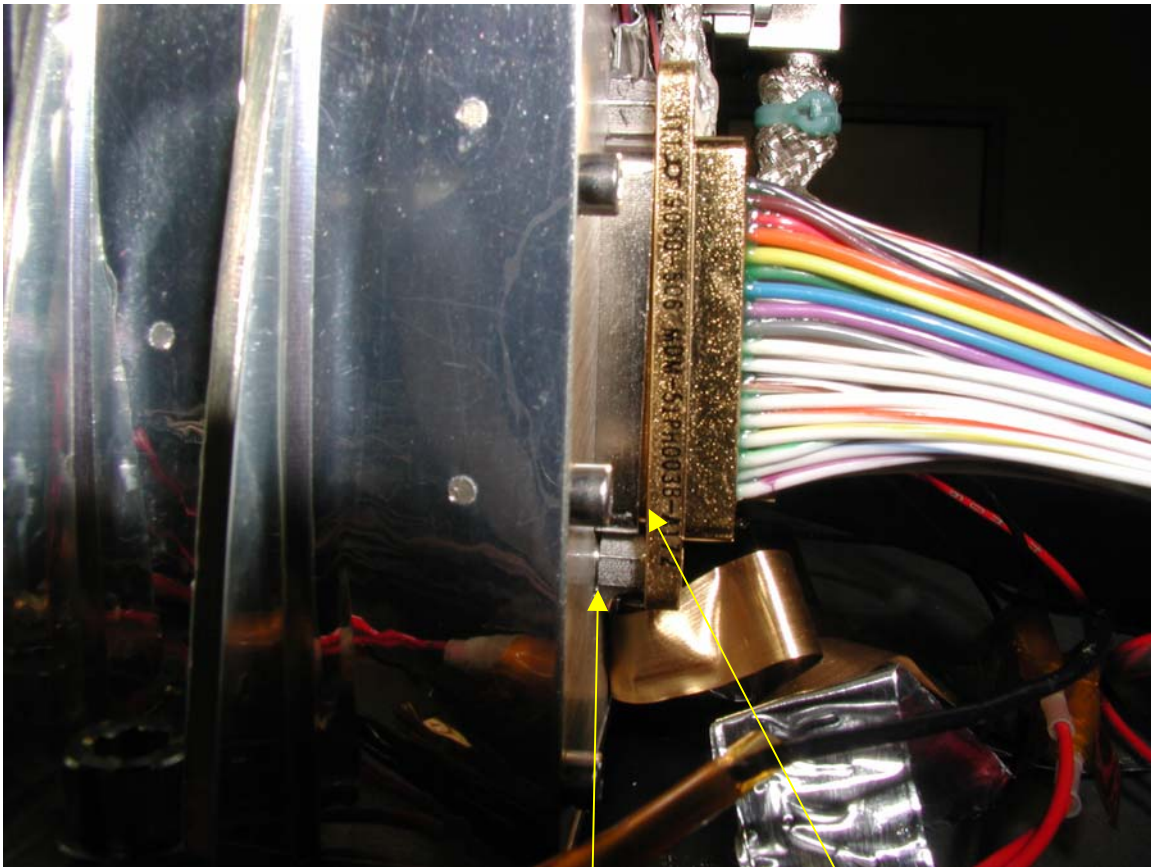
The post on the J1 connector on the SIT FM2 instrument is not seated fully and consequently doesn't allow the connector to fully mate. This post is staked.

Post is not seated. Connector not fully mated on this side.

The post was properly seated and torqued and the connector was reconnected and restaked. The hardware is captive in the connector housing.
