STEREO IMPACT

PROBLEM REPORT

PR-4003

Assembly : HET	SubAssembly :
Component/Part Number: FM1	Serial Number:
Originator: von Roseninge/Wortman	Organization: GSFC
Phone : 301-286-9454	Email : wortman@LHEApop.gsfc.nasa.gov

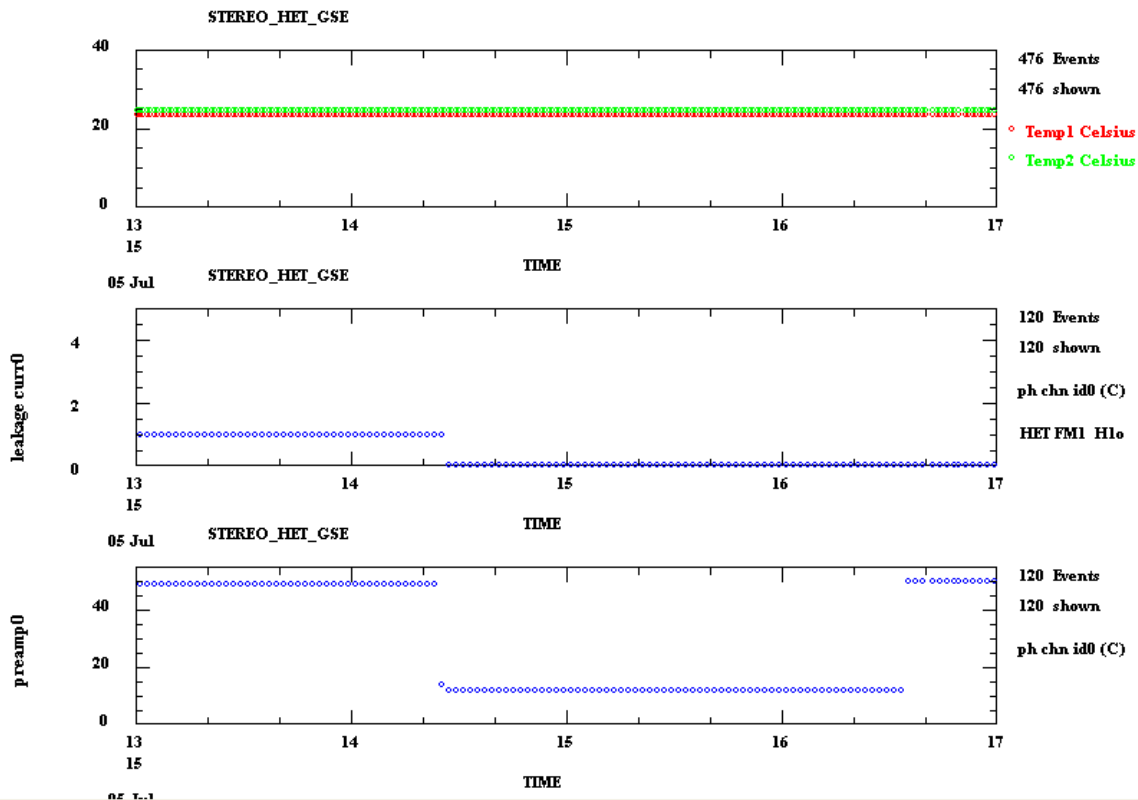
An anomaly was discovered with the H1 detector while invoking the onboard stimulus pulser on the H1o low and high gain channels. The H1o preamplifier ADC reading decreased from the nominal 50 to 12, which resulted in a voltage reading of 4.75 volts. It should be noted that the firmware attempts to adjust the PHASIC input resistance DAC in order to maintain a reading of 4.0 volts (+- .02 v). It should be noted that this H1 detector was previously tested and normally has a very low leakage current registering below one tenth of a microamp at 40° C. This test was conducted while the temperature was a nominal 23°C. Also, the input resistance DAC dropped from 1 to 0 at the time of this anomaly.

At the time this anomaly was noted, several unsuccessful attempts were made to invoke the firmware's detector leakage current balancing algorithm (by sending a setindacs command) which normally runs at boot up. Once all the detectors (H1i, H1o, H2-H6) were re-enabled, the preamplifier ADC for the H1o detector stabilized at 50 and the current reading of 4.0 volts was established and maintained.

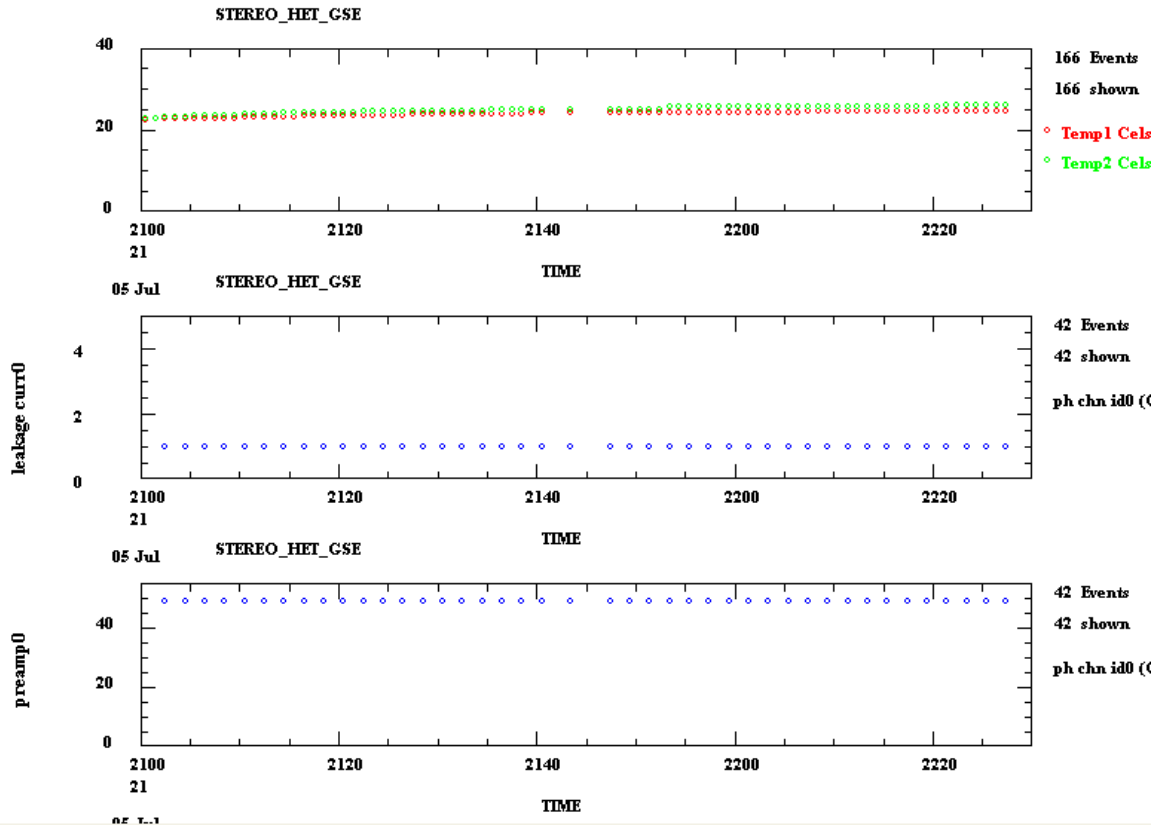
On July 21, the H10 channel was singly pulsed for over an hour when the temperature was 24°C and the input resistance DAC was constant at 1. The preamplifier ADC also remained constant at 50 to maintain the 4.0 volts (+/- .02 v). Thus the earlier problem failed to be reproduced.

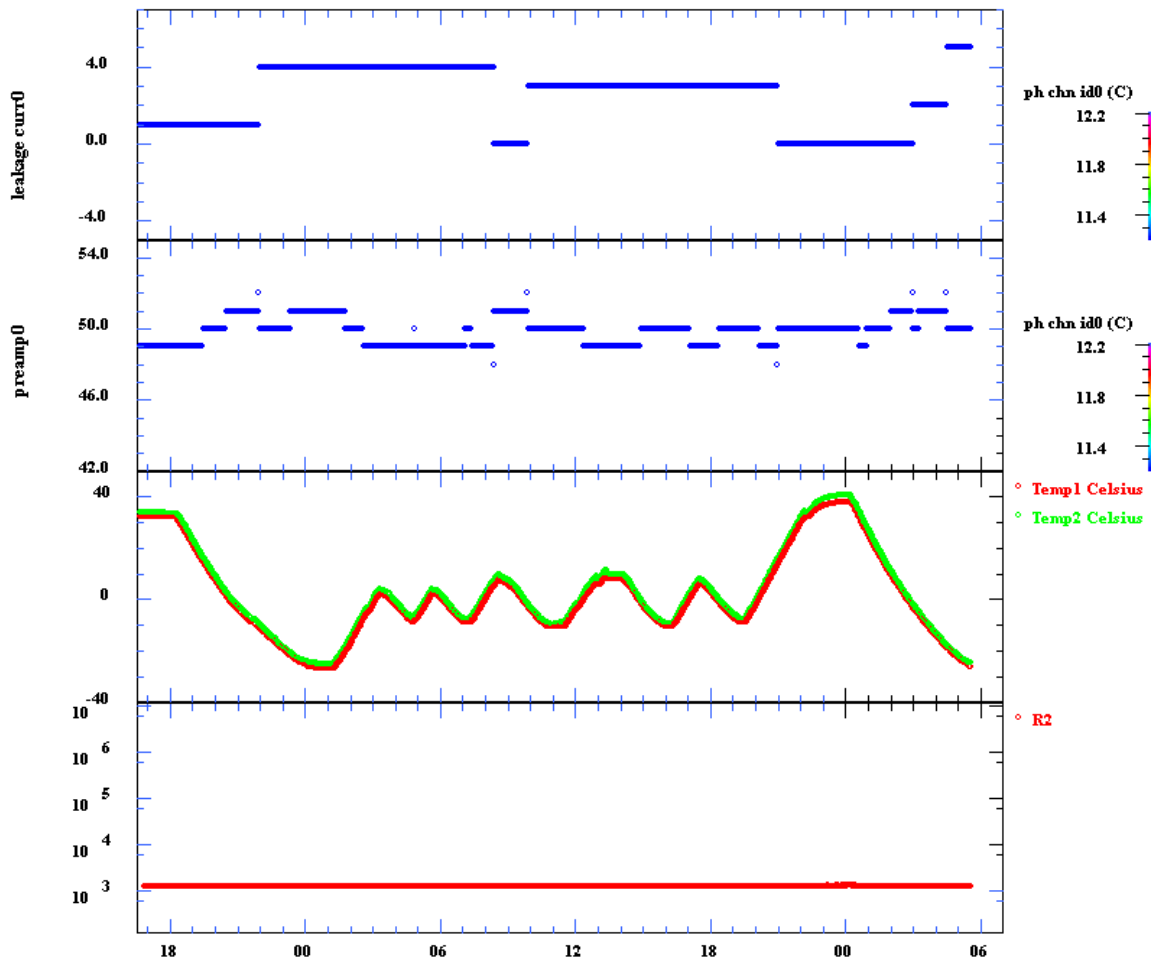
On July 23 13:00 to July 25 03:00, the H1o channel was also singly pulsed while temperatures were cycling from -25° to 35°C in thermal vacuum at which time the preamplifier ADC ranged between 48 and 52 to maintain the 4.0 volts (+-.02 v) and the input resistance DAC range was 0 to 5. So again, the original problem failed to reoccur.
