STEREO IMPACT

PROBLEM REPORT

PR-7002

SEPT-Detector

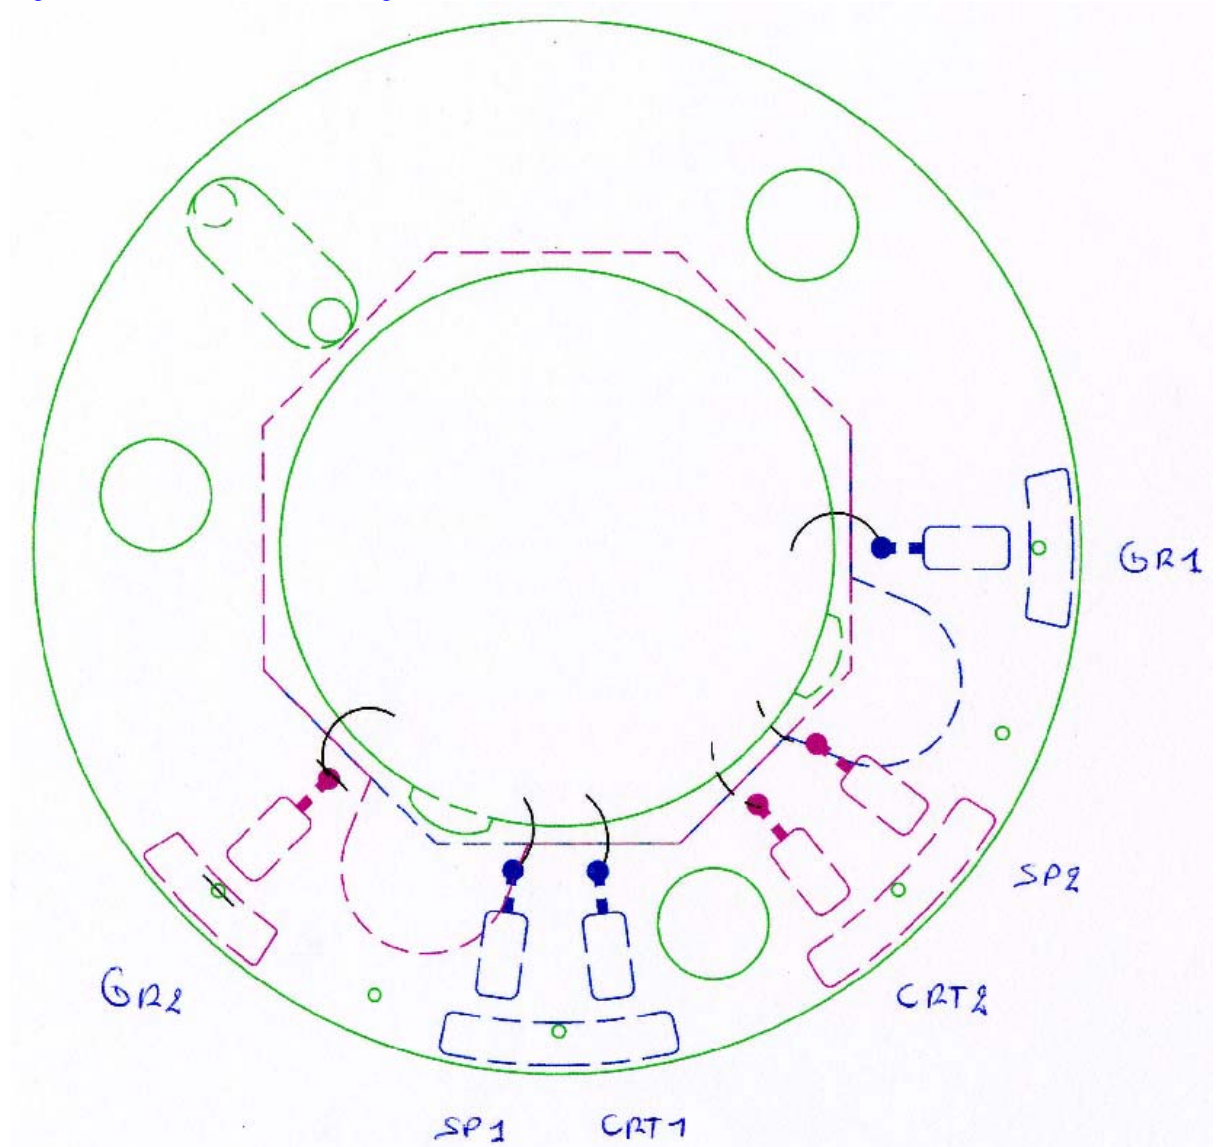
Figure: Junction side wire bonding

- The detectors are glued with EPO-TEK E4110-LV (formerly EP110-LV) to PCB frames. Differences in thermal expansion coefficients between frame, glue, and silicon might exist. Kiel had never operated detectors below $-30\text{ }^{\circ}\text{C}$ and cannot test below $-30\text{ }^{\circ}\text{C}$. Canberra/Belgium cannot test detectors below $-10\text{ }^{\circ}\text{C}$.
- The 0.1 mm diameter aluminium wire-bonds might not have enough clearance (gap between the paired detectors: $700\text{ }\mu\text{m}$). The DELRIN standoffs which define the gap might change with temperature.

The tests at Canberra were successful in revealing the cause of the failure: the height of the arch suspended by the wire bonds is higher than the separation distance of the two detectors in the stack. All eight detector stacks (not only the two failing ones) were disassembled, wire bonds removed, new wire bonds applied with maximum height of 0.6 mm, detectors separated by 1.0 mm instead of 0.8 mm and mounted in new housing. All four sensor units were re-assembled and integrated with their associated electronics units.

All eight detector stacks (not only the two failing ones) were disassembled, wire bonds removed, new wire bonds applied with maximum height of 0.6mm, detectors separated by 1.0 mm instead of 0.8 mm and mounted in new housing. All four sensor units were re-assembled and integrated with their associated electronics units. Nearly all of the detectors survived the opening of the stacks unharmed and could be re-used.
