STEREO IMPACT

PROBLEM REPORT

PR-7003

SEPT-Pinpuller

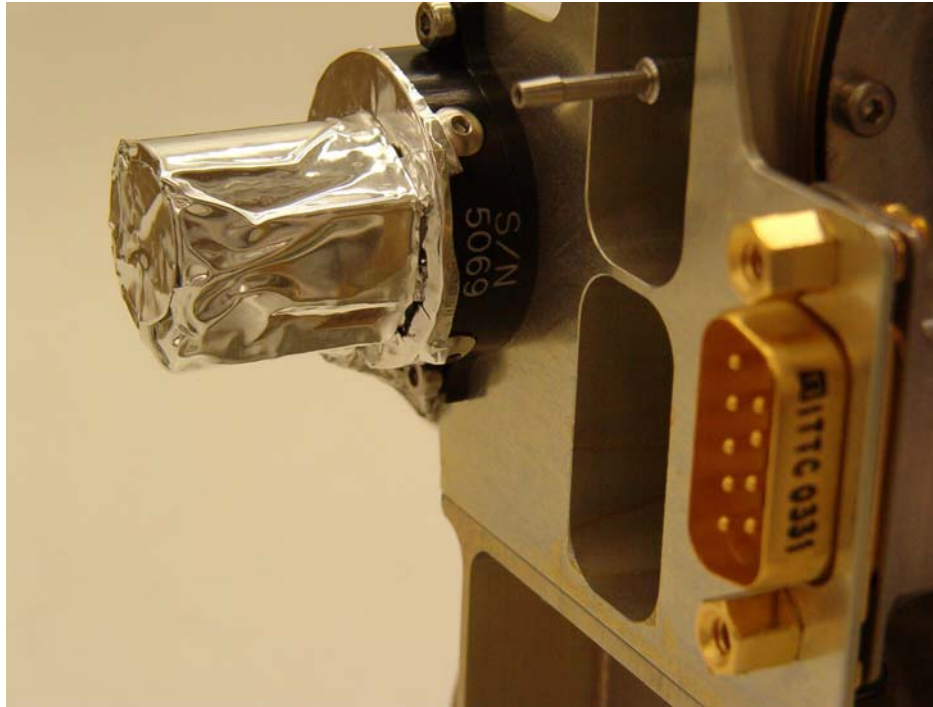
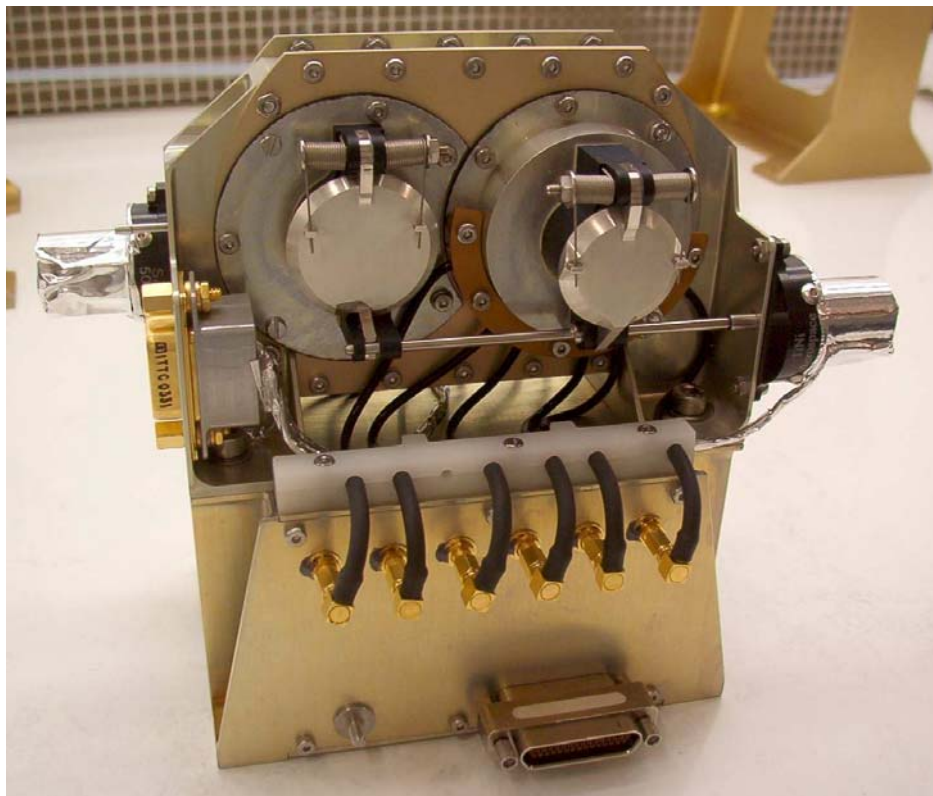
There are eight pinpullers (TiNi Part # P5-404-5RS) installed in four SEPT units. During TV cycle 6, four pinpullers are actuated at hot soak (+50 °C), four at cold soak (-40 °C). One of four (Serial # 5054) did not fire during hot soak, but did so at the following cold soak.

While still at hot soak, the pinpuller was disconnected at the TV chamber feedthrough from its power supply. The resistance between pin 1 and 2 was measured > 10 MOhms, should be 5 Ohms. When cooling down to cold soak of cycle 6, the resistance of 5 Ohms had re-established itself. The exact temperature when this happened could not be observed, as the temperature rate of change was 5 °C per minute, and the resistance was not monitored continually.

To a high degree of certainty we can exclude the chamber feedthrough and harness to be the culprit: we have wire redundant harness up to the 9-pin Sub D connector SEPTNS-P3. This connector shorts the redundant wires for ACT1 and also for ACT1 RTN. We could measure a resistance < 1 Ohm between these wires. After finishing TV test and opening the chamber at ambient, we closed the covers and restowed the pinpullers by pulling at the shaft. By manipulating the extended shaft it was possible to let the 5 Ohms resistance appear/disappear. We dismantled the pinpuller, restowed it with the TiNi extraction tool, but could then not reproduce the failure case.

The instrument configuration is shown in two attached pictures, not the failing case, though.

The pinpuller in question is replaced by a spare pinpuller and returned to TiNi for further inspection. It is anticipated that it will be repaired or replaced by TiNi, so we can assemble a complete spare SEPT unit.

Ten pinpullers were returned to TiNi for inspection. Some were found “questionable” w.r.t. sufficient margin in mechanical dimensions of internal contacts. They were reworked at TiNi, and all ten pinpullers returned to Kiel. Eight pinpullers were re-assembled into the sensor units.
