STEREO IMPACT

PROBLEM REPORT

PR-7006

SEPT-Rod

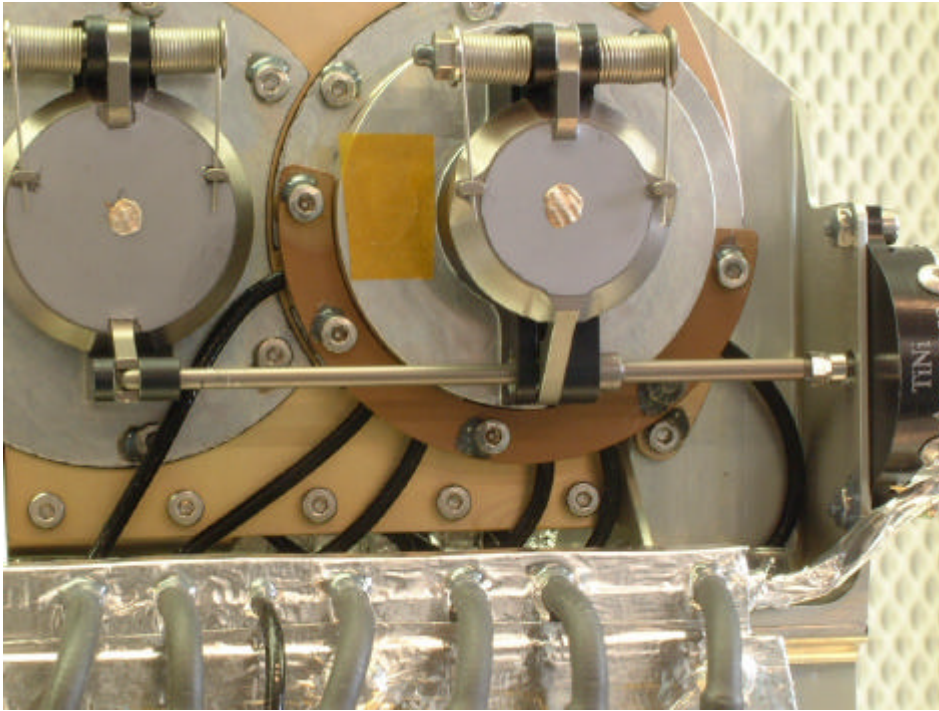
On November 23, 2004, SEPT-NS FM2 had finished its vibration tests and a door opening test was carried out. When attempting to open the doors on the rear side (i.e. side A) the pinpuller retracted correctly drawing 0.8 A for 45 ms as expected. However, both doors did not swing open, because the rod was still partly blocking the door clevises (see Fig. 1). Apparently, during vibration, the rod had loosened from the pinpuller pin because the rod was not sufficiently torqued into the pin tip which provides an M2 internal thread. Inspection of side B showed an identical failure, so it was not attempted to open side B (see Fig. 2).

The M2 thread was not staked prior to vibration for the fear of losing a pinpuller in case of a disassembly later-on for some unexpected reason. As the mechanical specification from the manufacturer TiNi of the torque load was not clear to us ("nominal stress of 50 ksi stress"), the rod was torqued to good engineering practise only. An earlier attempt to apply adhesive on the rod/pin interface on the outside surface was discarded because this interface will move right to the hole drilled into the sensor mounting lug through which the pin is retracting.

Figure 1: SEPT-NS FM2 side A after pin-puller actuation after vibration

The pinpuller of side A was re-stowed, the pinpuller rods of sides A and B were re-torqued to good engineering practise, the pinpullers were actuated and the doors opened nominally with expected currents and activation times. Having advanced thus far in the assembly and test program, we felt that it was justified to stake the thread on the pinpuller rods using Araldite 2014 adhesive. It was decided to stake all pinpuller-rods, even those which performed flawlessly after vibration. The SEPT materials list was updated to include Araldite 2014. The four SEPT units proceeded to TV testing with staking applied.

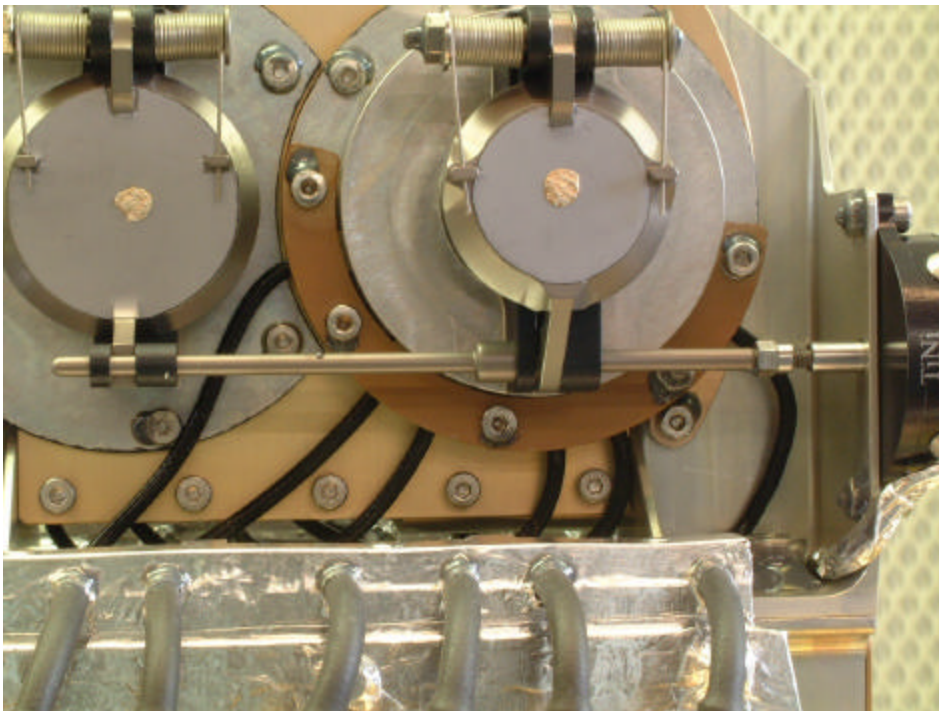
Figure 2: SEPT-NS FM2 side B after vibration, pin-puller actuation not attempted
