STEREO IMPACT SEP TOP LVPS FM1 REWORK INSTRUCTIONS

STEREO IMPACT SEP LVPS TOP BOARD

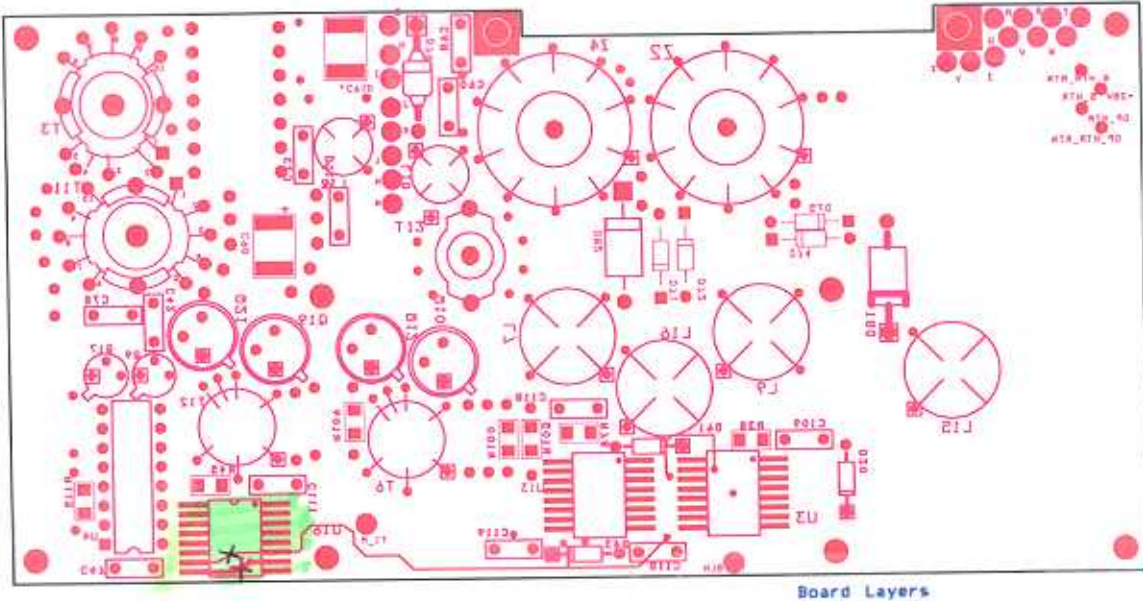
Figure 1:

SEP TOP board has a short between U16 Pin 6 and U16 Pin 10 due to schematic generating software error where two separate signal lines were named the same. In order to separate the signals, four traces need to be cut.

- 1) Cut the trace between U16 pin 6 and U16 pin 10. (See Layout Figure 1)
Completed by _____ Date _____
- 2) Cut the trace between U29 Pin 9 to the via (See Layout Figure 2)
Completed by _____ Date _____
- 3) Epoxy the traces that were cut.
Completed by _____ Date _____
- 4) Replace any parts that needed to be removed in order to cut the traces. Record the reference designator and the new date code below.
