STEREO IMPACT

PROBLEM REPORT
PR-6001
HVPS_thermal
2003-09-15

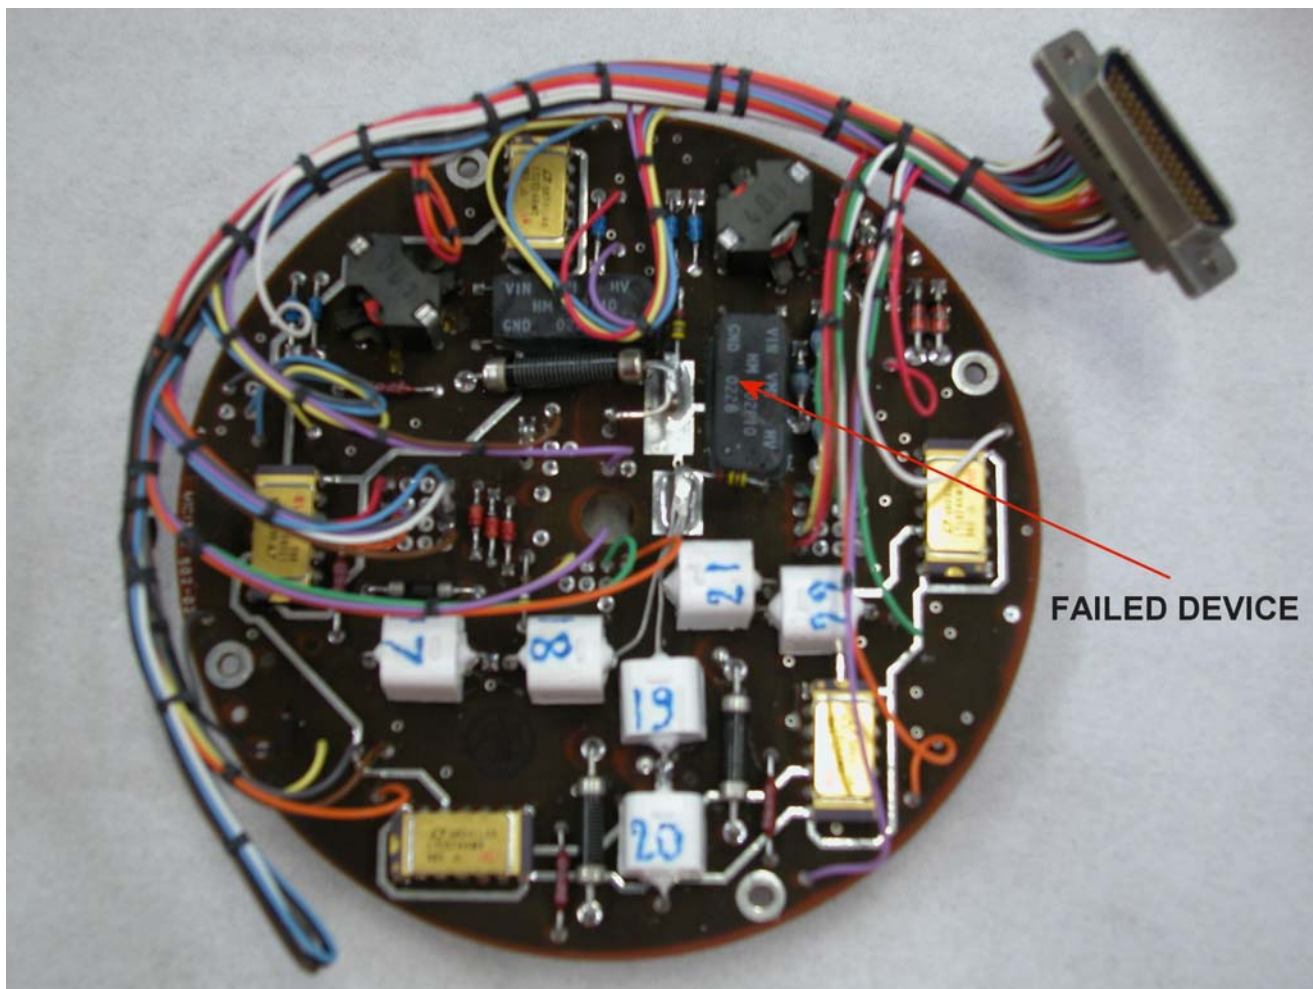
Appendix to STEREO IMPACT PFR 6001, VMI multiplier failure
2003-12-2 Dave Curtis, Claude Aoustin

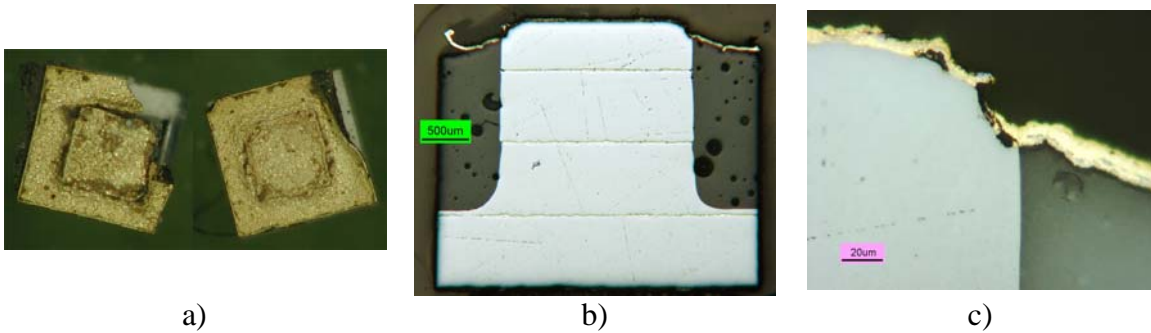
Figure 3. Overall view of the diodes (a), cross-section (b), and close-up of gold metallization (c). Note peeling of the gold plating which suggests poor process control and possible contamination in the gold layer.

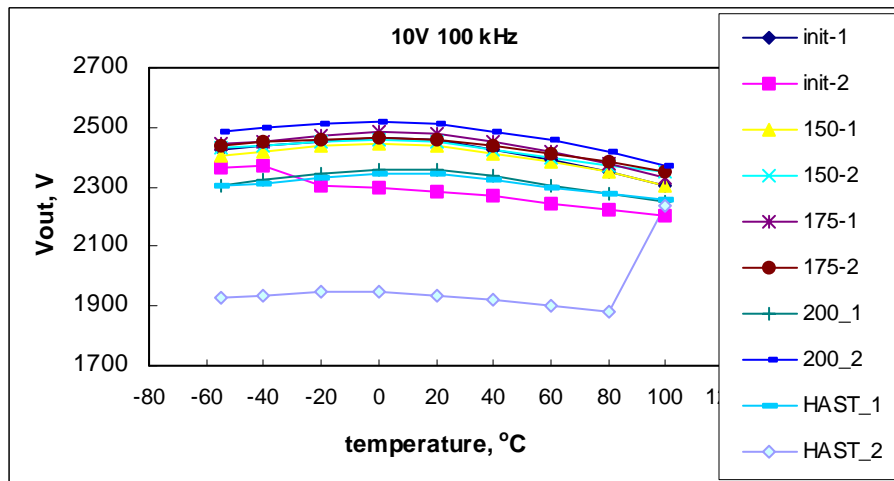
Figure 5. Temperature dependencies of the output voltage for the two samples after different stress testing.

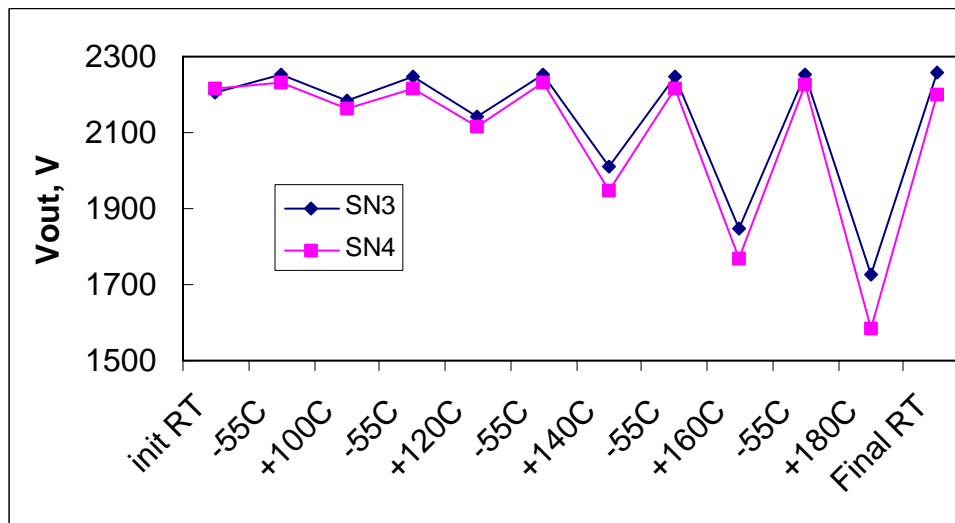
Figure 8. Initial monitored temperature cycling of two parts from a new lot.

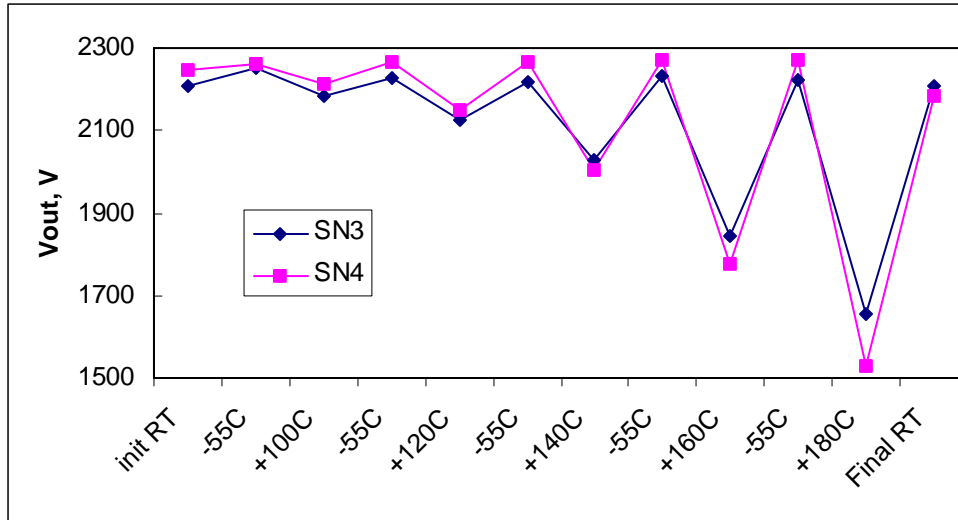
Figure 9. Results of monitored temperature cycles after storing for 100 hrs at $200\text{ }^{\circ}\text{C}$.

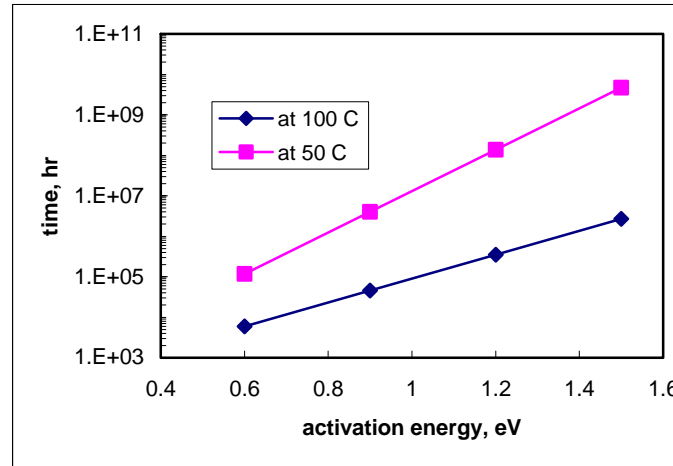
Figure 14. Calculation of the time equivalent to 100-hour aging at 200 °C for operating temperatures of 50 and 100 °C.
