# STEREO IMPACT

PROBLEM REPORT

PR-1015

SEP LVPS FM1

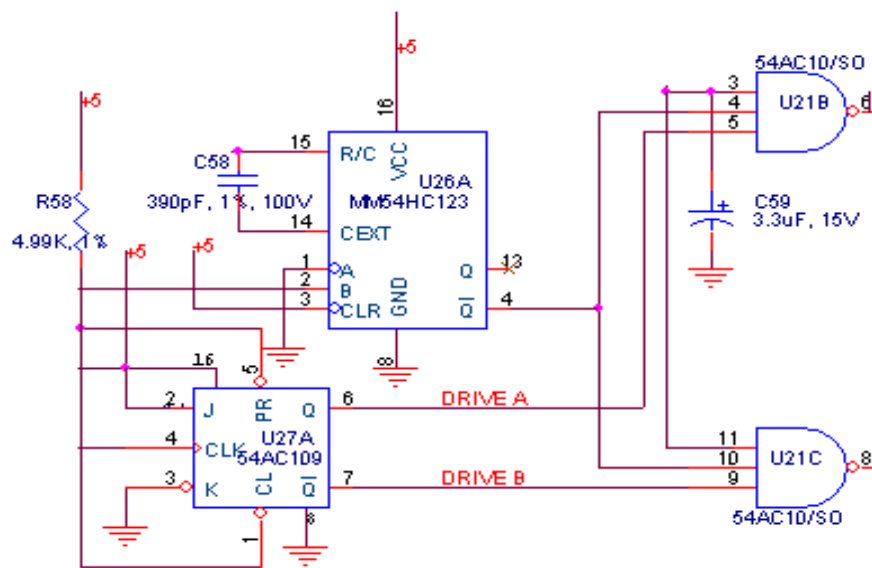
U27 Repair

1. The issues found during the troubleshooting for the noise problem (U27 and then U21) were most likely caused when the boards were disassembled. (Reference the corrective actions steps 1 – 4 below). This fix only applies to FM1.
2. The noise problem required a change in the tuning capacitor for the LTC1877. (Reference corrective action step 5.) This fix is required on both flight units.

- 1- Removed and replaced the flip-flop U27
- 2- Removed and replaced the triple 3-input NAND gate U21.
- 3- Connected U27 pin 6 to U21 pin 5; connect U27 pin 7 to U21 pin 9. (Note: they must be twisted together per rework document dated 4/02/04)
- 4- Staked the wires using Uralane 5753. (Added more staking to the wires to protect this connection)
- 5- Changed C32 to 390pF capacitor to eliminate the unstable output at 2.6V. The drawings were updated to reflect this change. (This fix applies to both flight units.)
