STEREO IMPACT

PROBLEM REPORT

PR-3011

Assembly : SIT Instrument	SubAssembly : ATOF electronics board
Component/Part Number:	Serial Number: 01
Originator: Walpole	Organization: UMd
Phone : 301-405-6217	Email : Walpole@umd.edu

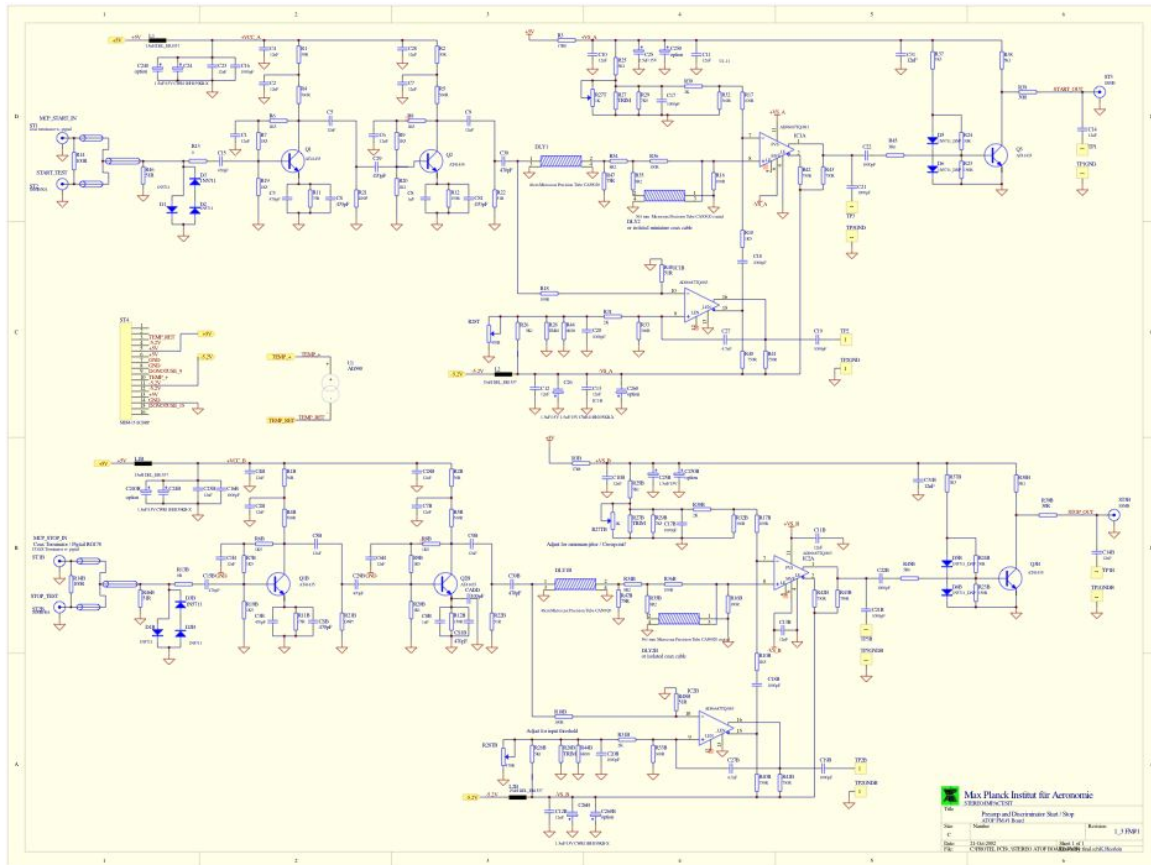
Looking back, we find that this problem first showed up during Thermal Balance testing of the FM1 unit. The fm1 stop rate went to zero in thermal balance around 3-4PM on Feb 14; this was noted at the time, and was deemed to be due to the MCP "cleaning up". We had believed that there was no discharge since the SIT misc did not reset in association with this incident, and in all other cases of suspected HV discharges, the misc had reset. Also, the HV showed no anomalies. After the thermal balance, a functional would have identified the failure, but this was not done while SIT was hooked up to sep central since the blankets were in place, etc. After it was disconnected from sep central, it would have required a return to UMd to do the functional and we decided against this -- clearly not the right decision.

Looking in detail at the thermal balance data, the failure was around 19:56 UT (see attached plot). There is a burst in the START rate that decays over a period of time -- possibly there was spark that took out the STOP channel, and produced some ionization that was counted by the START (which continued to operate). The HV shows no change, and the MISC continued as before. At the time of this discharge, the telescope had been under HV for about 10 hours at the nominal operating state ("b8").
