STEREO IMPACT

PROBLEM REPORT

PR-7002

SEPT-Detector

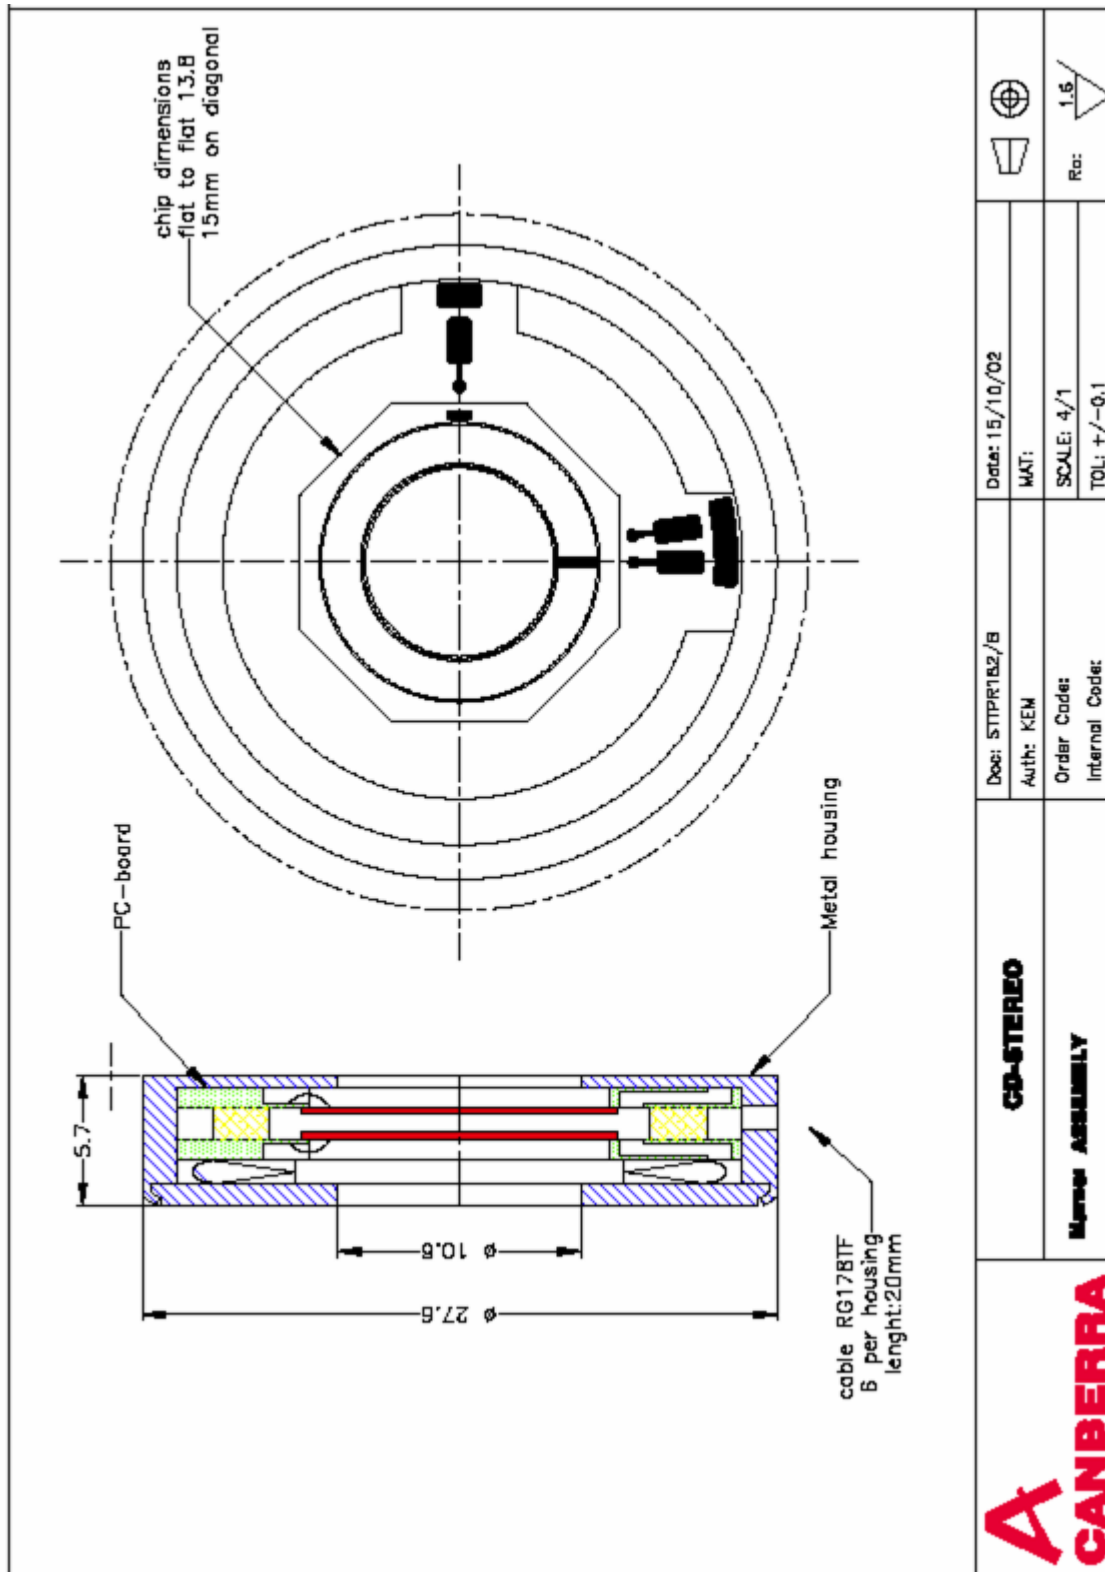
There are 16 passivated implanted planar silicon (PIPS) detectors (Canberra Part # CD-STEREO-300-EB) installed in four SEPT units. The detectors are packed in stacks of 2. During TV cold soak (-40 °C), 3 detectors in 2 stacks (Serial # 51863 and # 51860) produced high leakage currents: SEPT-E FM1 detector 2 in cycle 1, SEPT-E FM2 detector 1 in cycle 1, SEPT-E FM2 detector 0 in cycle 2. The leakage current measurement shows saturation, time resolution of the measurement is 1 minute.

The onset of the failure is sudden like a switch: below a certain trigger temperature, the failure is continually present and absent above this temperature. The trigger temperature is different for the three detectors and is observed to move to higher temperatures in the course of the thermal cycling (e.g. from -35 °C to +9 °C).

Simultaneously the current on the -80 V bias supply switches from 4.3 µA to 22 µA in the case of a one-detector failure (FM1), and in a second step to 43 µA in the case of a two-detector failure (FM2), time resolution of the measurement is 1 second. Note: this is not detector leakage current which is in nA range!

In the case of the SEPT-E FM1 failure, vacuum was broken, detector 2 disconnected from its electronics and connected via a chamber feedthrough to the EM electronics outside the chamber. During cold soak the failure signature could be reproduced, i.e. the origin could be located inside SEPT sensor. The suspected cause is the detector mount and/or wire-bonding which might lead to short-circuiting to analogue ground. (More attached)

The tests at Canberra were successful in revealing the cause of the failure: the height of the arch suspended by the wire bonds is higher than the separation distance of the two detectors in the stack. All eight detector stacks (not only the two failing ones) were disassembled, wire bonds removed, new wire bonds applied with maximum height of 0.6 mm, detectors separated by 1.0 mm instead of 0.8 mm and mounted in new housing. All four sensor units were re-assembled and integrated with their associated electronics units.

All eight detector stacks (not only the two failing ones) were disassembled, wire bonds removed, new wire bonds applied with maximum height of 0.6mm, detectors separated by 1.0 mm instead of 0.8 mm and mounted in new housing. All four sensor units were re-assembled and integrated with their associated electronics units. Nearly all of the detectors survived the opening of the stacks unharmed and could be re-used.
