STEREO IMPACT

PROBLEM REPORT

PR-1006

STE-U FM1 Miswire

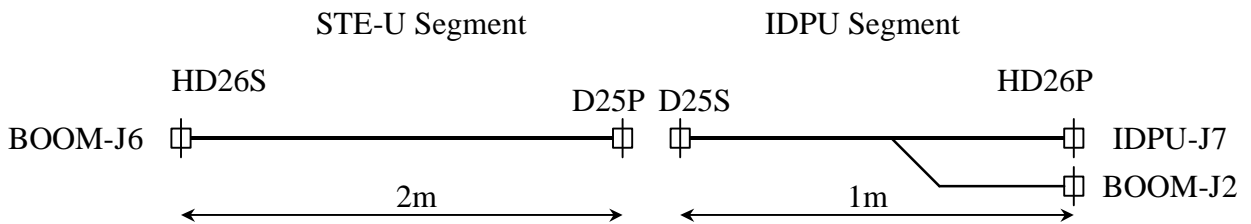
When this harness is used with the STE-U by itself (connected to STE-U P1 instead of BOOM-J6), the spacecraft-monitored STE-U temp sensor is included. Those signals are routed on the IDPU end to BOOM-J2, which is the connector that the temp sensor is routed to inside the boom.

Wire should be PTFE stranded wire, coax should be RG178. Wires and connectors should be cleaned before assembly (Alcohol wipe), and should be assembled clean using gloves. After assembly, bag harness.

1.1 STE-U segment

Pin	Signal	Destination	Harness
1	OUTPUT1	D25P pin 1	Coax w/2
2	OUTPUT RET	D25P pin 2	Coax Shield w/1
3	OUTPUT2	D25P pin 3	Coax w/4
4	OUTPUT RET	D25P pin 4	Coax Shield w/3
5	OUTPUT3	D25P pin 5	Coax w/6
6	OUTPUT RET	D25P pin 6	Coax Shield w/5
7	OUTPUT4	D25P pin 7	Coax w/8
8	OUTPUT RET	D25P pin 8	Coax Shield w/7
9	Spare		
10	Test RET	D25P pin 9	Coax Shield w/11
11	Test	D25P pin 10	Coax w/10
12	Ground	D25P pin 14	#26 TT w/13,14
13	+5V	D25P pin 15	#26 TT w/12,14
14	-5V	D25P pin 16	#26 TT w/12,13
