STEREO IMPACT Technical Progress Report

Subject: IMPACT Monthly Technical Progress Report, Contract NAS5-00133

Enclosed is the monthly technical progress report for the STEREO IMPACT project for the month of October 2004.

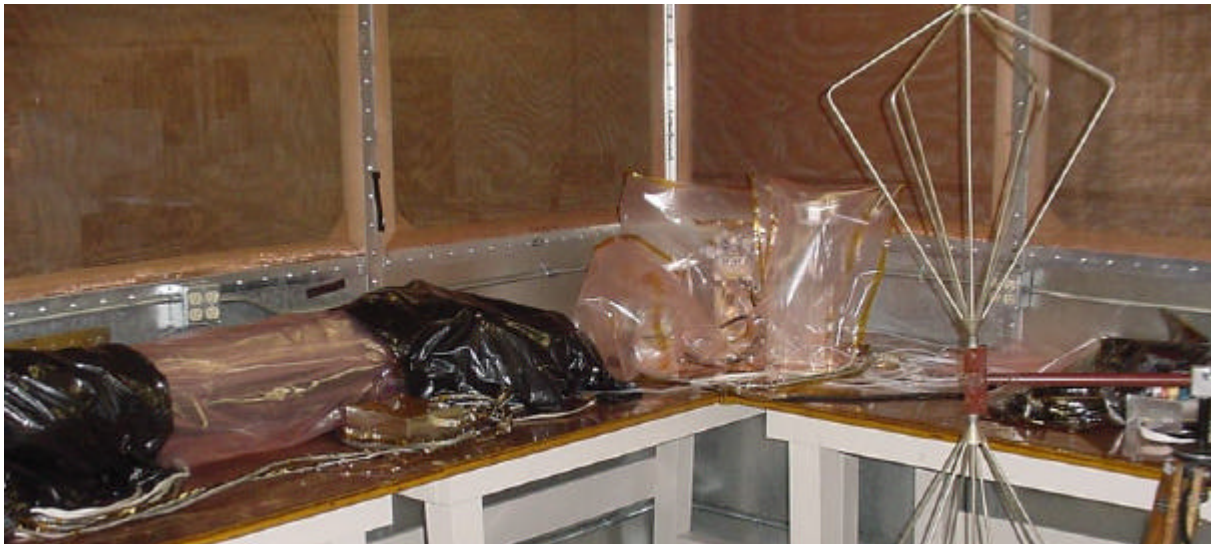
IMPACT Suite at EMC

- Completed full IMPACT Suite Integration and Test
- Completed IMPACT Suite EMC tests
- Completed IDPU/SWEA TRR
- Completed SIT door review
- Participated in Project EMC committee meetings
- Participated in various MRB/FRB meetings
