STEREO IMPACT Technical Progress Report

Subject: IMPACT Monthly Technical Progress Report, Contract NAS5-00133

Enclosed is the monthly technical progress report for the STEREO IMPACT project for the month of February 2005.

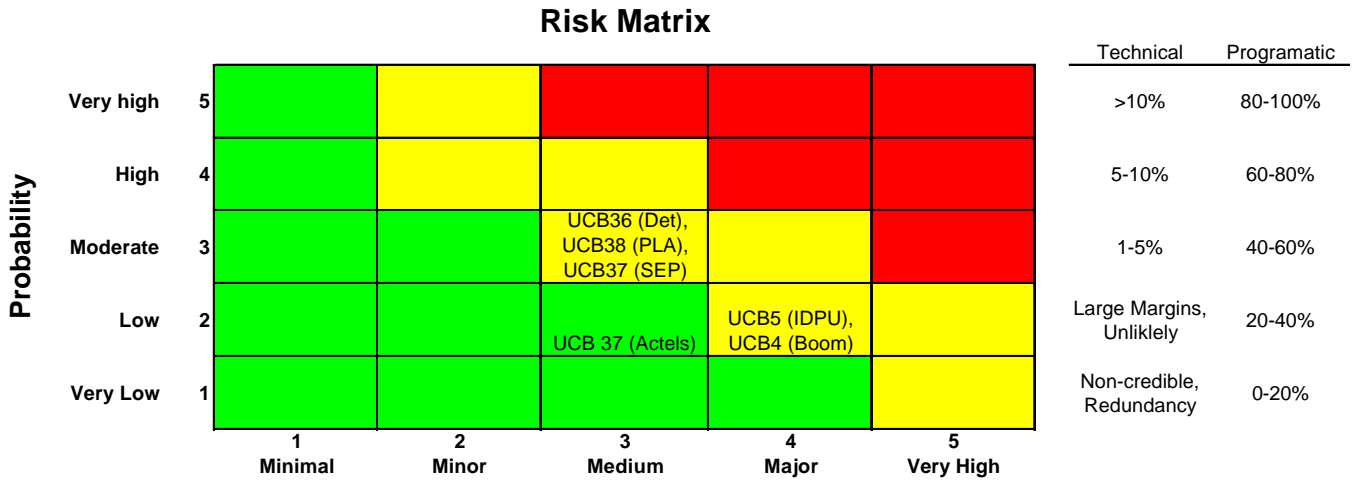
IMPACT Top Ten Risks 1/2005

Minimal cost / no schedule, design margins	<3% cost, non- critical path slip, work-around	3-10% cost, Critical path slip, loss of capability	>10% cost, 1-3 mo, Level 1 science	>20% cost, 3 mo launch slip, Mission failure
--	--	---	--	--
